MEMORANDUM FOR RECORD: Inspection of Ice Jam at Athol, Ma. 22 January 2004

Project: FY04 Monitoring New England Ice Jams

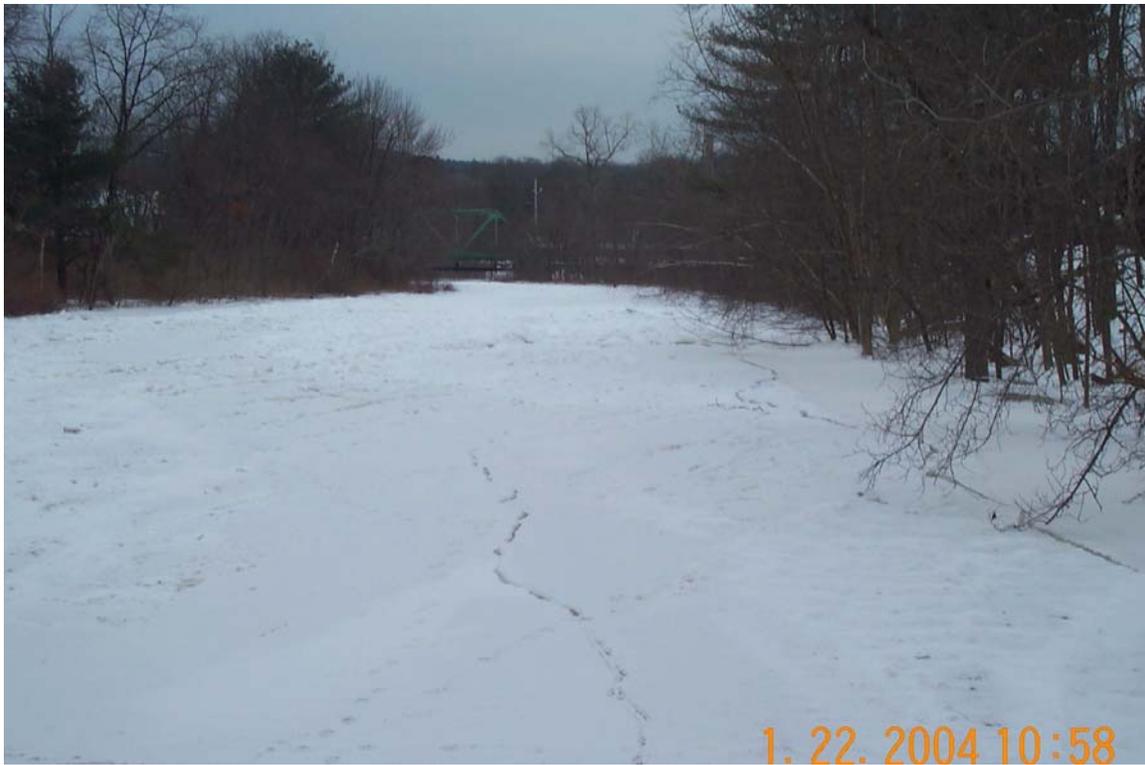
2. We met with Athol Fire Chief Jim Wright at 10:00 hrs. and discussed the sequence of events leading to flooding and also the best access points to the Millers River. Chief Wright recalled that the last two severe cold spells resulted in backyard flooding, with the most significant being on the weekend of 17 January. We decided to make our first measurements at the intersection of Union Street and Shore Drive. This was the closest access point to the recent flooding of the Wheeler property at # 149 Pequig Avenue. Table 1 contains ice thickness measurements indicated a substantial amount of frazil ice in the channel. The width of the active channel from right to left bank was 96 feet. Figure 1 shows conditions at the ice thickness measurement site. Figure 2 shows the actual drilling. An aerial view of the site is given in Figure 3.

Figure 1. View looking upstream at the exchange street bridge from intersection of Shore Drive and Union Street where ice thickness measurements were taken.

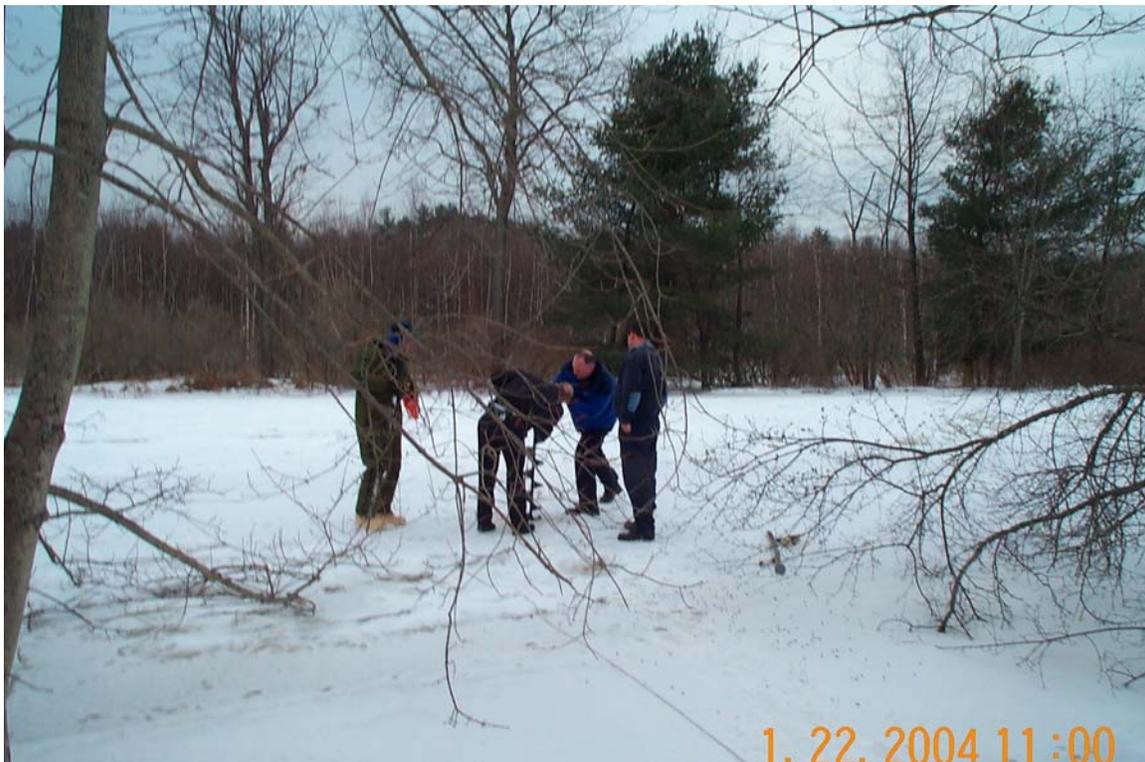
Figure 2. Assistance drilling ice by Athol Fire Department on Shore Drive

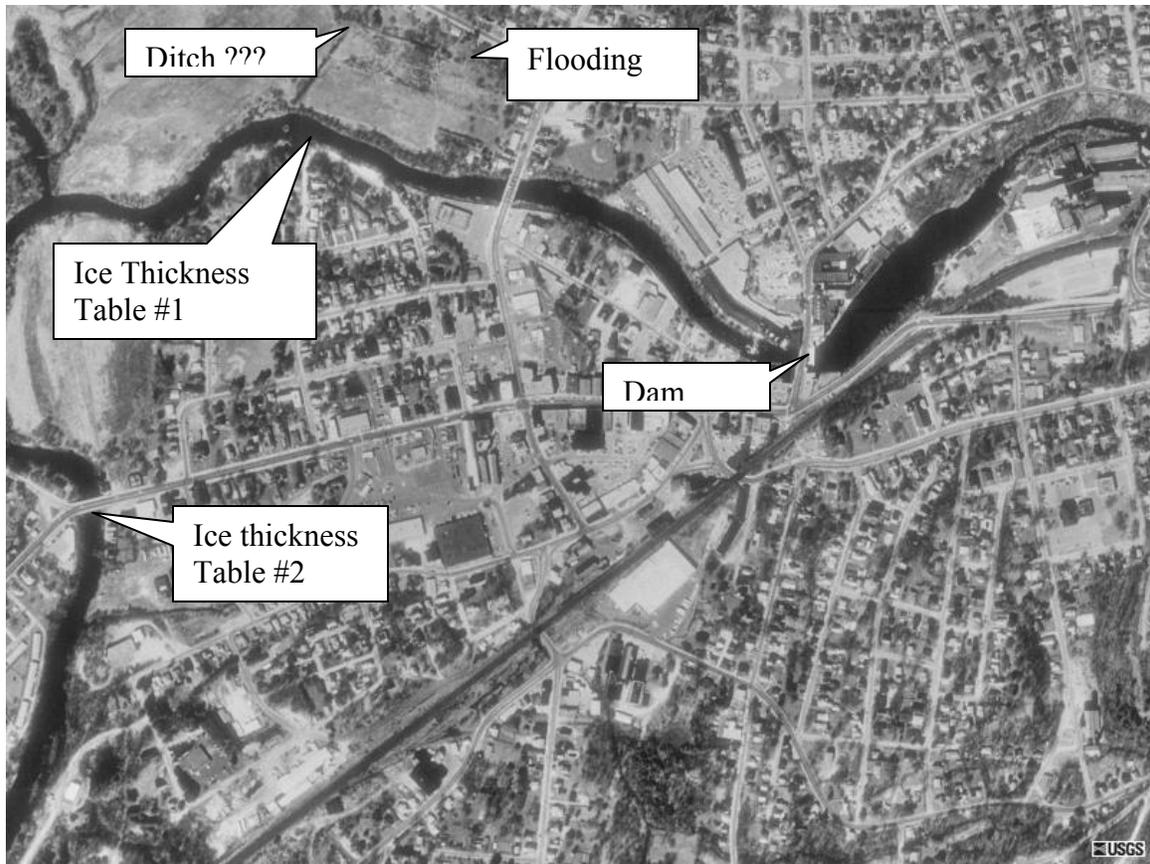
Figure 3. USGS Air Photo, Flow is right to left.

3. We then talked with Mrs. Wheeler a resident at #149 Pequig Avenue (Figure 4). She stated they have been at this location for 6 years and never been flooded. She also mentioned a ditch between their backyard and the river. A review of the USGS Air Photo (Figure 3) shows what may be a drainage ditch that could contribute to the backyard flooding via backwater from the Millers River, where water levels had been increased due to frazil ice accumulation. Further inspection of this area and the slope of the terrain could prove useful.

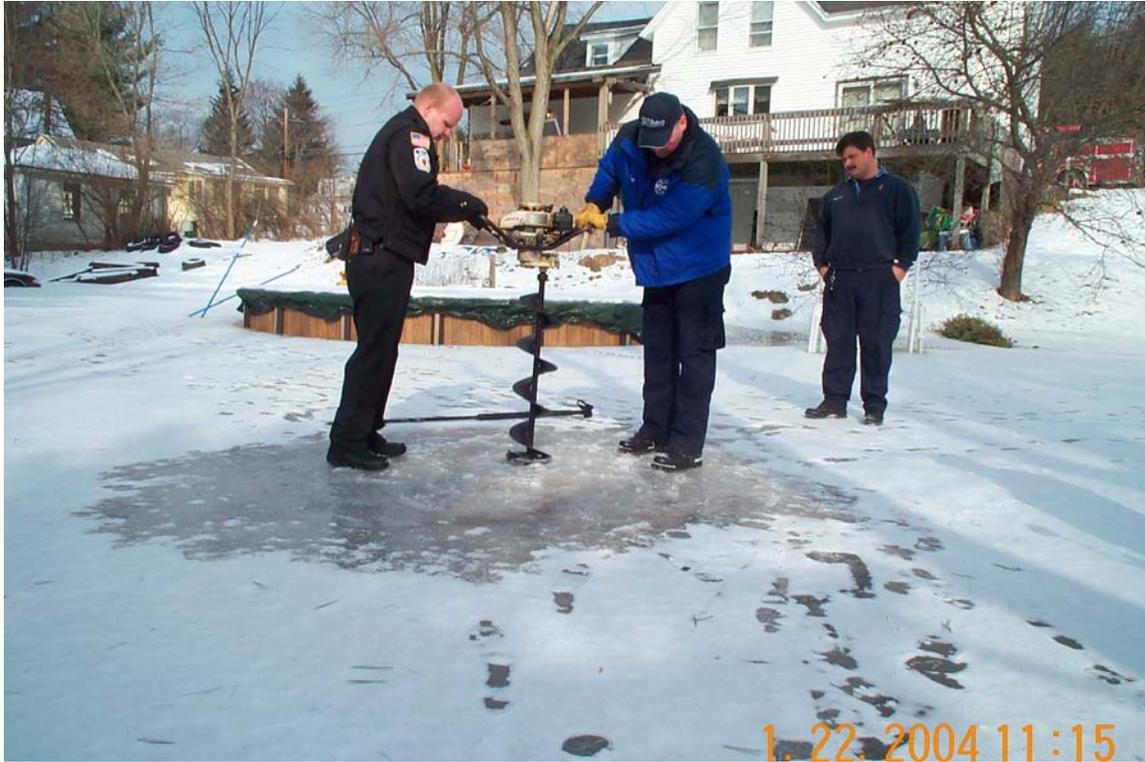
Figure 4. Backyard flooding at #149 Pequoig Avenue

4. Measurements of the ice thickness at #149 Pequoig Avenue (Figure 4) indicated two layers of ice from the two flooding events. The first event left an ice thickness of 0.7 foot frozen to the existing ground. The second cold event added an additional 1.8 feet of water with a 0.6 feet thick floating ice sheet on top. The fact that the water level was still at this level indicates that the restriction in the channel still remains and could get worse with the forecast of additional cold weather this weekend. Temperatures in January have been colder than normal (Figure 5).

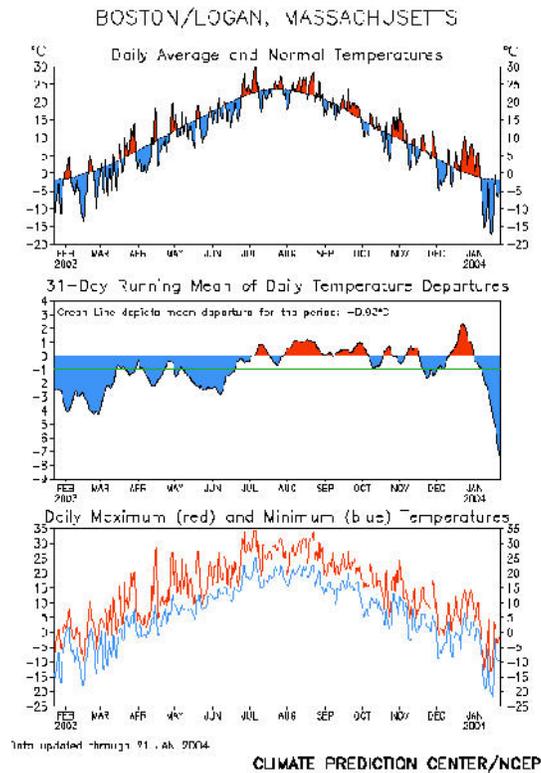
Figure 5. Air temperature record at Boston, MA. Note extremely cold temperatures in January 2004.

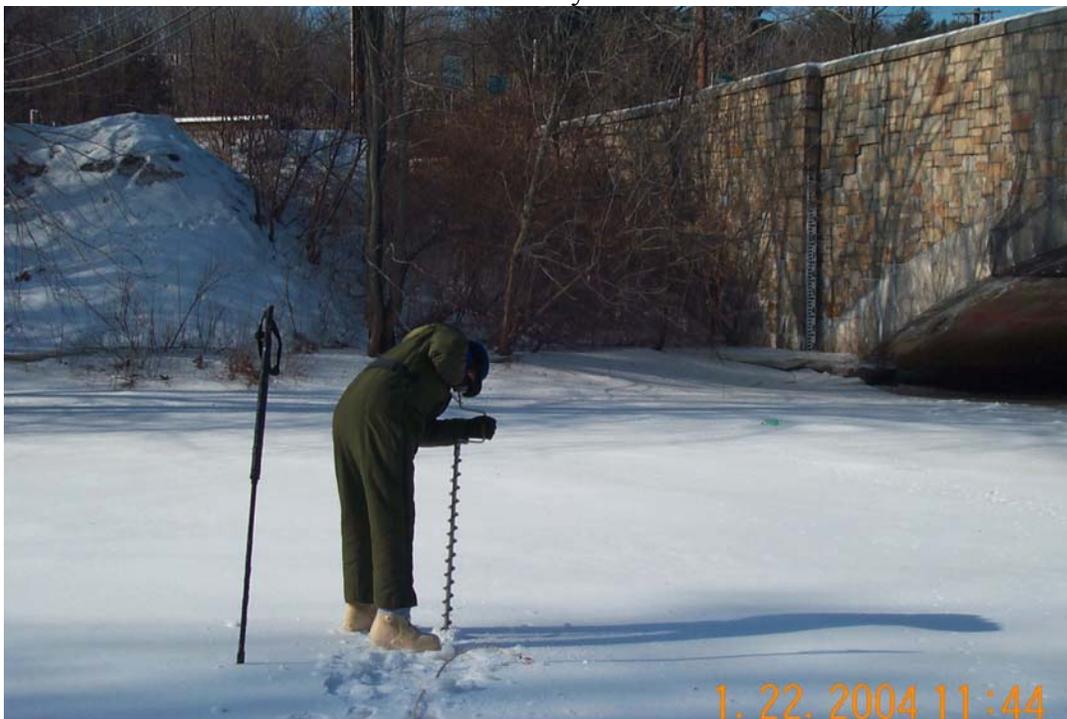
5. We then took ice thickness measurements at the downstream side of the Main Street Bridge (Table 2). In Figure 6, the staff gauge at the bridge is visible in the background on the bridge face. Flow is primarily in the center of the channel with noticeable variations in the ice surface as a result of heavy frazil deposits along both sides of the channel.

Figure 6. Ice thickness measurements downstream of the Main Street Bridge. Staff gauge in the background on the bridge face.
