Special Report 89-36

**US Army Corps
of Engineers**

Performance of wall coatings for concrete and masonry buildings in Alaska

Charles J. Korhonen and John J. Bayer, Jr.

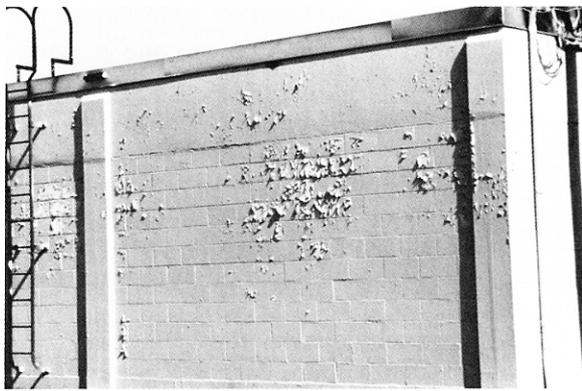
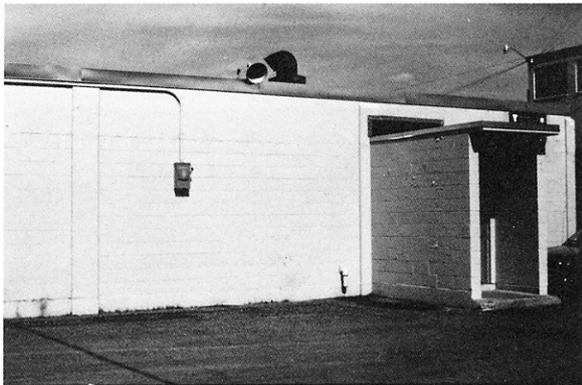
Building 610, Fort Greely, offered the best evidence of moisture from within a building causing exterior paint to debond from a wall. Its walls, starting from the inside, consist of a 1/2-in. gypsum board (painted), a 3/4-in. air space, and 8-in. concrete masonry block (latex coated on the outside). It is divided in half into computer and office space by a concrete block wall. The building is heated to 70°F and maintained at 45% RH on the computer side, while no moisture is intentionally added to the air on the office side. Because some humidity will seep into the drier office space from the computer space, we estimate the office to be at about 30% RH, which is a bit higher than normal office buildings in interior Alaska. (Flanders et al. [1982] measured office humidity typically at 20% RH.)

This humidity difference between the two sides of the building caused the external latex paint to fail at different rates. On the humidified side the paint peeled off the wall every 2 years according to maintenance personnel. On the lower humidity side, the paint lasted for 4 years (Fig. 4). Clearly, indoor humidity is harmful to exterior paint if it can condense behind the paint.

Figure 4. Two-year-old paint on building 610 at Fort Greely with sections of high and low humidity. The paint on the high humidity side of this building failed every 2 years while the paint on the low humidity side lasted 4 years.

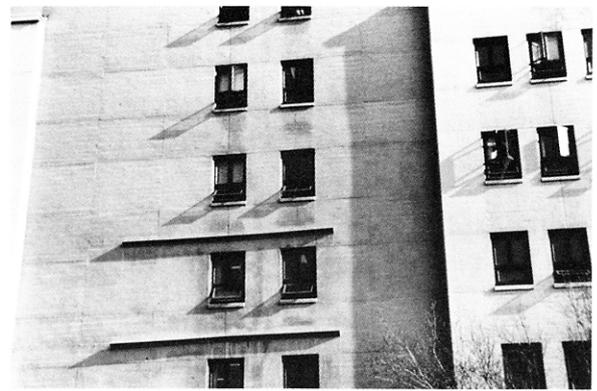
Condensate, although not seen on building 610, was evident behind coatings on other buildings. For example, the dark areas under the left column of windows in Figure 5 (building 4065, Fort Wainwright) were damp. The right windows of that building were exposed to more sunlight and thus had a chance to dry out before this photo was taken (some of the darkness was also caused by dirt). Another building (3591, Fort Wainwright) exhibited damp areas at random locations. On it, water beaded up on the outside face of the wall as the coating was scraped away from damp areas. Removing this coating was relatively easy when water was present but it was not so easy when the wall

behind the coating was dry. There were no obvious ways for exterior water to get behind these coatings. Thus, like building 610, interior humidity had to be the source of the observed moisture. We estimate the humidity of buildings 4065 and 3591 to be between 30 and 40% RH.

Figure 5. Moisture problems on building 4065, Fort Wainwright, which was coated with XL-70 paint. Moisture can be seen as dark areas beneath the left windows.

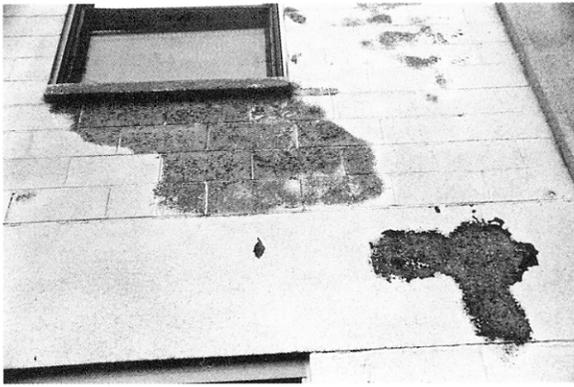
Figure 6. Frost-damaged areas. Large areas of textured coating failed revealing frost-damaged walls, particularly under windows and near bathrooms.

recommended for cold-weather application. On the other hand, our inspection of the building showed us that the paint failed primarily between the original latex paint and the wall. To us, this meant condensation. It was reasonable to suspect that water pushed the latex paint off the wall as it had done to latex paint on other buildings. Only this time, the outer coating of textured paint, being flexible, held together long enough to trap water and cause surface spalling (Fig. 6).

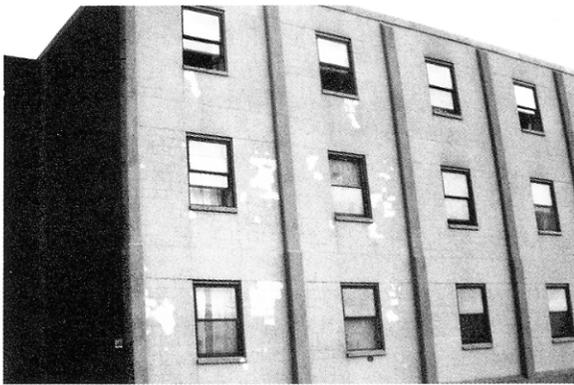
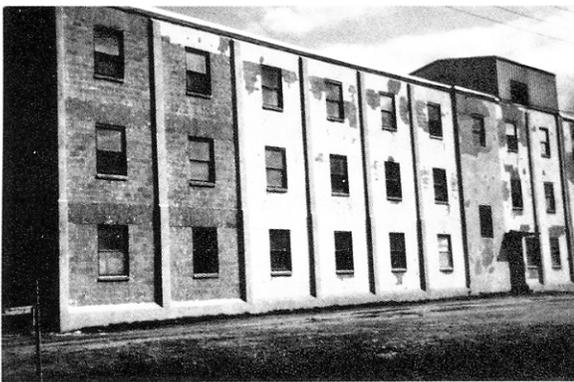
Once water becomes entrapped behind a coating, it can freeze and cause spalling of the wall. Building 3401 at Fort Wainwright provides a good example of that. This building has the longest and most troubled history with textured coatings of all the buildings we studied. In 1979, the existing latex paint was cleaned, primed and coated with XL-70. The multilayered paint began to peel a few years later. Problems eventually became so bad that the loosened paint was removed and another layer of primer and XL-70 was applied. Within a few years the paint failed again.

Many felt that improper application techniques or faulty paint, or both, led to both failures on 3401. A review of contract documents showed that the weather was rainy and cool around the time the coating was applied, so these could have caused the failure. Oil-based paints as a rule are not tolerant of wet walls during application, nor are they

By 1986 it was obvious that the walls of 3401 had to be sandblasted to bare concrete before being painted again (Fig. 7). A return trip to this building in 1988 showed that the single layer of XL-70, applied to primed concrete, was problem-free. The

Figure 7. Failure of the XL-70 coating on building 3401, Fort Wainwright. Its second recoating is shown beginning to fail in 1984 after being on the building only a few years. In 1986 the building is shown in preparation for a third coating.

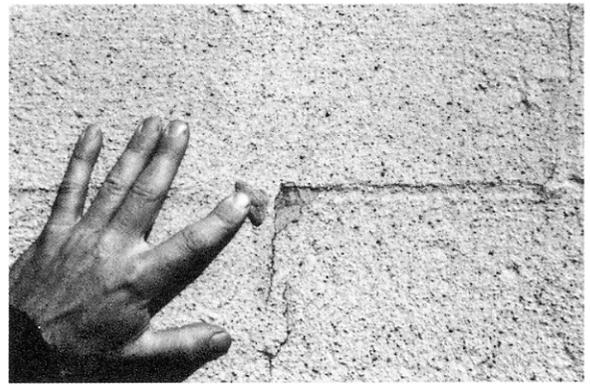
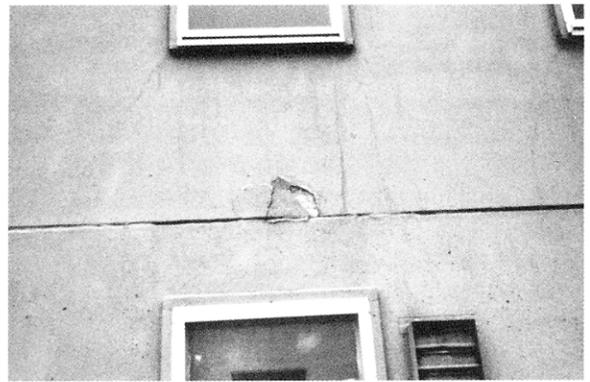
Figure 8. Pieces of substrate falling off a building with textured coatings as the paint began to fail. Evidence was most often slight (a) but occasionally a rather large area was affected (b).

On a smaller scale, spalling occurred on several other buildings. In those cases, small bits and pieces of the wall usually came off with the paint (Fig. 8). Interestingly, this only occurred to walls coated with textured paint. Walls coated with latex paint were unmarked (see the frost damage column in the tables of Appendix A). Either textured paint traps more moisture than latex paint because it is less breathable or because it stays intact longer. The laboratory study addresses that issue.

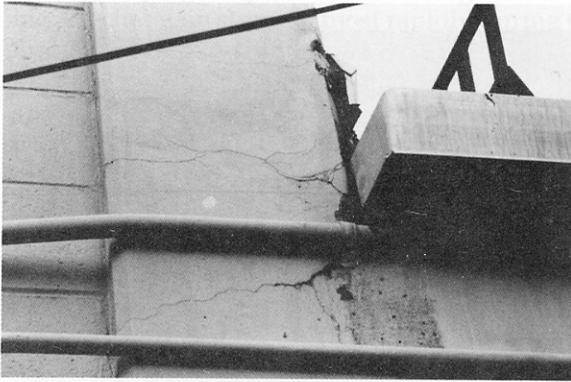
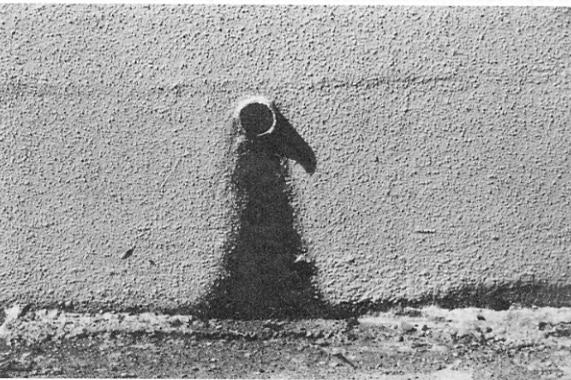
b. Building 764, Fort Richardson. This did not happen if the outlet protruded at least 6-in. past the wall.

Figure 9. Exterior water damage. Water from roofs and roof drain outlets eroded coatings, exposing the subsurface to weathering.

External coatings were not only attacked by moisture from within buildings, but, to a lesser degree, they were also effected by outdoor moisture. Rain and snow had little effect on exterior coatings except when they were concentrated onto small areas of wall. Then, deterioration was striking. Figure 9 shows two examples. In Figure 9a, repeated wettings from water overtopping the roof's edge caused this concrete column to crack by freeze-thaw action. A simple patch will repair this column but, if the water problem is not corrected, freeze-thaw damage will continue. Figure 9b is also related to roof water. In this case the water that made it to internal roof drains was not carried far enough away from the edge of the building to prevent paint erosion.

These types of problems are avoidable. Drains, flashings, gutters, overhangs and downspouts, if kept in repair, would prevent the problems shown in Figure 9. To correct the damage shown in Figure 10, simply redirect the offending moist air away from the buildings.

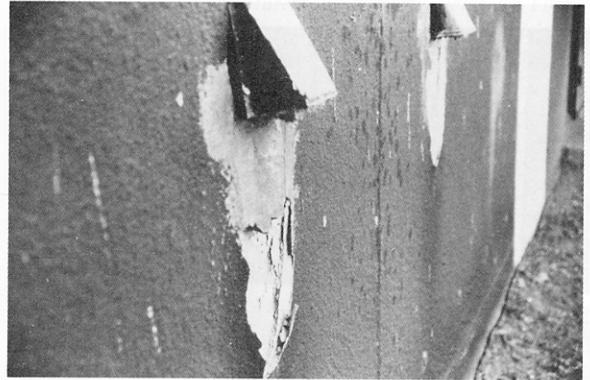
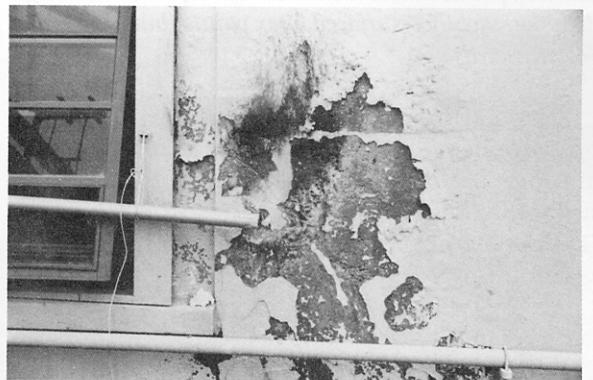
Figure 10. Dramatic signs of frost damage from exhaust moisture.

shown in Figure 10, coatings were destroyed and walls were significantly spalled by this warm, moist air. It is possible that thermal cycling, caused by the fan turning on and off, aided in debonding the coatings from the wall, but the spalled concrete could only have been caused by freezing moisture. Much of this damage occurred in as little as 1–2 years after painting.

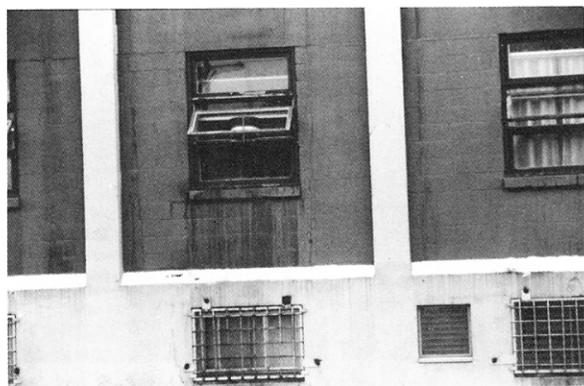
Figure 11. Dirty building surface. The rough finish of textured paints makes them more susceptible to soiling than the smoother-surfaced latex paints (building 632, Fort Richardson).

presence usually creates a need for repainting to improve the building's appearance. The rough-surfaced paints seemed to get the dirtiest (Fig. 11). Dirt came from roof runoff water, airborne dust and building occupants.

Although dirt may not directly cause coating failure, repeated paintings, because of dirt, can increase a wall's resistance to vapor flow. And as discussed earlier, heavy films shorten paint life.

The best way to avoid paint buildup and to improve appearance is to wash off the dirt with detergent and water. (We recently learned of a stain for some of the textured coatings that does not increase paint thickness but we are not sure of its effect on breathability.)

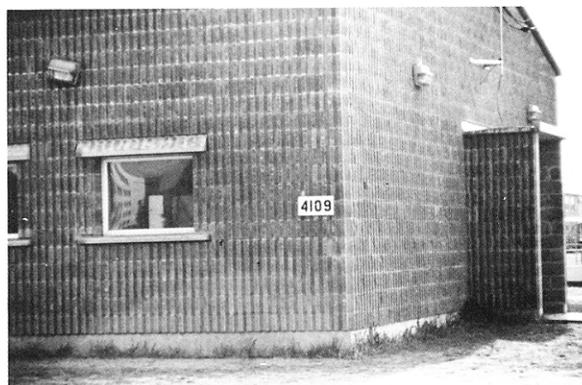
Figure 12. Uncoated buildings performed the best. Except for efflorescence, no other problems were noticed on these types of buildings (building 4109, Fort Wainwright).

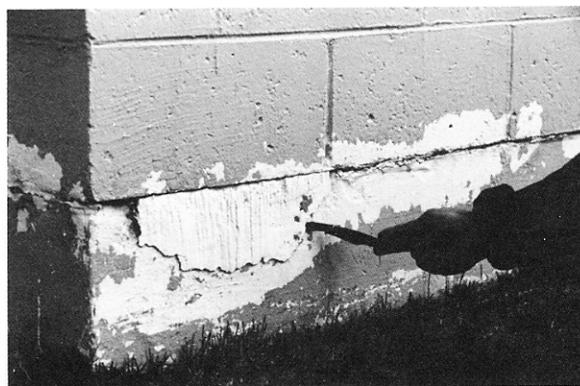
Figure 13. Patching problems. Patches failed, often revealing loose substrate below (building 655, Fort Greely).

Patches, really another form of coating, also had difficulty in remaining bonded to a wall. Figure 13 shows a typical patch. It has shrunk inward from its sides, spalled near its edges and loosened at its subbase. Not all these problems are related to the cold. The shrinkage and edge-spalling are indications of poor workmanship, whereas the loose patch may have been caused by frost action.

Patches shrink because of volume changes caused by the evaporation of water from the mix. They can shrink for years, but most of it happens in a relatively short time following placement. Shrinkage is lessened by using as little mixing water as possible and by keeping the patch moist during initial curing. Patches gain strength most rapidly during the first few days following placement. Excessive water loss when a patch is weak will accentuate shrinkage. Whether these patches received proper curing was not determinable, but, after looking at how much they did shrink, it appears to us that they did not.

As mentioned, frost action is the likely cause of the entire patch debonding from the wall. We concluded this when several patches were removed, revealing a lightly crumbled subbase—much like that seen behind some of the coatings. As with coatings, patches also need to be breathable.

Patches should never be tapered to a thin edge as spalling will occur, regardless of how well they were cured. Patches should be cut square so that the patch material will have some edge thickness. Normal expansion-contraction forces will crack patches that are too thin. For this patch the perimeter should have been recessed 1/2 in., which it wasn't.

It would be best to repair concrete with the same material as that of the substrate. In the case of Figure 13, a portland cement mortar of low water content would provide a patch having similar breathability and minimal shrinkage upon final curing.
