Inspection of Ice Jams At Farmington, ME on 18 December 2003
Steven Daly and Andrew Tuthill
ERDC/CRREL, Hanover NH 03755

On 18 December 2003, Steven Daly and Andrew Tuthill drove to Farmington, Maine, to meet with town officials at the request of Dave Schafer, Emergency Operations Center, New England District. The following is a description of the conditions that were encountered along the way and at Farmington..

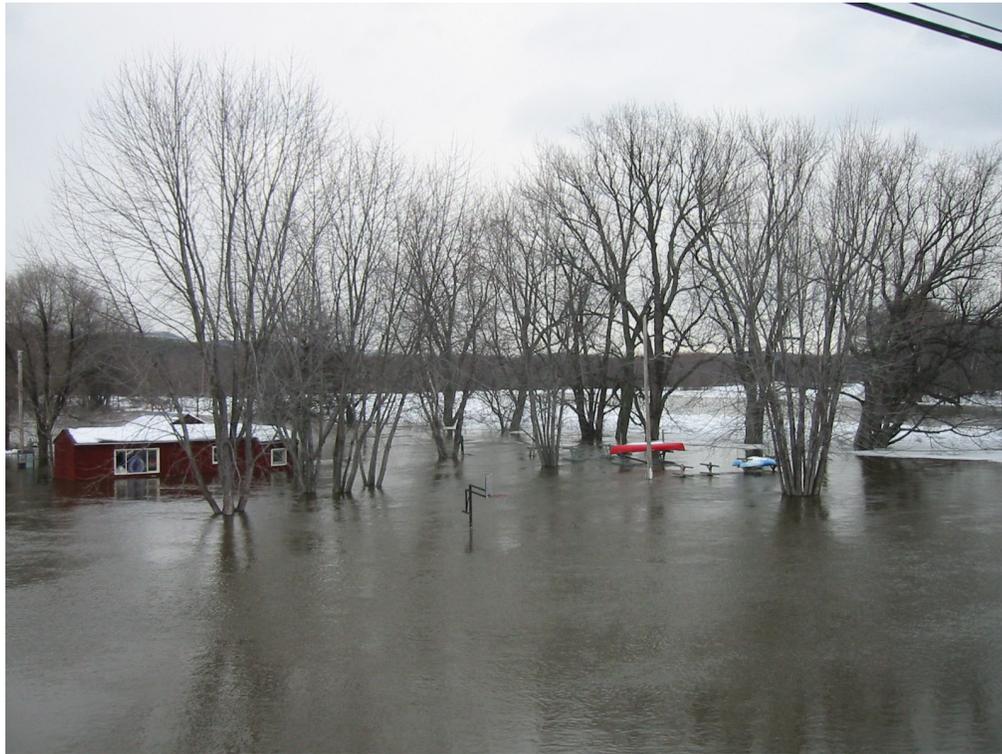
**Flooding at Bethel ME on 18 December 2003 from the Androscoggin River.
View from the Route 2 Bridge.**

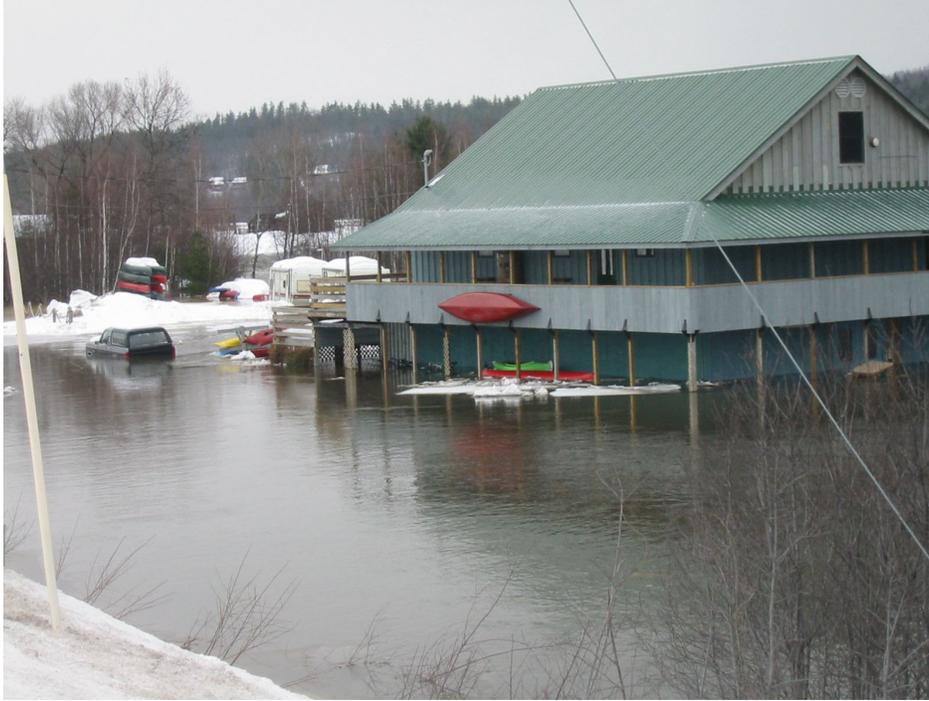
**Flooding at Bethel ME on 18 December 2003 from the Androscoggin River.
View from the Route 2 Bridge.**

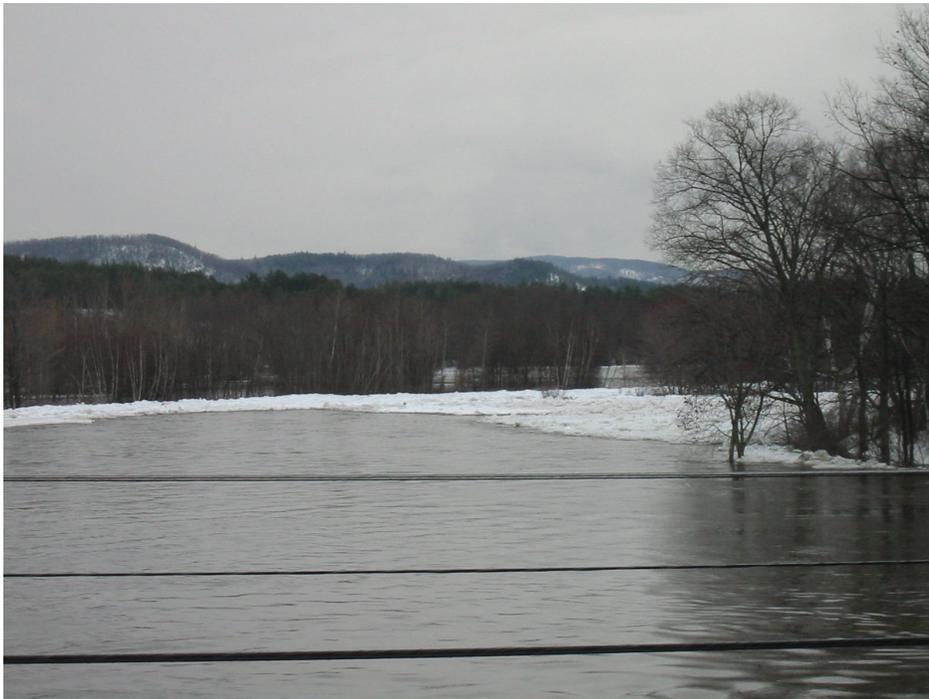
**Ice jam at Bethel ME on 18 December 2003 in the Androscoggin River. View
from the Route 2 Bridge.**

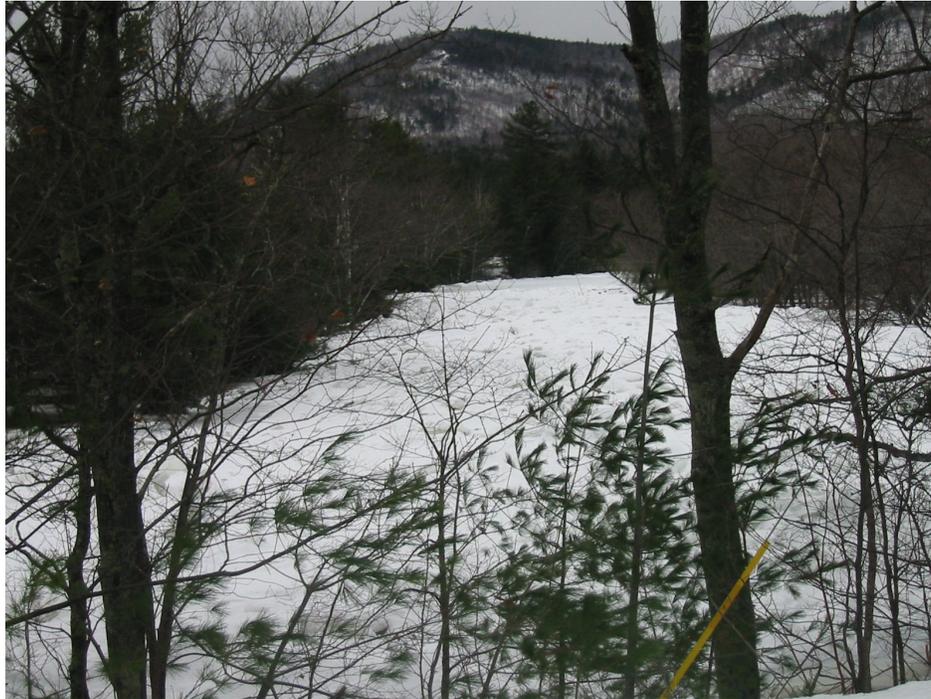
Ice Jam in tributary of the Androscoggin River

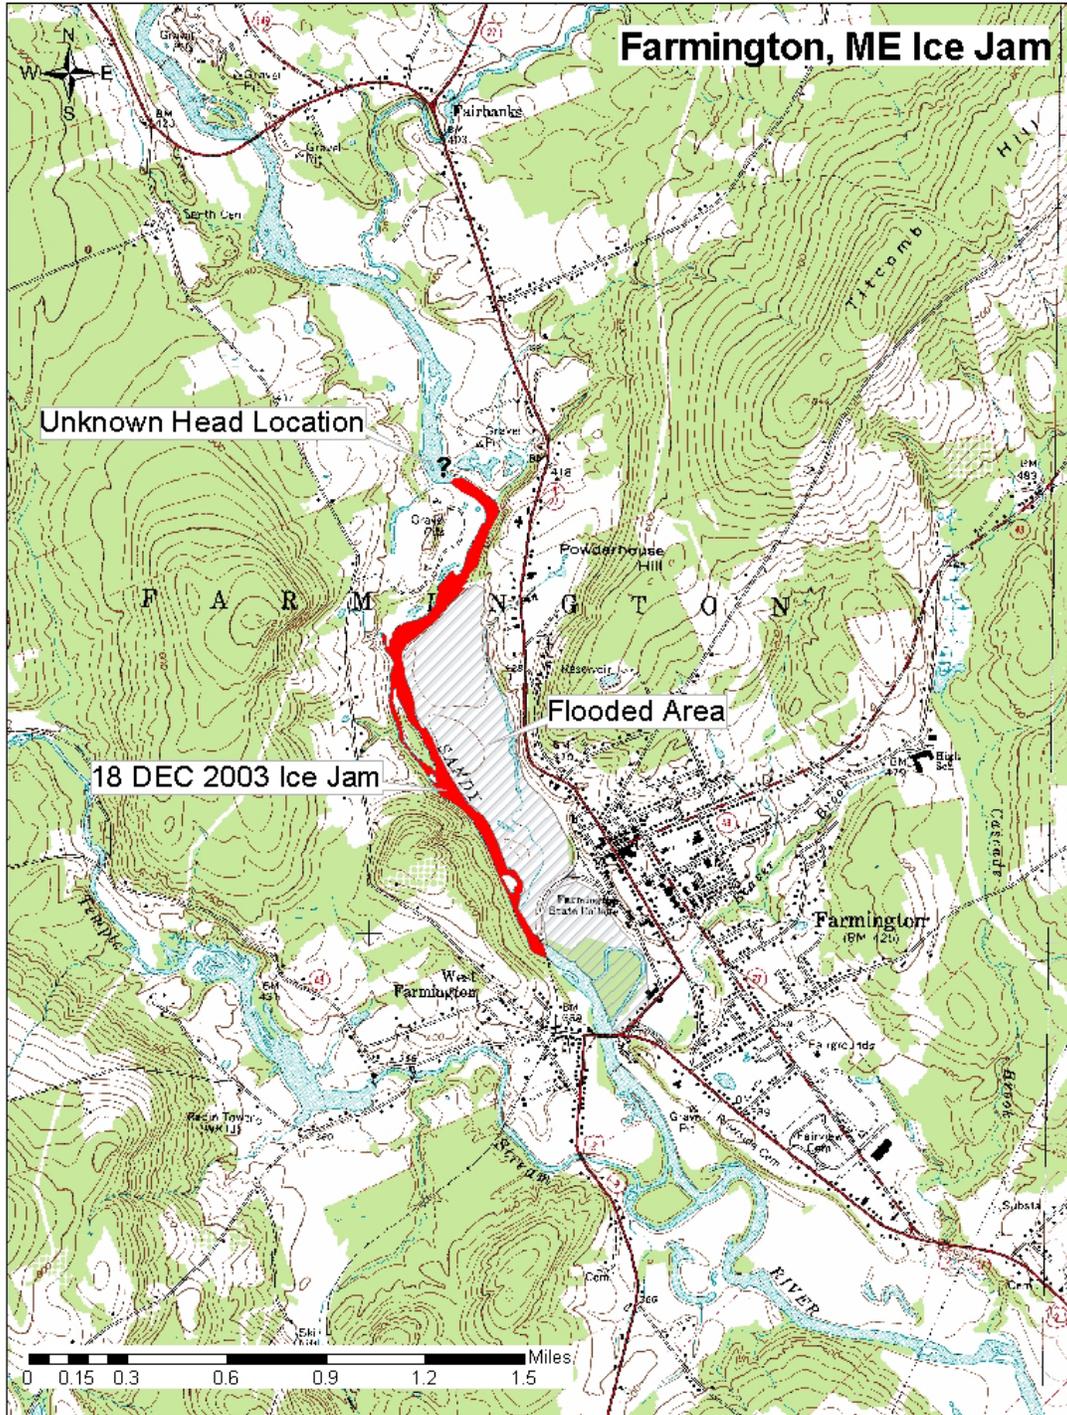
Daly and Tuthill met with the Town Manager, Richard Davies, the town engineer, and the Fire Chief. The major portion of the ice jams in Farmington had moved out at about 0700 that day. There was still an ice jam in place upstream of the abandoned railroad bridge. (See map.) The ice jam was diverting a lot of flow into the overbank area. This ice jam could remain in place for a considerable length of time. The floods had destroyed several small structures in the flood plain. A parking area of the University of Maine at Farmington had been flooded with approximately 35 vehicles in place. The vehicles had been towed out. Several points were discussed.

Ice Conditions at Farmington, ME on 18 December 2003. The upstream head of the ice jam was not visible from the roadways or from the bridge upstream of town.

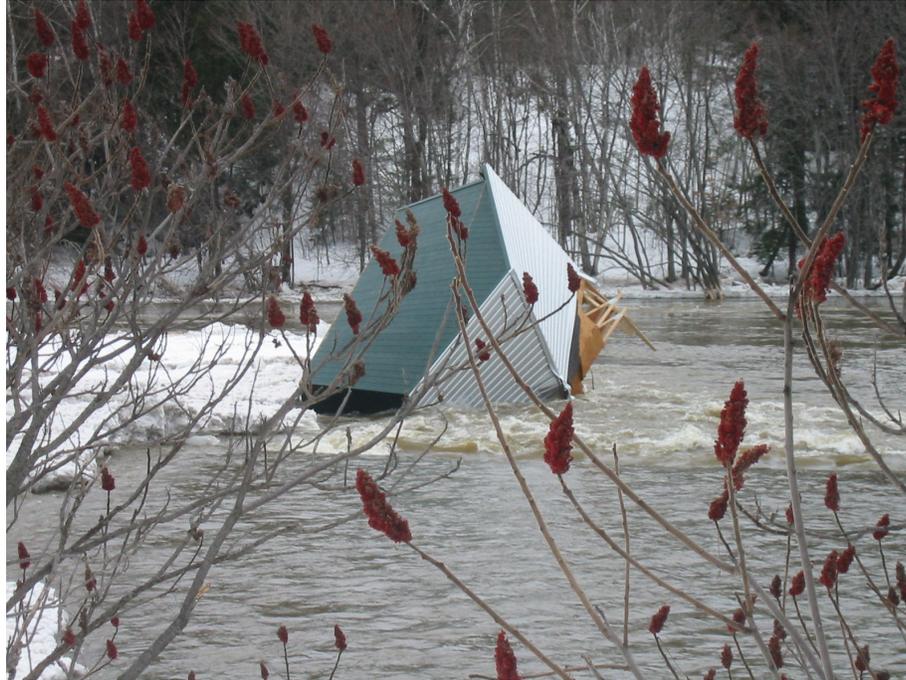
Structure moved and destroyed by flood waters of the Sandy River at Farmington, Maine

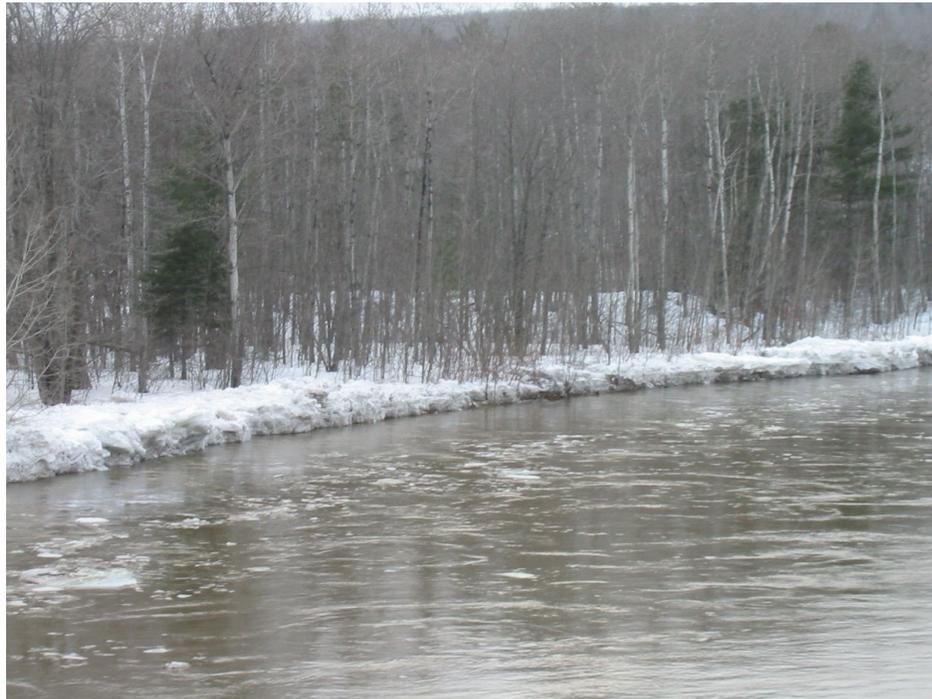
Shear walls left in place on the left bank of the Sandy River upstream of Farmington, Maine.
