Hardwick Vermont Site Visit /Field observations and 2003-2004 Winter History

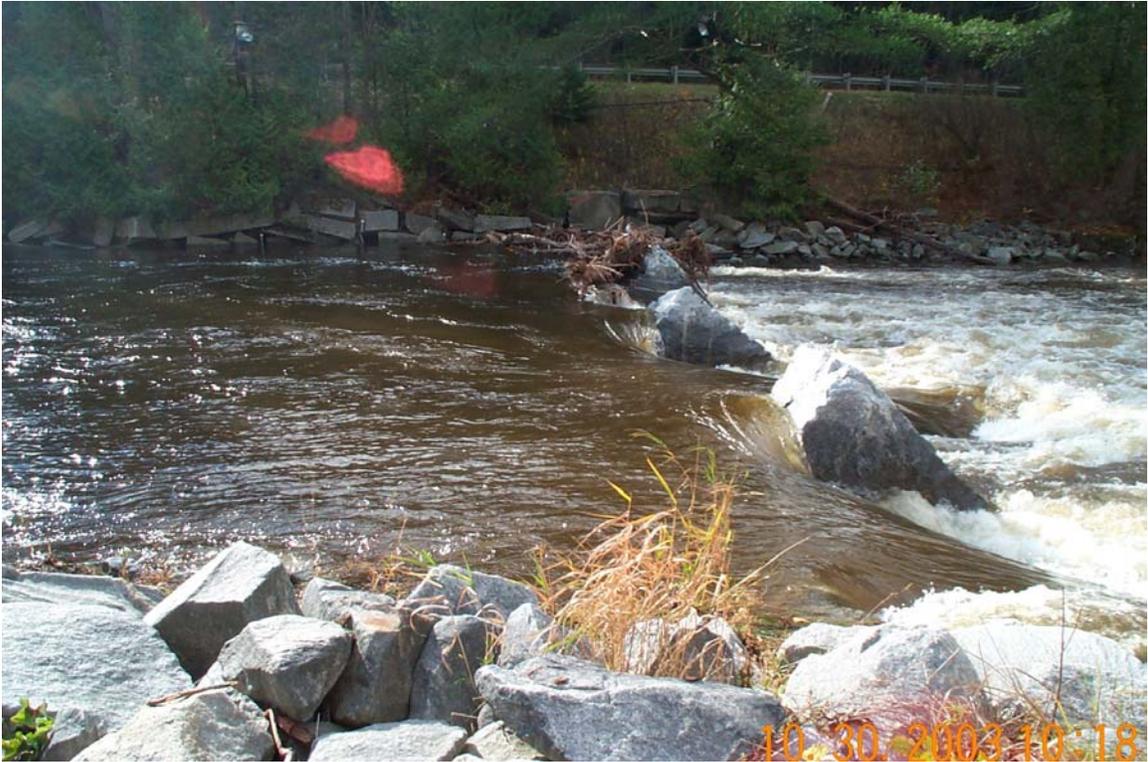
Hardwick Vermont ICS Hardwick Vermont ICS November 30,2003 (Fig 4)

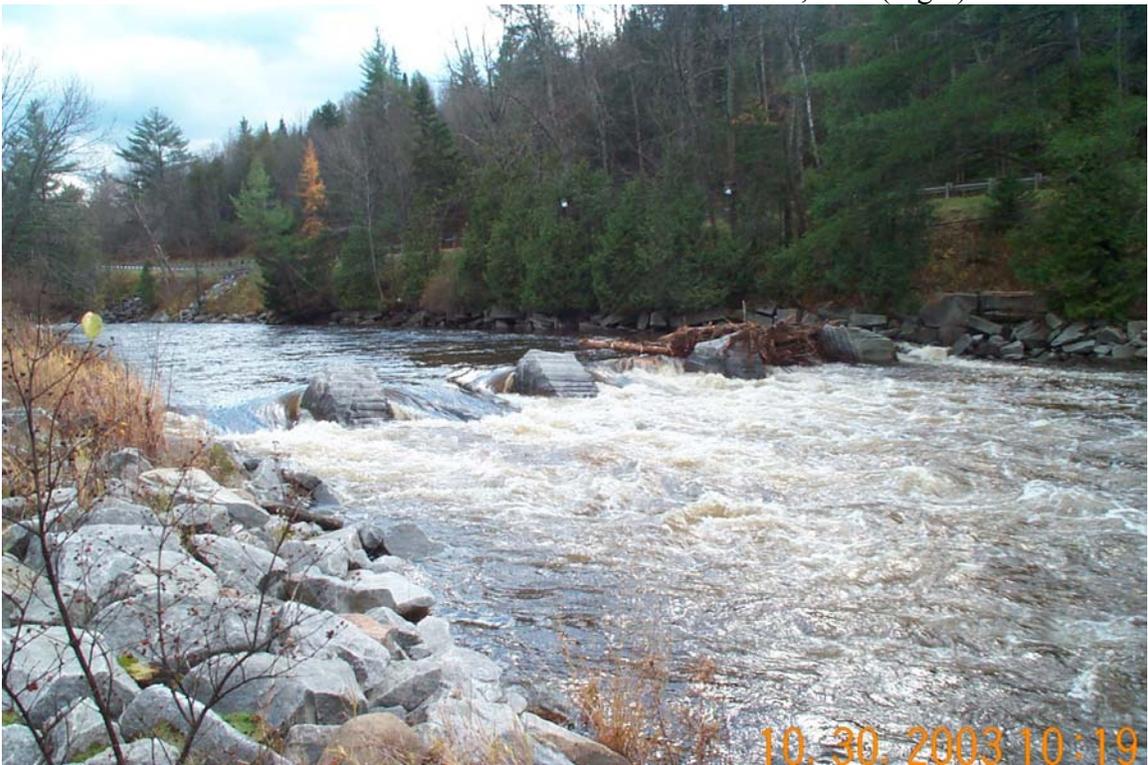
Debris accumulation at Hardwick Vermont ICS November 30,2003 (Fig 5)

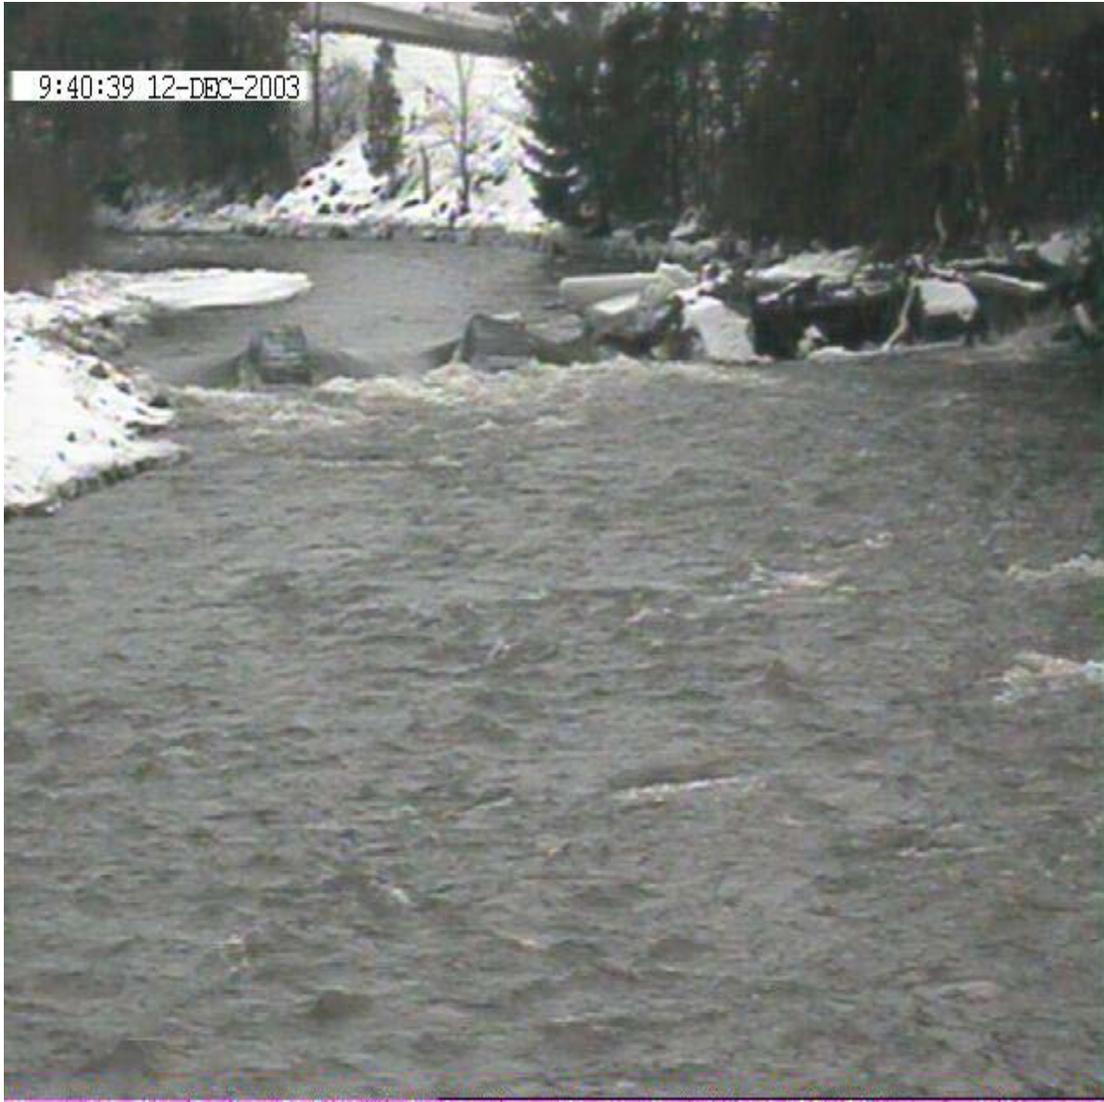
Looking upstream Ice run on or before 12/12/03 (Fig 6)

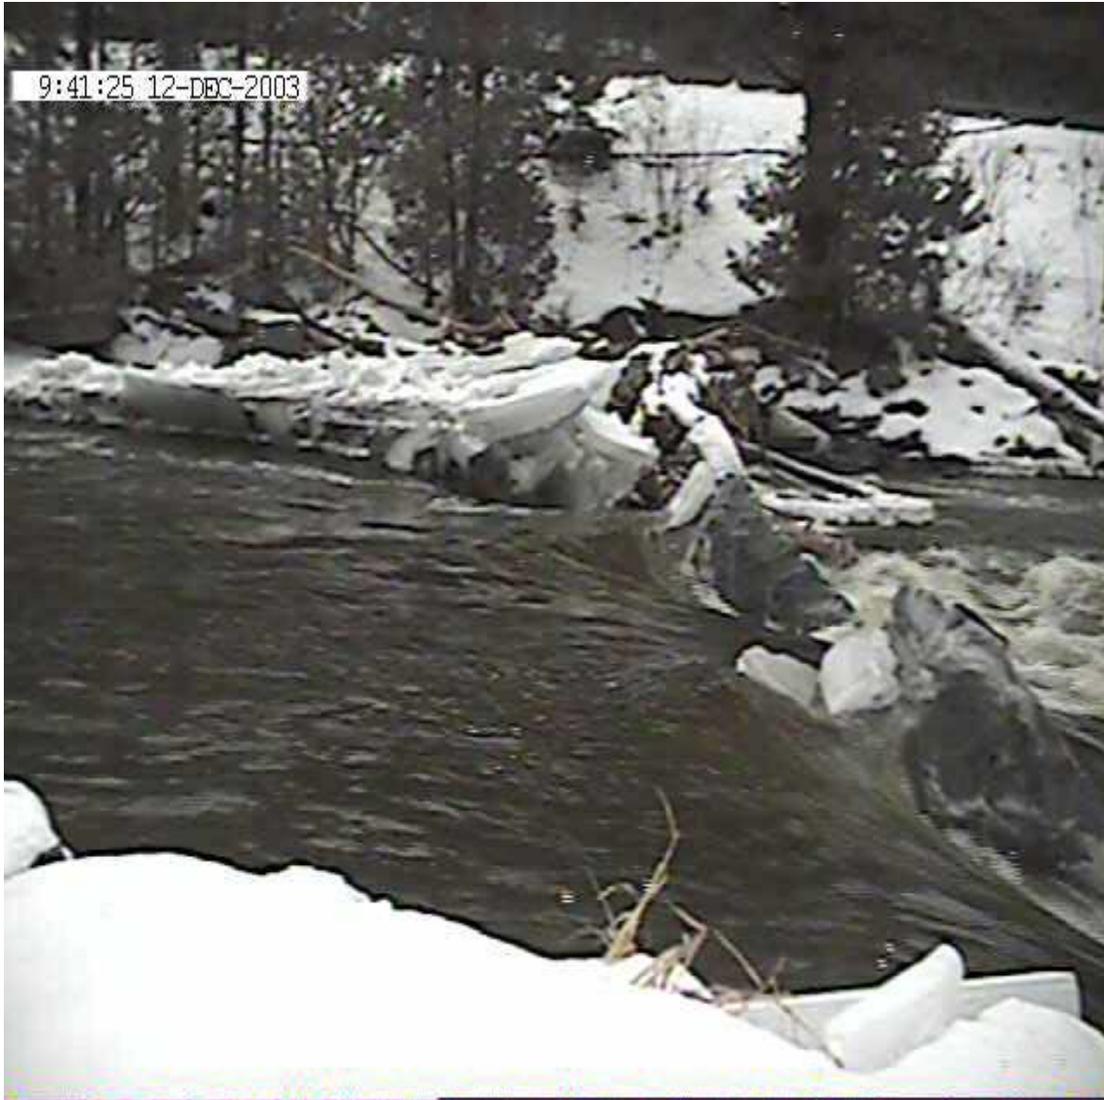
Remnants of Ice run on or before 12/12/03 Web cam photo from right bank (Fig 7)

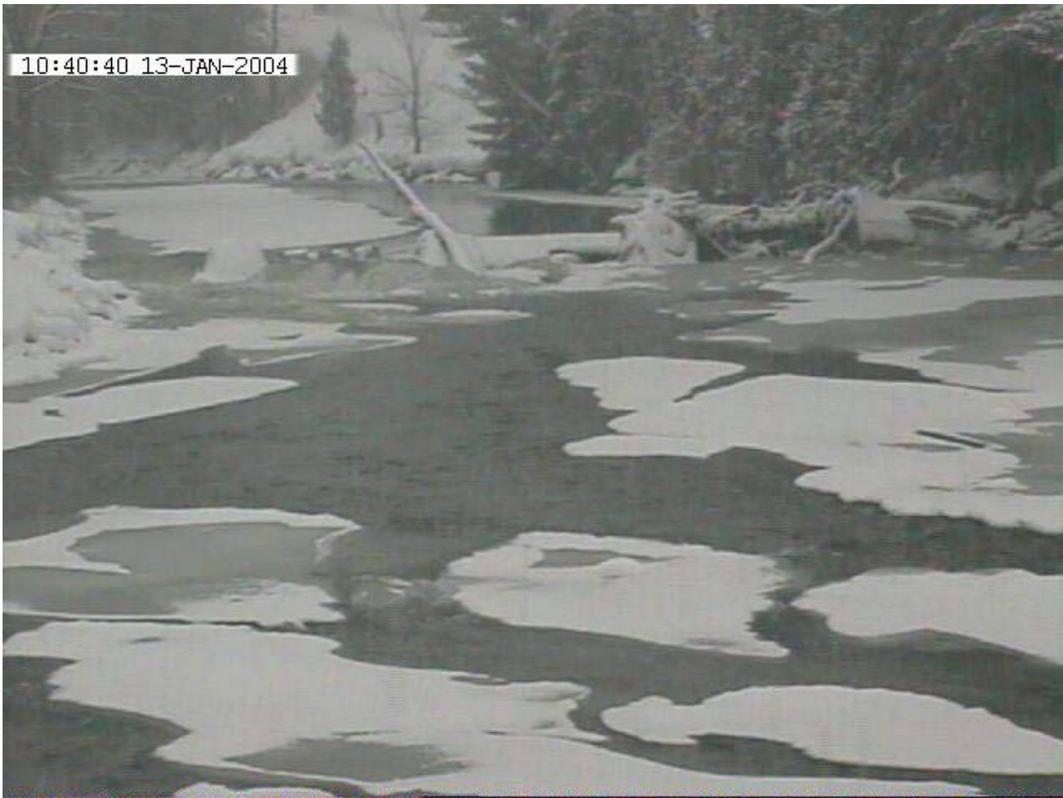
January 13,2004 Lamoille River Looking upstream at ICS partial ice cover
Hardwick Web Camera (Fig 8)

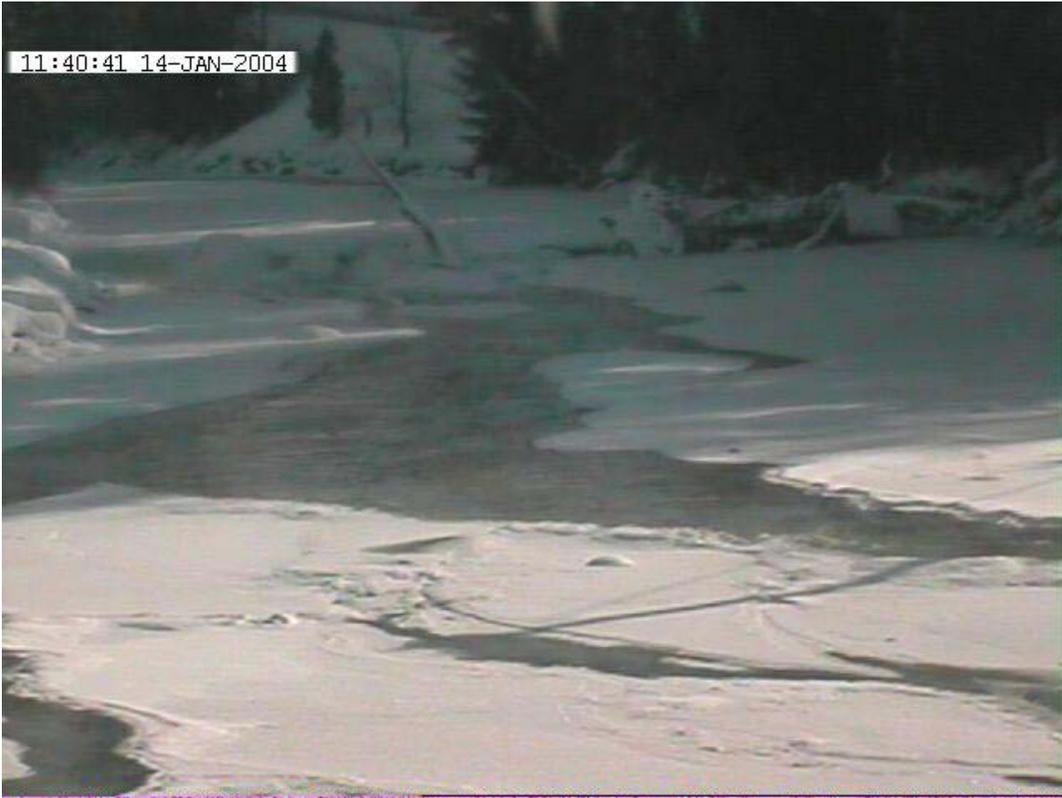
January 14,2004 Complete Freeze Up upstream of ICS Hardwick Web Camera (Fig 9)

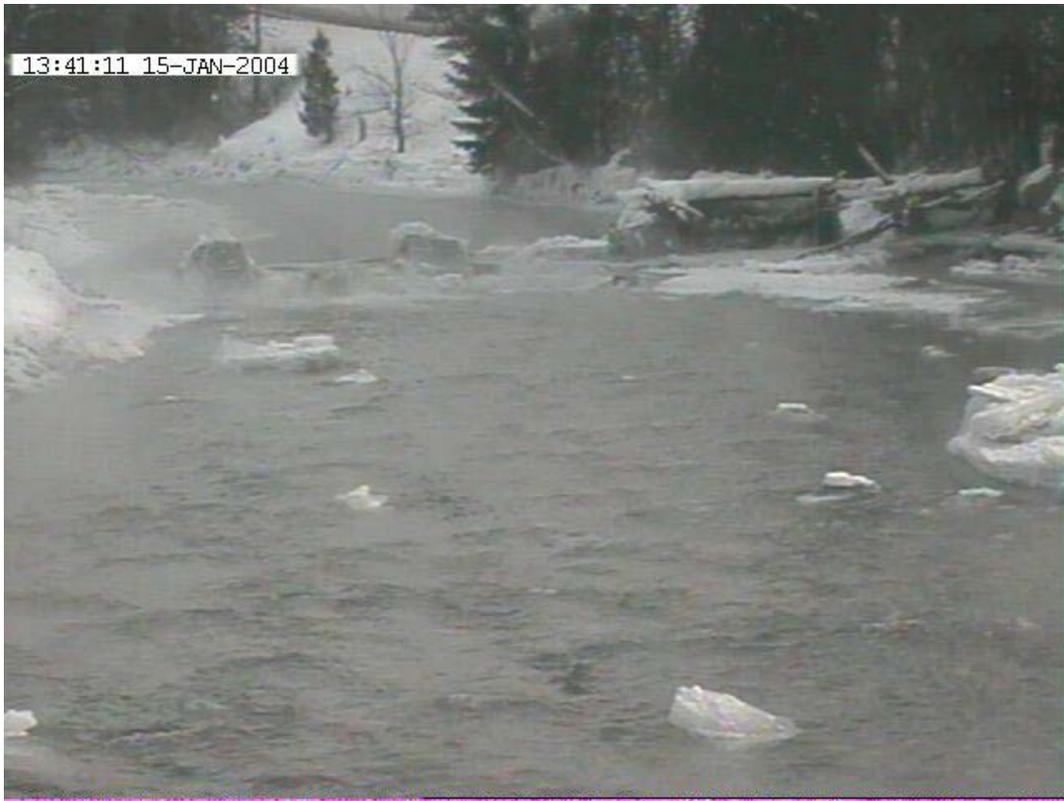
ICS Following Ice Run overnight Hardwick Web Camera (Fig10)

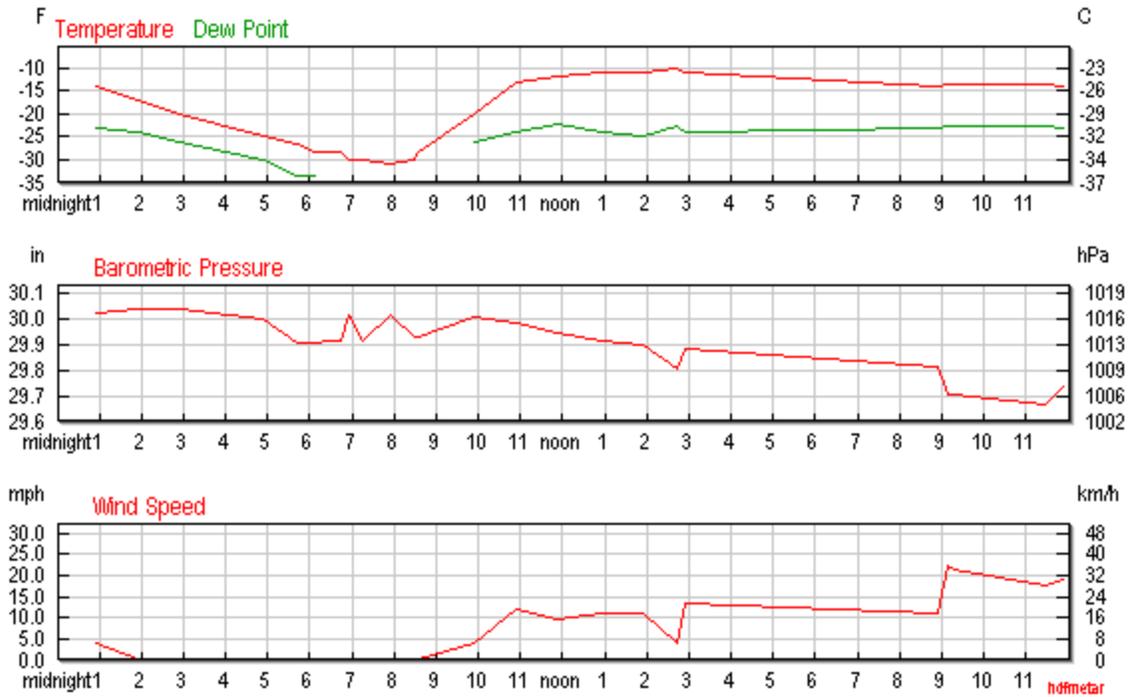
Temperature records from a nearby town of Morrisville indicate the extreme cold snap prior to the ice release at the Hardwick ICS on 15 January 2004. (Fig 11)

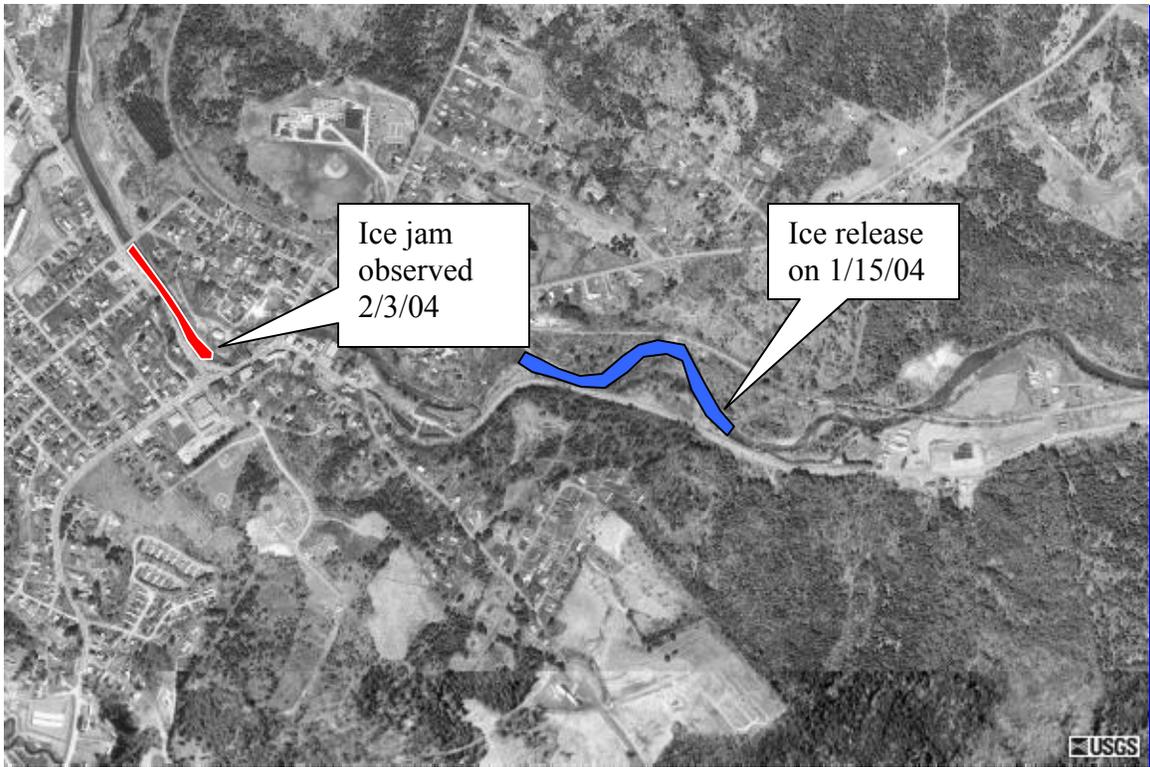
Ice jam location on February 3, 2004 from January 15th ice release (Fig 14)

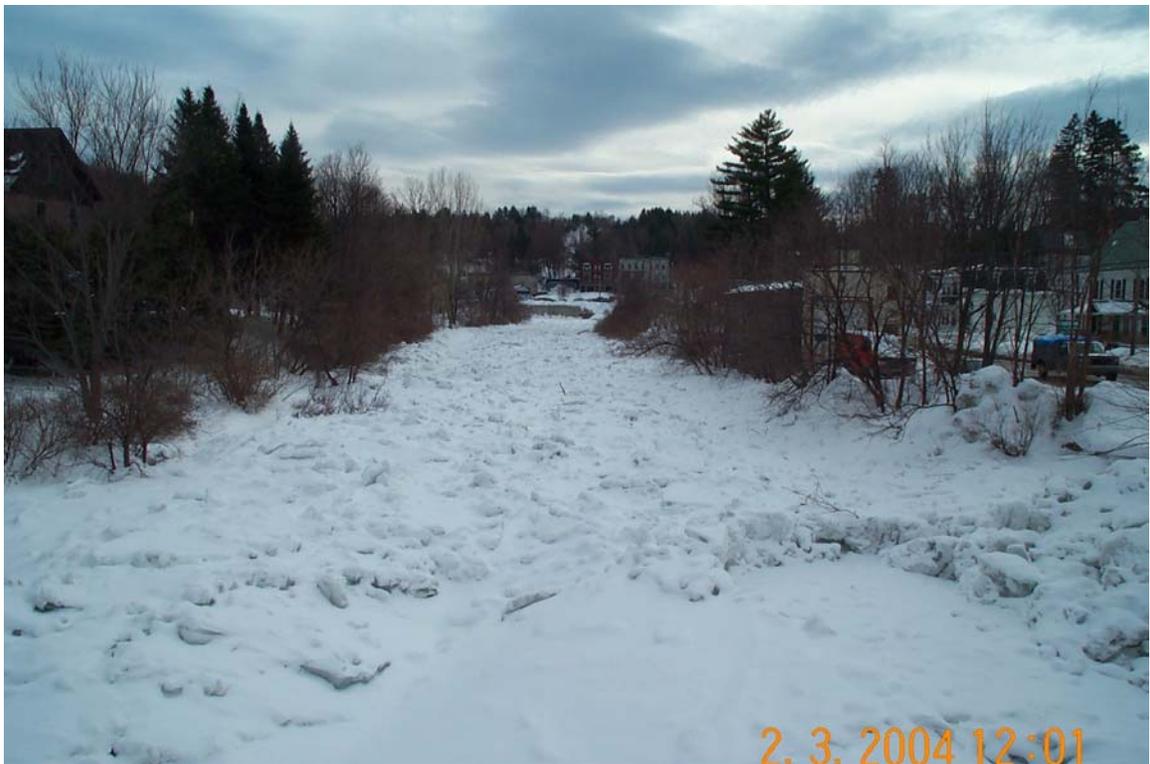
Ice jam location on February 3, 2004 looking upstream of cottage street bridge (Fig 15)

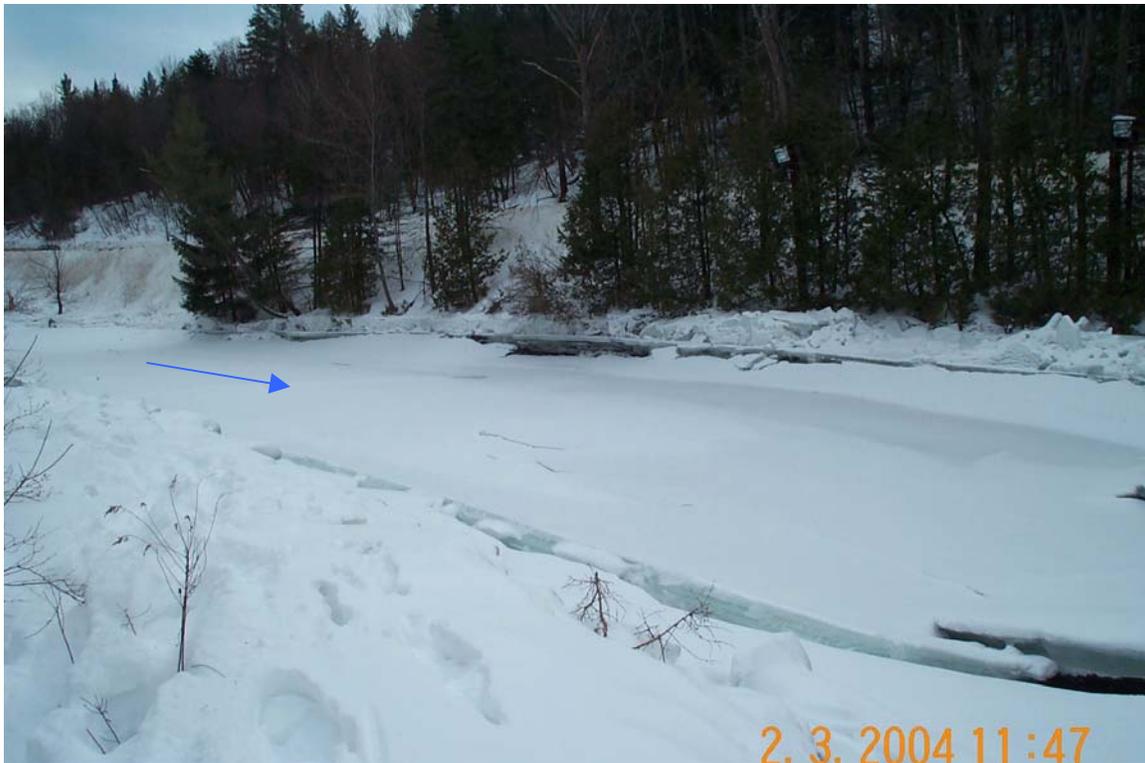
2. Ice thickness measurements were made in the pool upstream **Fig 17-18** of the structure and photo's show the condition of the ice and the remnants of the release on January 15th and the additional accumulation of ice between the 3rd and 4th structural element on the left bank side of the river. **Fig 17and 19**.

Pool area upstream of ICS on February 3,2004 with a one foot ice cover and evidence of the January 15,2004 ice run along the banks (Fig 17)

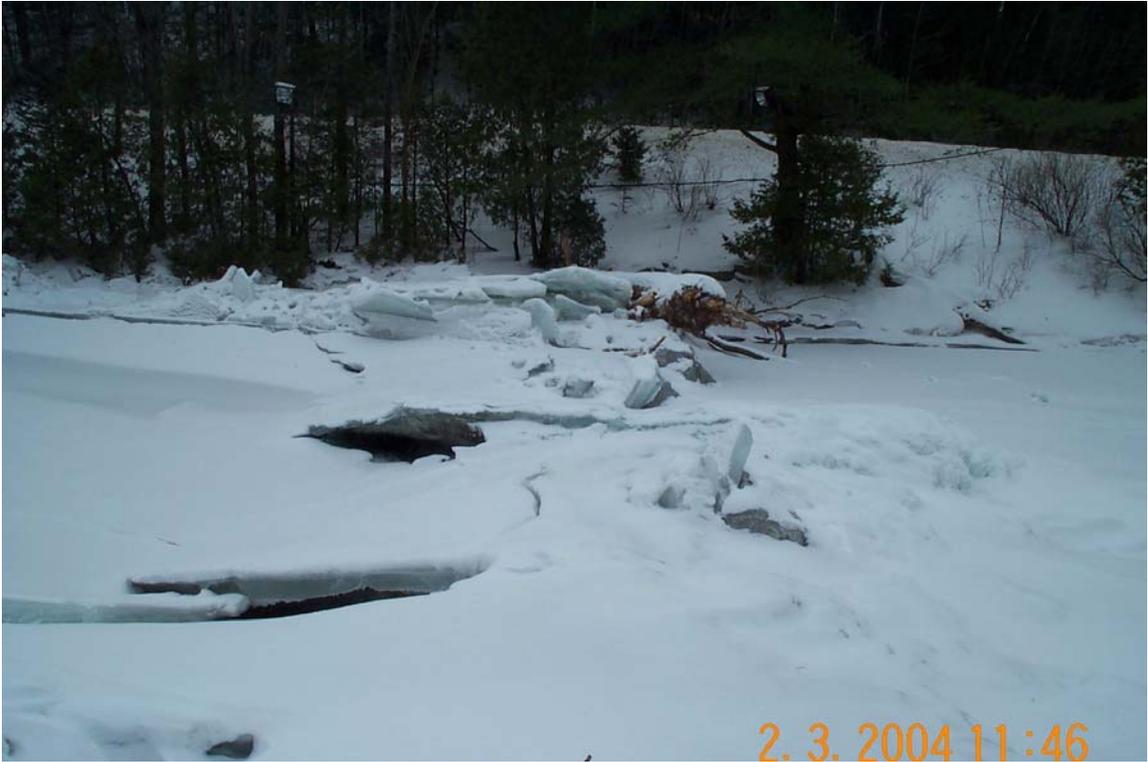
ICS with new one-foot thick ice cover formation on February 3,2004 (Fig 19)
