Design and Operational Issues While Tunneling in Firn at the South Pole Station

Michael Walsh

ERDC/CRREL TR-03-17
September 2003

Prepared for NATIONAL SCIENCE FOUNDATION
Office of Polar Programs

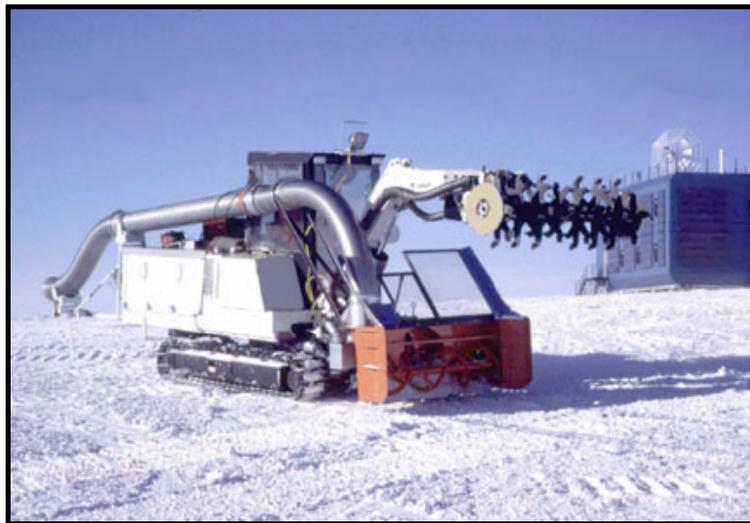
Figure 3. Tunneling machine (photo, M.R. Walsh).

The tunneler proved to be underdesigned for the conditions initially encountered at the South Pole. The biggest factor was the higher than expected snow strength attributable to the increased tunneling depth specified upon our arrival. The snow strength that was used in the tunneler design calculations was 0.5 MPa. This was based on an anticipated depth of 9 m and undisturbed snow compacted through natural mechanisms (Gow and Ramseier 1964, Mellor 1964). However, the actual depth of the tunnel was up to 16 m and the area into which the tunnels were driven was highly disturbed and thus more compacted and stronger than anticipated. The difference in strength for these conditions is substantial, over twice that for undisturbed snow. The power required to meet the production goal

(3 m/h) thus went from 8 to about 25 kW. Concurrent with the power, higher torque is necessary to machine the snow and maintain the production rate. The available torque at the drum with the system as originally designed limited the possible depth of cut. In very hard material, approaching the consistency of ice in places (density greater than 800 kg/m^3), the depth of cut was limited to 0.05 m instead of the 0.24 m used under the original design conditions. In 1997, following the analysis of the South Pole tunneling operations in 1996, a 19-kW hydraulic pump was specified to replace the original 10-kW pump. This pump is the maximum size compatible with the original drum drive system. However, a 23-kW pump was shipped by the supplier and installed for testing and training in 1999. This pump was inadvertently left on the unit, overdriving the drum and causing premature failure of the drum drive components in subsequent tunneling operations.

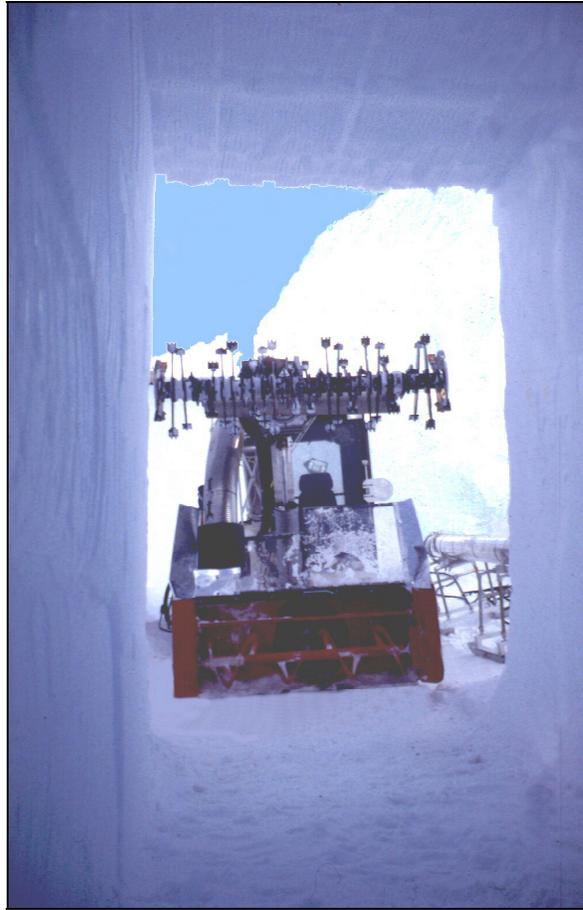
A second problem associated with the center-impeller snowblower is the stress on the joint where the ejector tube meets the snowblower. The ejector tube is unsupported from the snowblower to the end of the tunneler (up to 7 m), with a sliding joint and a large-radius 100° elbow between. When the snowblower is

lifted or lowered, extended or retracted, high stresses are experienced at the snowblower joint. In addition, the uneven distribution of weight adds stress to the lift/extension frame for the snowblower. Both assemblies failed several times and were modified. Some problems still persisted, although they may be attributable to overuse of the system.

Figure 4. Front of tunneling machine showing snowblower (photo, M.R. Walsh).

The speed and torque of the snowblower impeller are too low. Because of the configuration of the throat, an attempt was originally made to meter the snow into the airstream through the throat to avoid clogging. This did not prove successful. Higher rotational speed and more torque will be necessary to give the debris enough momentum to fully engage the airstream. This should improve the efficiency of the disposal system.

The ejector tube connection point failure at the snowblower was a recurrent problem that was addressed but never fully resolved. The stresses at that point are quite large, and the joint is stressed often during operation. It was redesigned and rebuilt twice, resulting in increased reliability, but the joint will have to be reexamined if the system is to be used again.

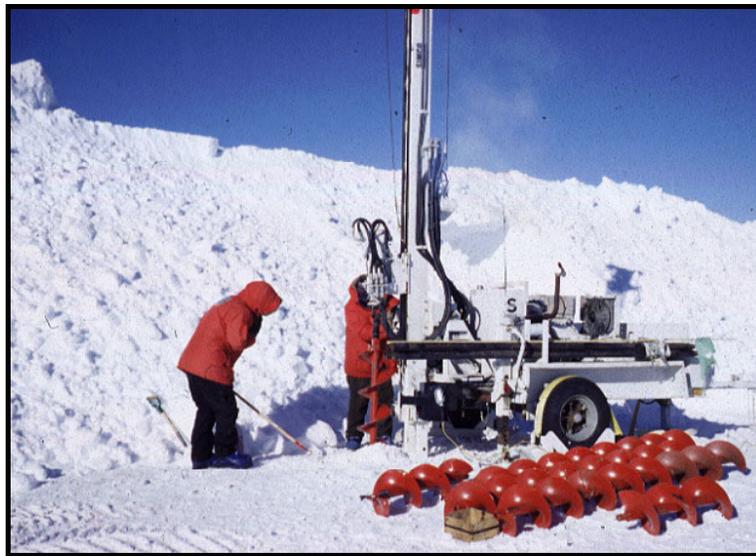
The drill rig (Fig. 5) did not operate in the cold as well as expected. Starting the unit was very difficult, even with a block heater and hydraulic oil heater. When back boring the 1-m diameter escape shafts, the drill string tends to whip violently as the bit approaches the surface. This becomes especially dangerous when the bit breaks through. Varying the drilling parameters had little effect on this behavior. A means of stiffening or stabilizing the rod needs to be found and implemented.

Figure 5. Drill rig used at pole (photo, M.R. Walsh).

Starting problems with the mobile drill in the cold were resolved by warming the unit for longer periods with a mobile heating unit. This did not fix the problem of cold starting but it was a work-around. The hydraulic reservoir is equipped with heaters, but the oil temperature was too low for efficient operation. Adding an insulated cover to the tank resolved this problem.

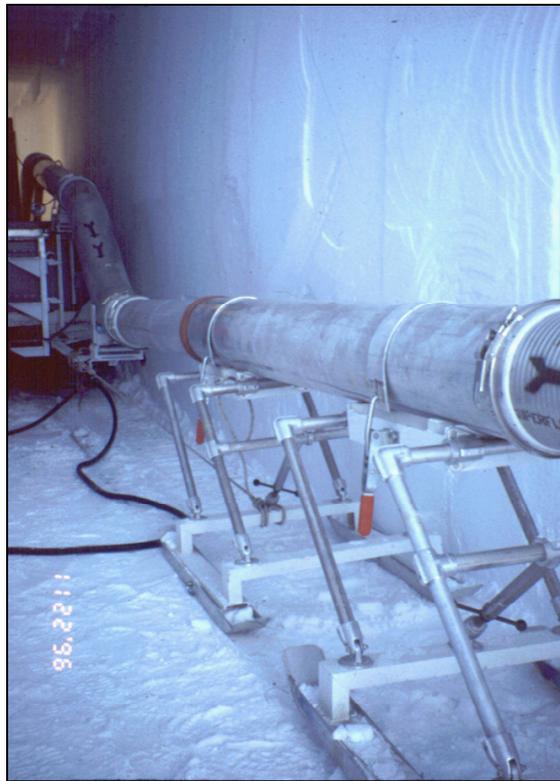
Figure 6. Single-expansion duct unit mounted to tunneler (photo, M.R. Walsh).

The problems associated with the remainder of the debris transport system were successfully addressed. Stressing of the horizontal ducting during the frequent positioning of the tunneler were resolved with the fabrication of a short single expansion duct unit that was mounted directly behind the tunneler (Fig. 6).

This unit is much lighter than the regular double expansion units and runs much smoother. The hard stops used on the horizontal ducts to prevent tube separation were removed and expansion limits maintained with cables. This eliminated the pull-out problems experienced earlier when advancing the tunneler. Polyethylene sleeves were inserted in the ducts to facilitate sliding. Hard stops were installed on the opposite ends to limit tube contraction. The separation of the flow at the fan inlet was eliminated by the addition of a 2-m straight expanding duct between the fan and the elbow where the vertical tubing exits the surface (Fig. 7). This had the added benefit of simplifying the positioning of the fan assembly, as its placement at the access hole in the surface was no longer as critical, resulting in reduced setup times.

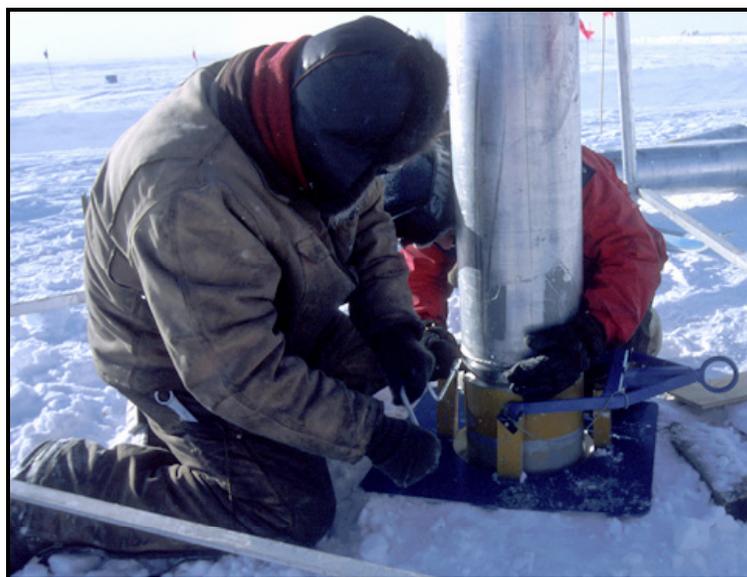
Figure 8. Yoke and attachment arrangement for vertical tubes (photo, M.R. Walsh).

The vertical duct line separation was addressed following experience gained in the 1996 deployment. A more robust retention system using circumferential V-clamps was designed for the vertical tubes to prevent tube separation during installation and use. A yoke was designed and the tubes modified to facilitate

lowering and raising them in the access hole (Fig. 8). Finally, the retention line for the short sliding tube assembly mounted at the lower end of the vertical tube run was beefed up for better retention of the sliding tube.
