MEMORANDUM FOR RECORD: Inspection of site conditions for flood early warning sensors at Bethel, Rumford Point, Mexico and Canton Maine, 24 March 2004

Project: FY04 Monitoring New England Ice Jams

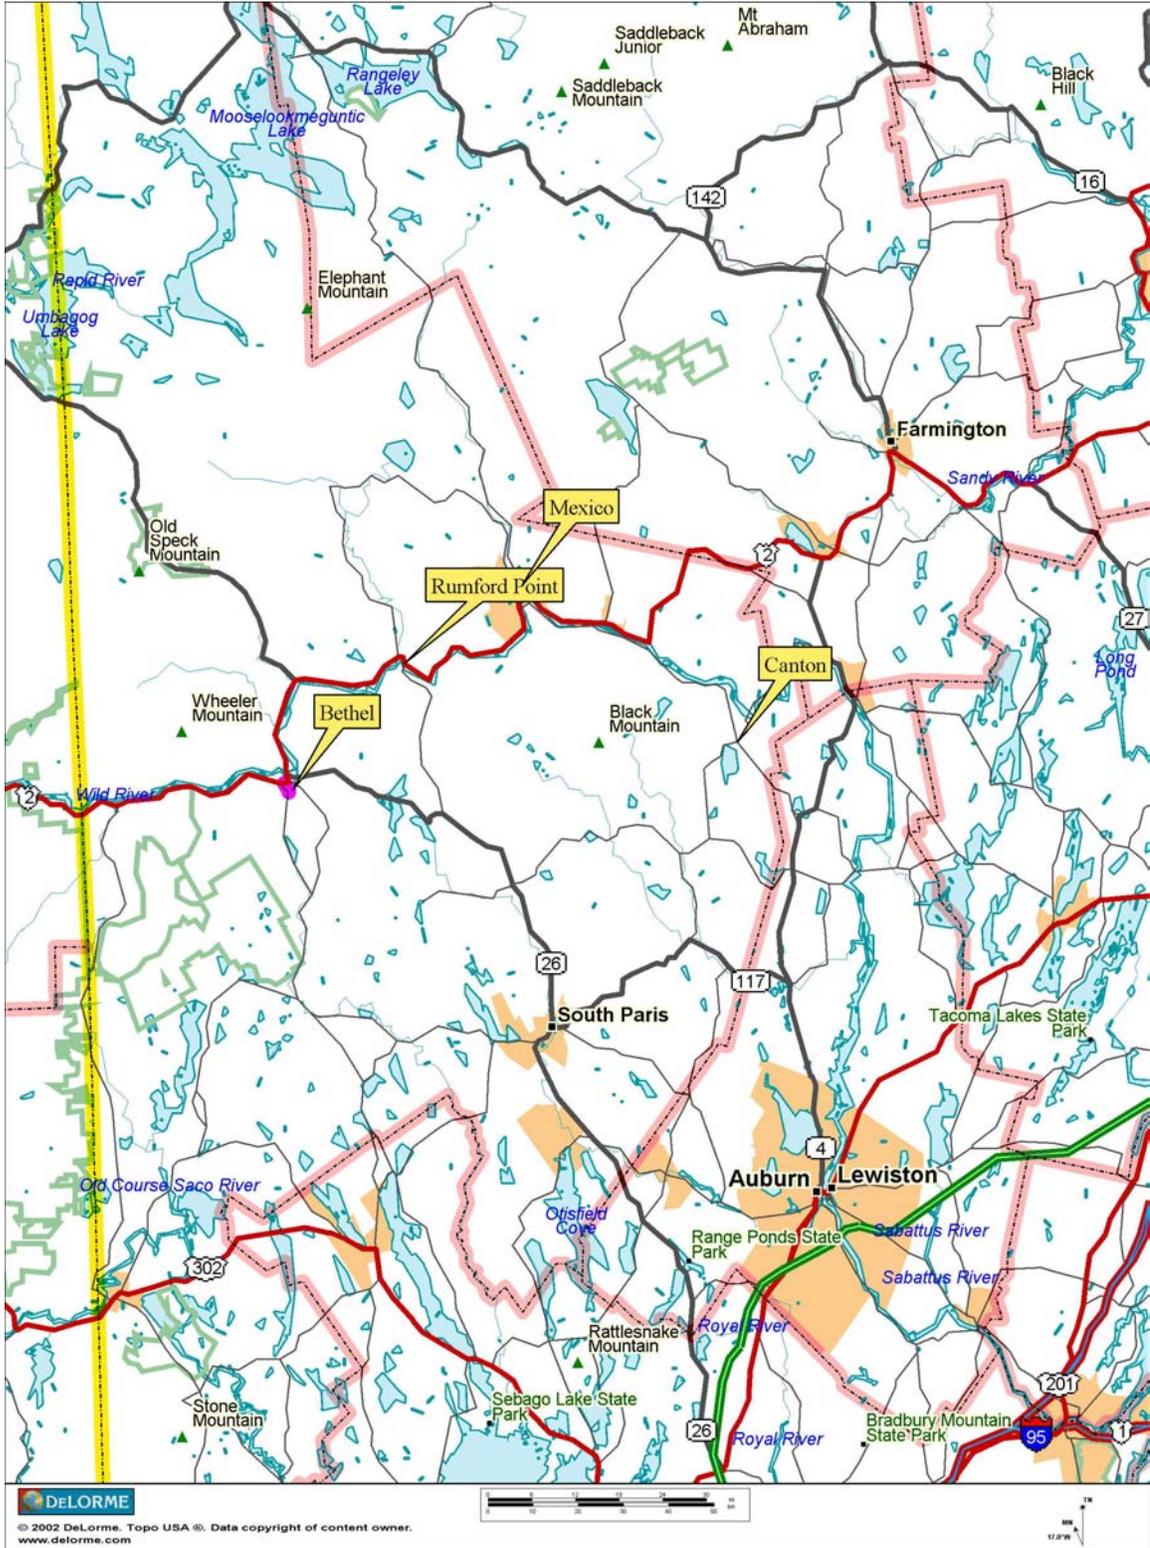
1. On Wednesday 24 March 2004, Troy Arnold and I drove to Bethel Maine at the request of Dan Schorr, Oxford EMA. The purpose of this visit was to meet with local officials, and to provide technical assistance on the location of four ice/flood alert systems along the Androscoggin River from the town of Bethel at the upstream location to Canton Maine on the most downstream location (Figure 1). The following is a description of the conditions we observed.

Figure 1. Proposed early warning river locations

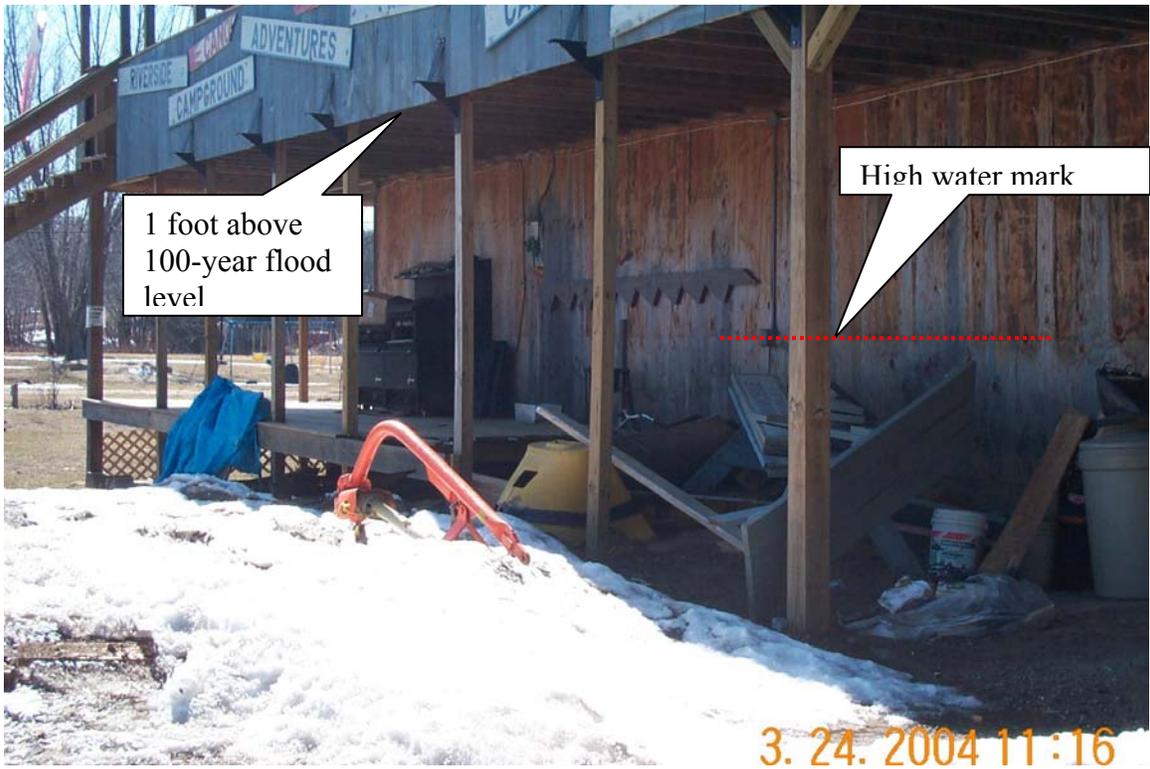
- b. We discussed the recent December 2003 flooding event and had Jeff point out the high water mark left behind by the flood on the first floor wall of his building (Figure 2). He told us that the second floor was built one foot above the 100-year flood level. Troy and I later measured the change in elevation from the Androscoggin river water surface to the flood level mark and obtained a change in elevation of 17 feet with an additional 5 feet to what was referred to as a 100 year flood level. We estimated that the river was an average of 3 feet deep on Androscoggin River at the Rt. 2 bridge pier location. State Highway bridge maps should provide more accurate information on the distance from the bridge steel to the riverbed and also distances to the data collection and transmit antenna. If the preferred (RF) radio transmission system is used and mounted on the bridge railing, long runs of cable and trenching would not be unnecessary.

Figure 2. Outdoor Adventure Center, Bethel, ME

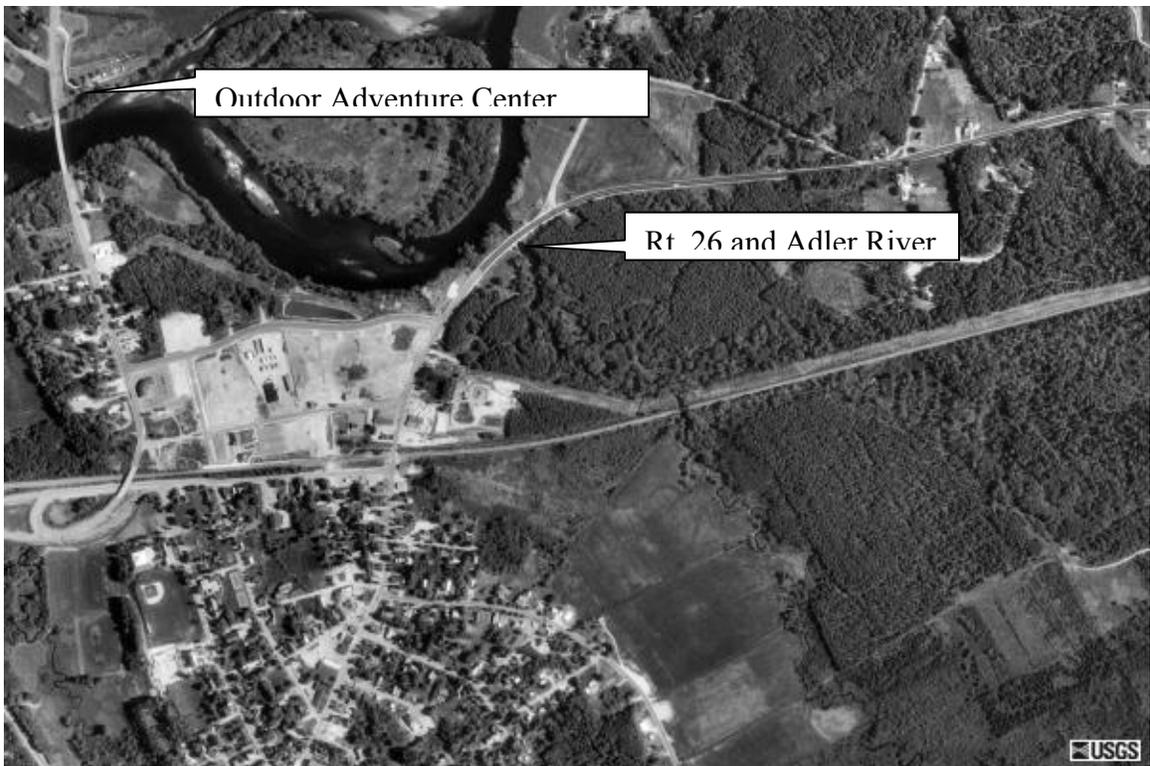
- c. We then drove downstream to the roadway along RT 26 in Bethel to document the flooded area at the confluence of the Adler River (Figure 3). Dan felt that the ice jam and resulting backwater effect of the Androscoggin River was the main cause of the flooding in the Adler River along Rt. 26 (Figure 4-6).

Figure 3. USGS Air Photo, Bethel Maine

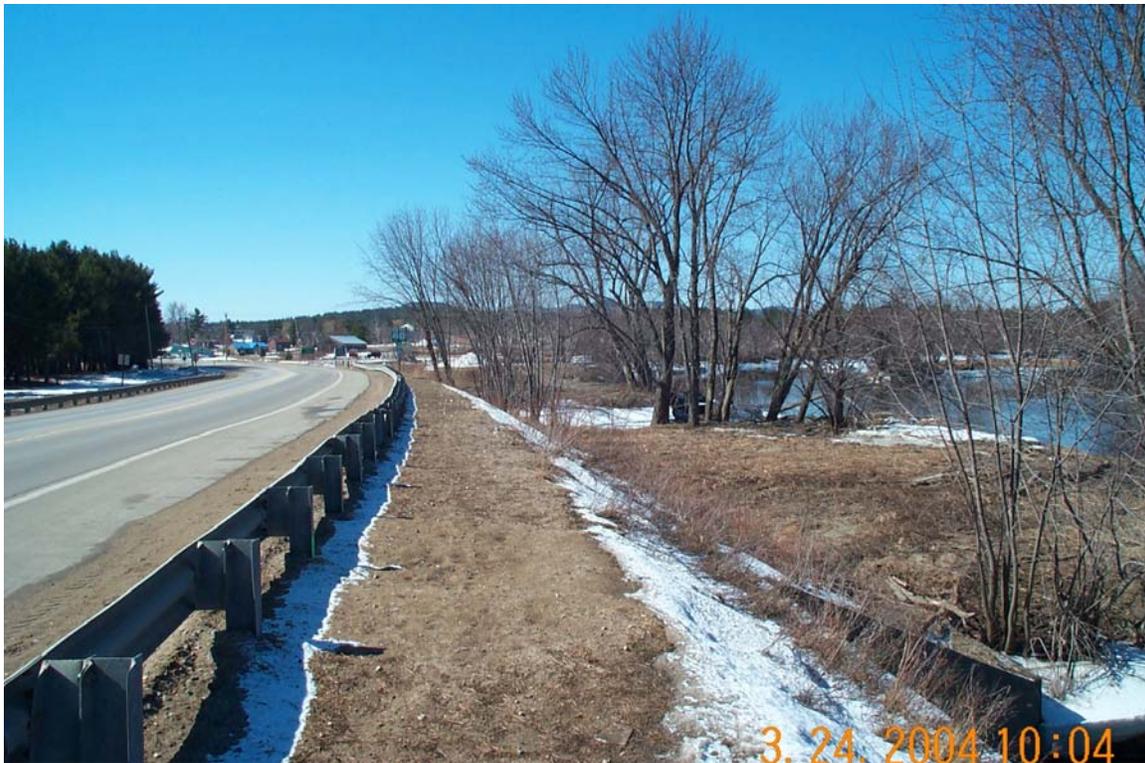
Figure 4. Looking upstream at flood-susceptible area along RT 26 with the Androscoggin River on the right side of the photo

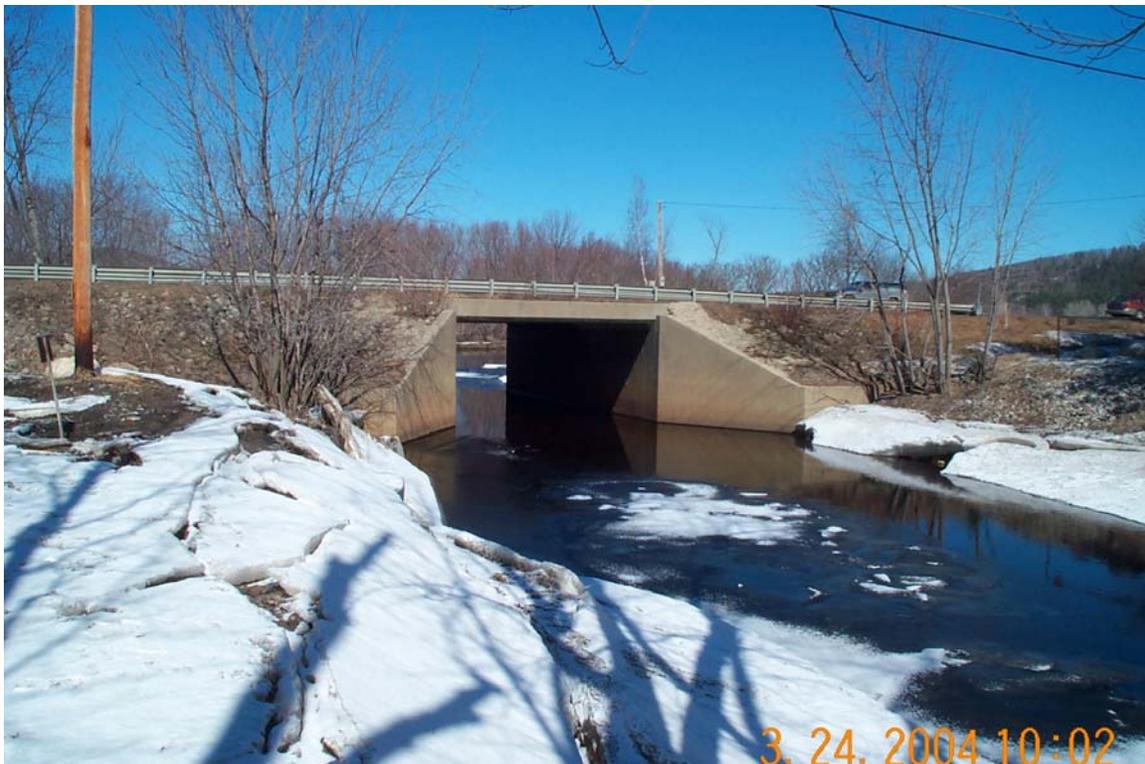
Figure 5. Confluence of the Adler River passing under Rt. 26, looking through the culvert to the Androscoggin River

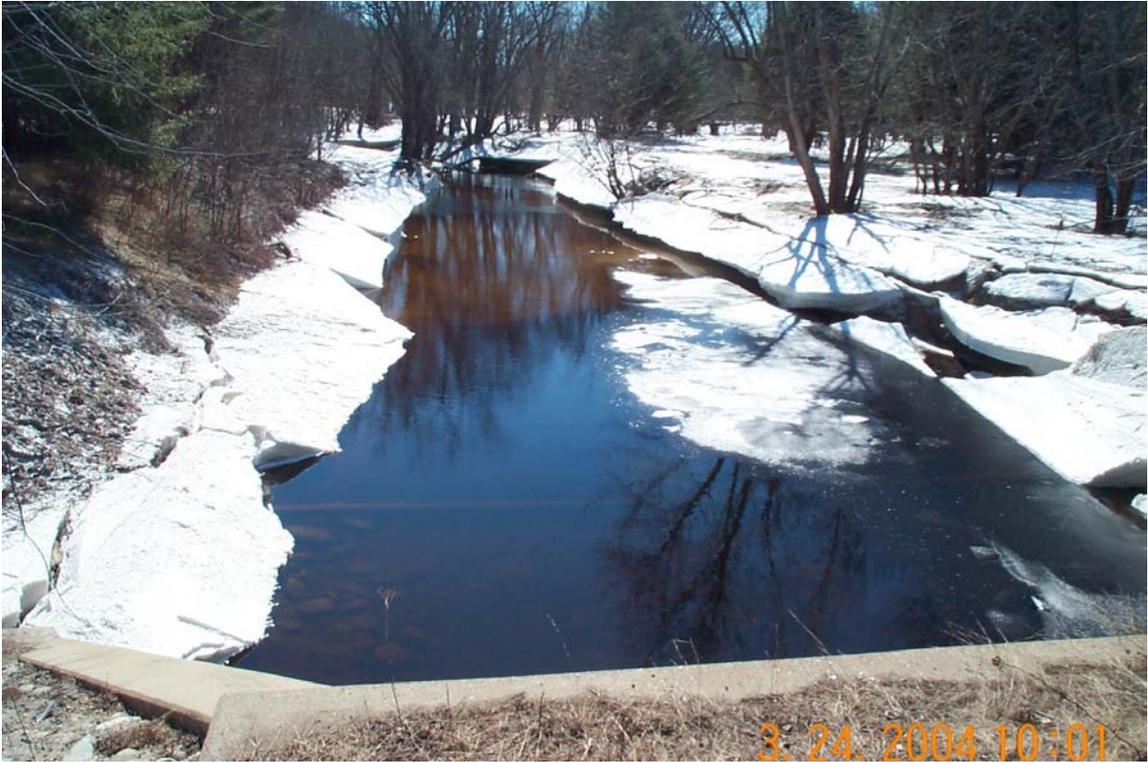
Figure 6. Adler River from Rt. 26, looking upstream

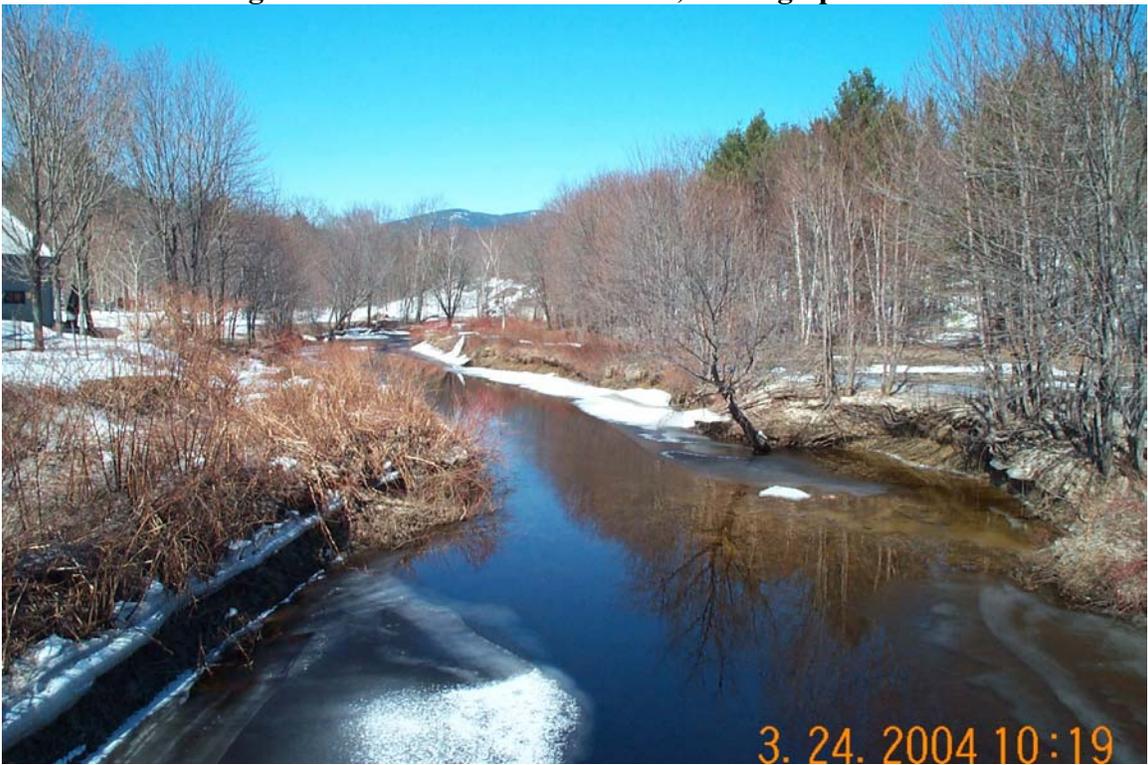
- d. We then proceeded to the Pleasant River and Bog Brook tributaries to the Androscoggin located approximately 4.5 and 8.0 miles upstream of the Rte 2 Bridge. These tributary locations respond early to rising stage on the Androscoggin River (Fig 7 -10). Andrew Tuthill (603-646-4225) gives

Figure 7. Pleasant River looking downstream from Rt. 2 Bridge

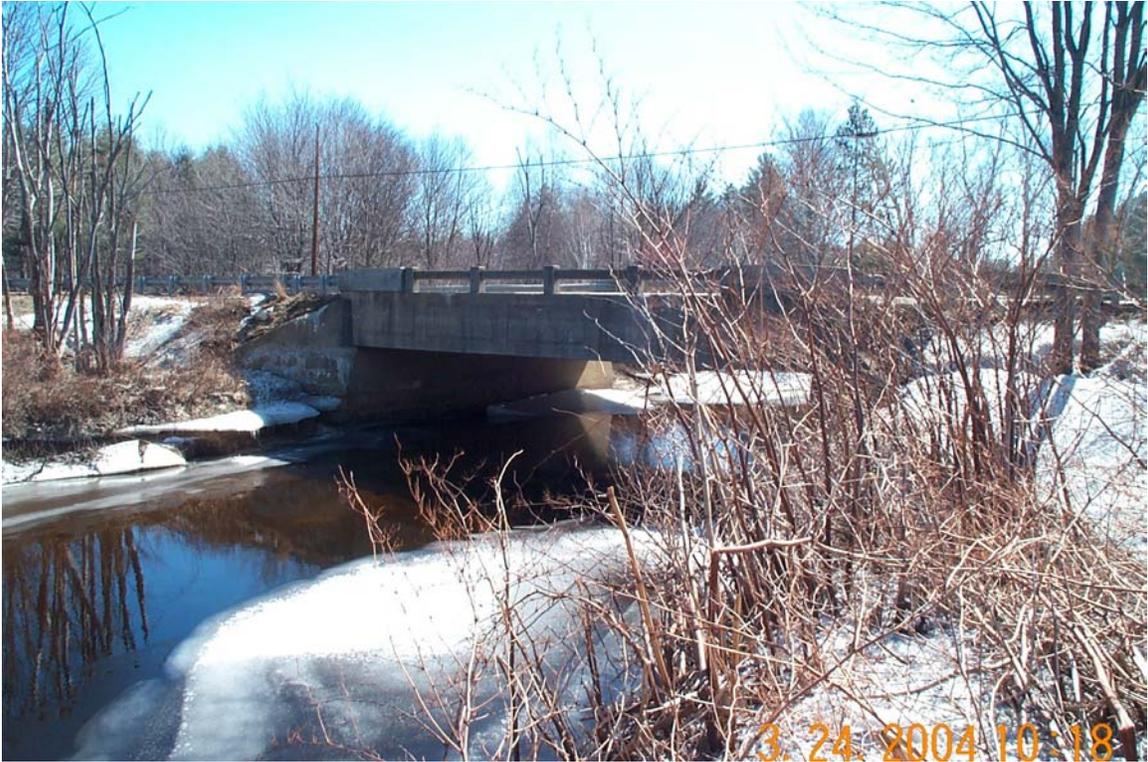
Figure 8. Pleasant River looking upstream at Rt. 2 Bridge from left bank

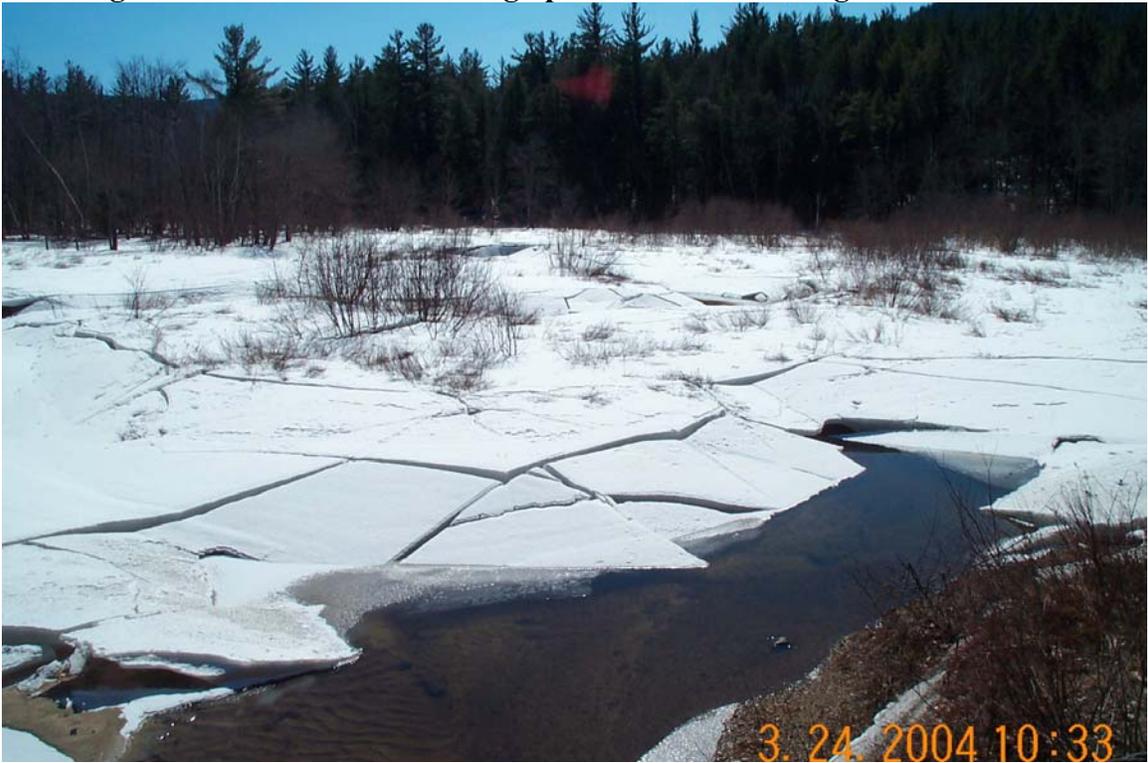
Figure 9. Looking upstream at Bog Brook from Rt. 2 Bridge

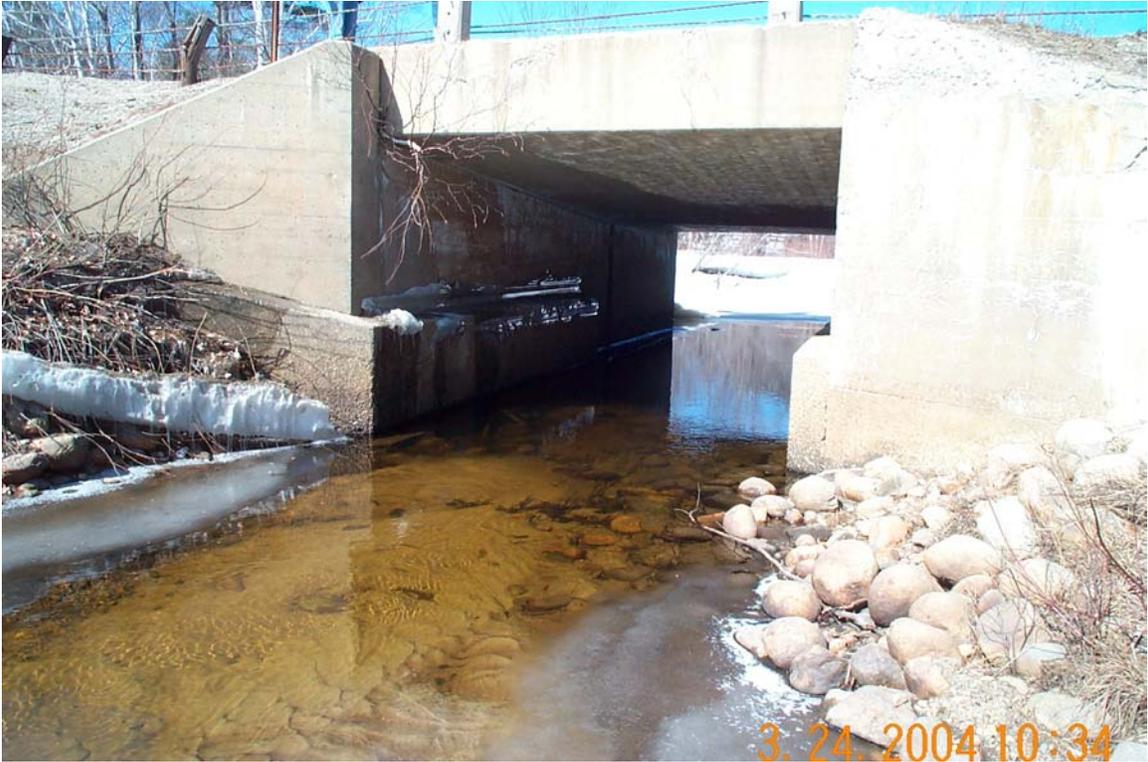
Figure 10. Bog Brook Bridge on Rt. 2, looking downstream toward Androscoggin River confluence

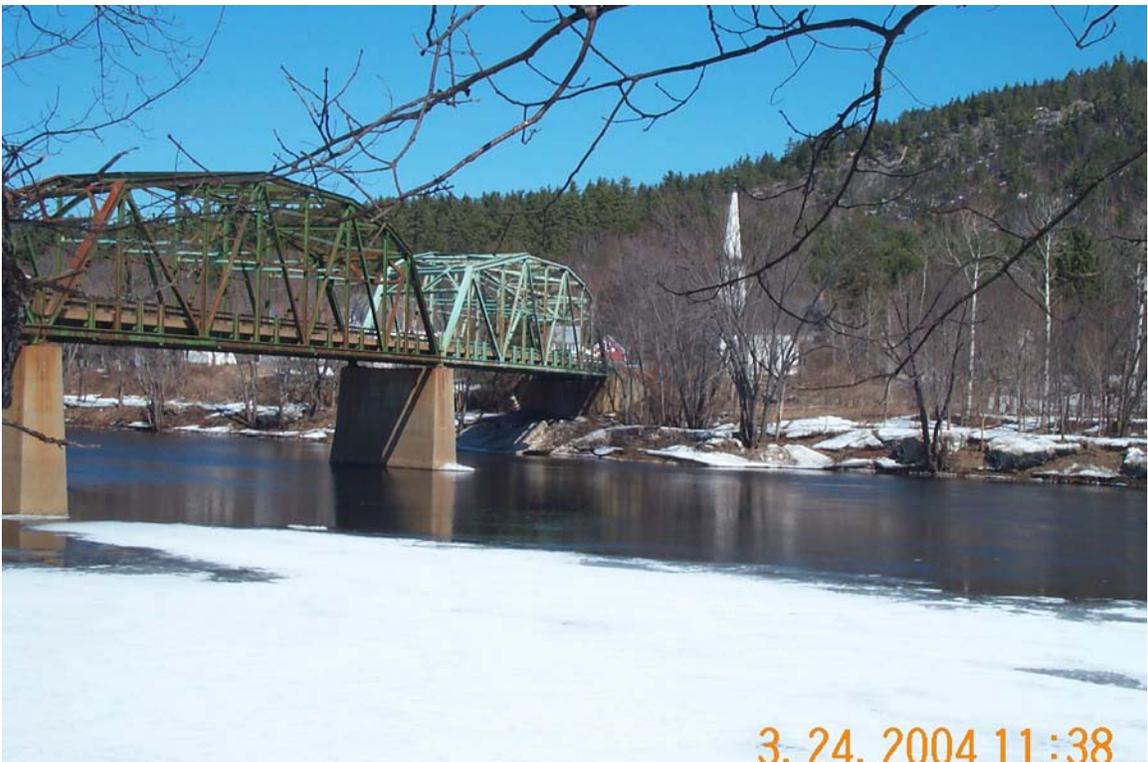
2. The second site was located at Rumford Point Bridge where it crosses the Androscoggin River, approximately 13 miles downstream of Bethel. The site is approximately 2000 feet downstream of the confluence with the Ellis River (Fig 11-12). The Concord River flows into the Androscoggin River 1.8 miles downstream of this location. Water depths were 2-3 feet and riverbed conditions were similar to the Bethel location. The left bank bridge pier is approximately 650 feet from the church that was suggested as a secure location for instrumentation. (Fig 13).

Figure 11. Rumford Point bridge looking upstream from the right bank

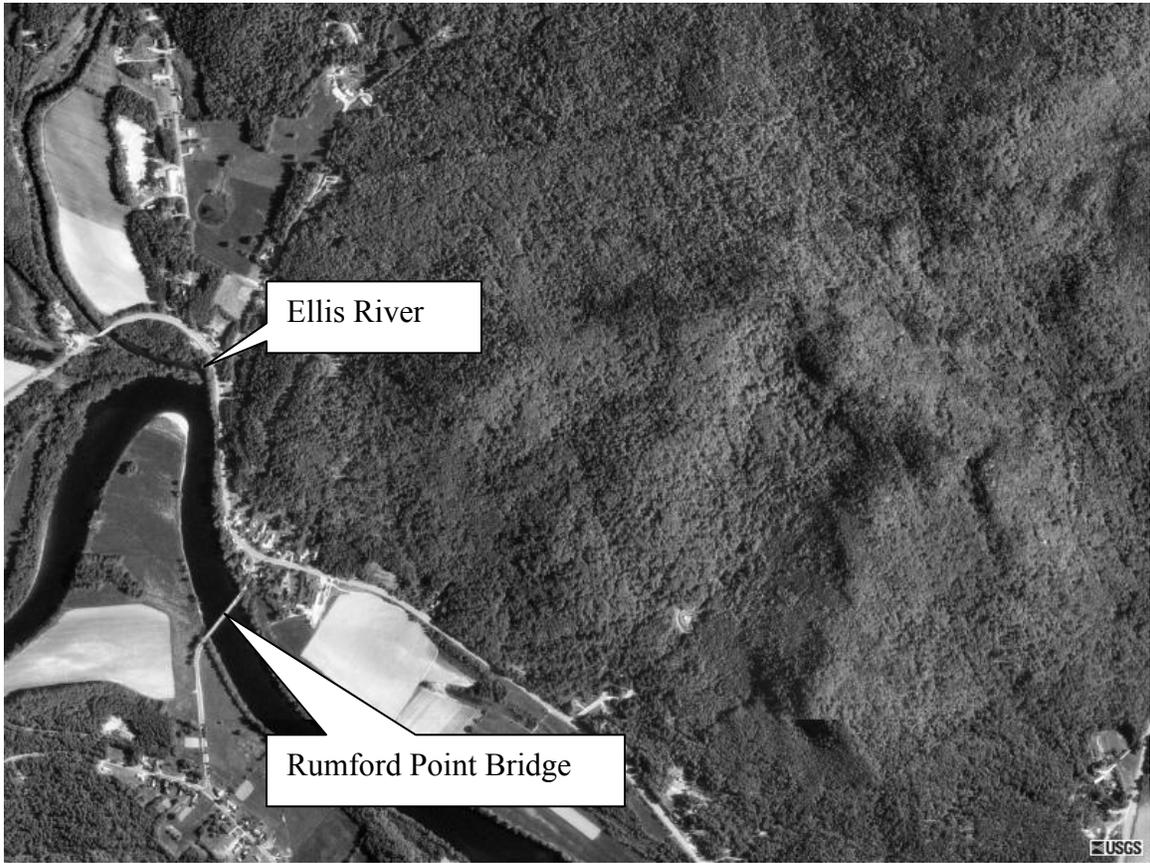
Figure 12. USGS Air Photo of Rumford Point Bridge on the Androscoggin River

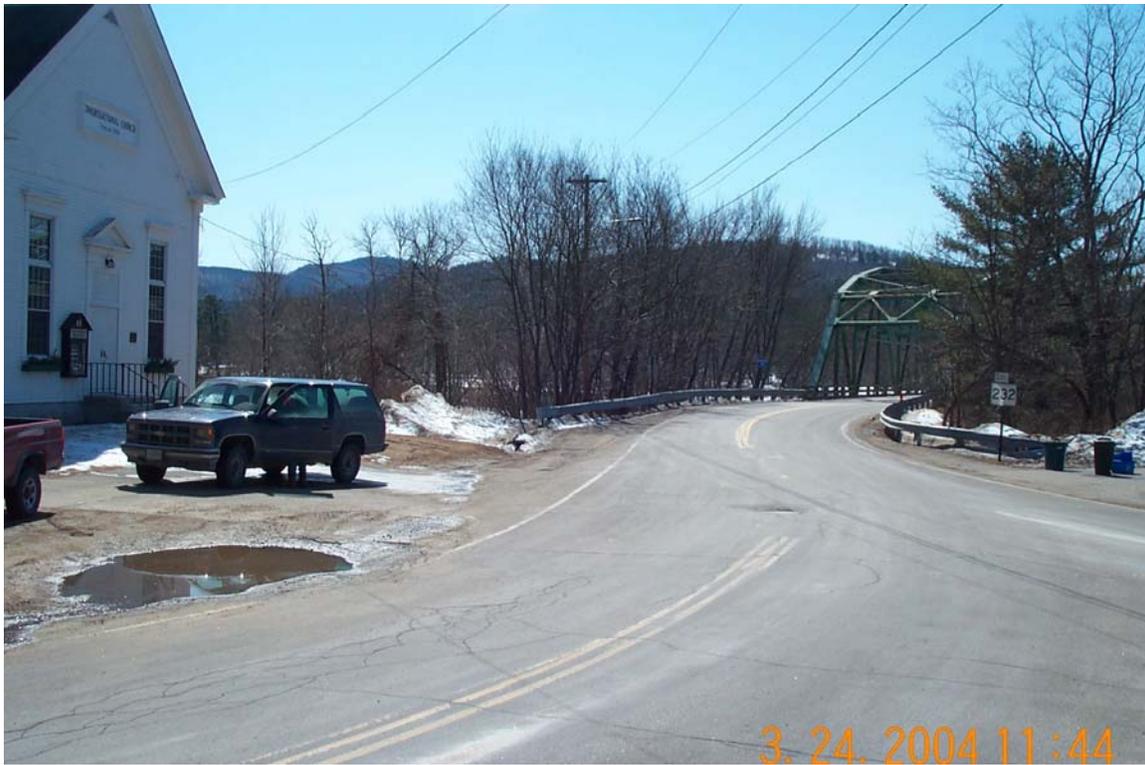
Figure 13. Rumford Point church and bridge crossing

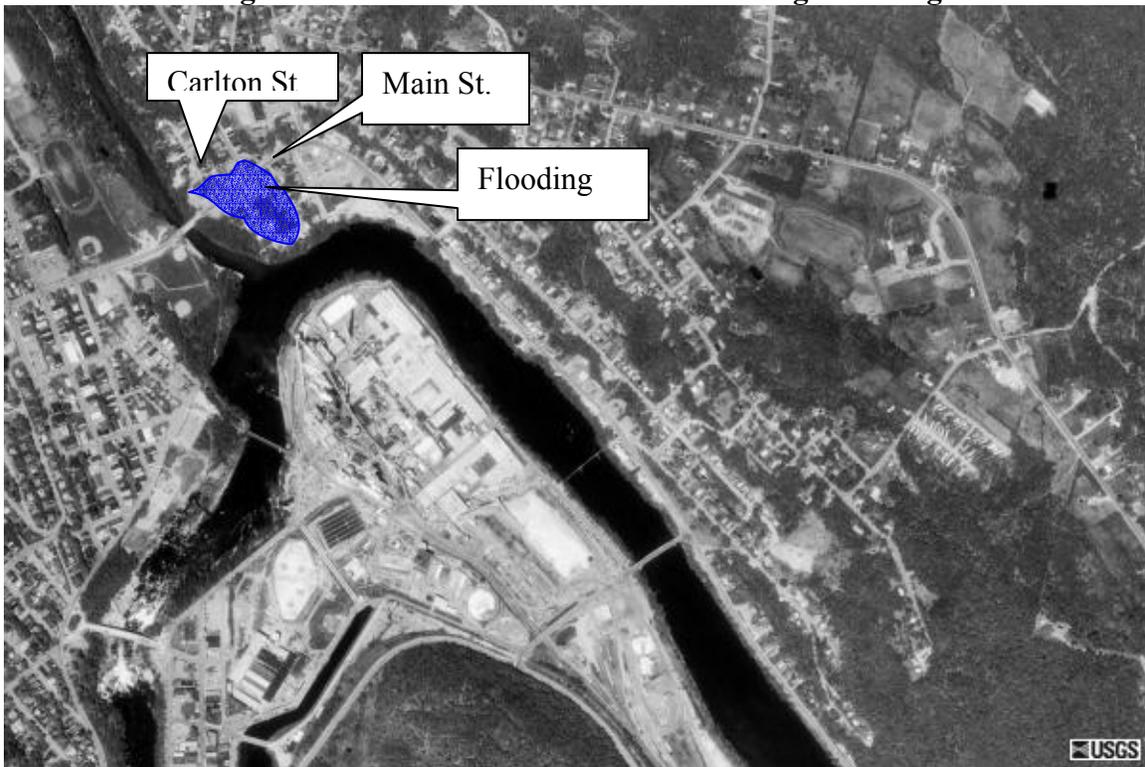
3. Site three was located at the Rumford-Mexico town line approximately 11 miles downstream of site 2 (Figure 14). We met with fire chief Gary Wentzell who described the typical flooding they experienced in the town of Mexico along Main street and adjacent low lying areas (Fig 15-17). This bridge site was characterized by shallow water and not suitable for placement of a water level transducer due to the expected thick ice and freezing winter temperatures.

Figure 14. USGS air photo Rumford/ Mexico Maine

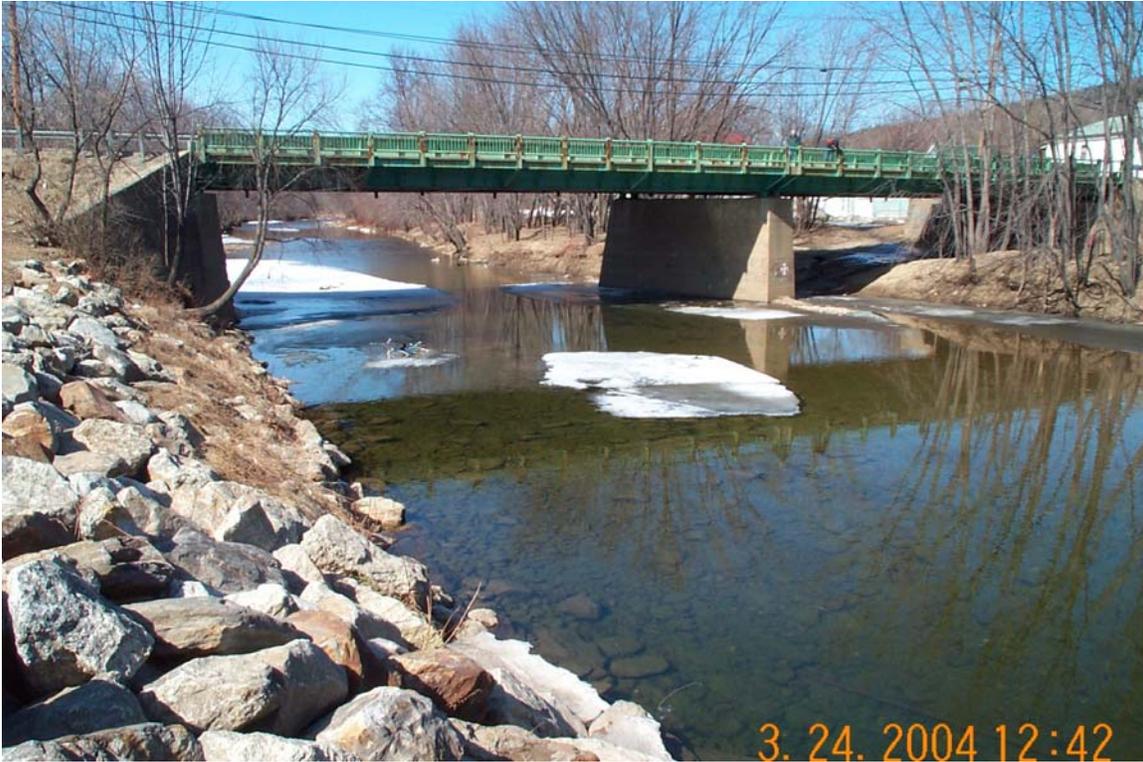
Figure15. Swift River looking upstream at the Main Street Bridge

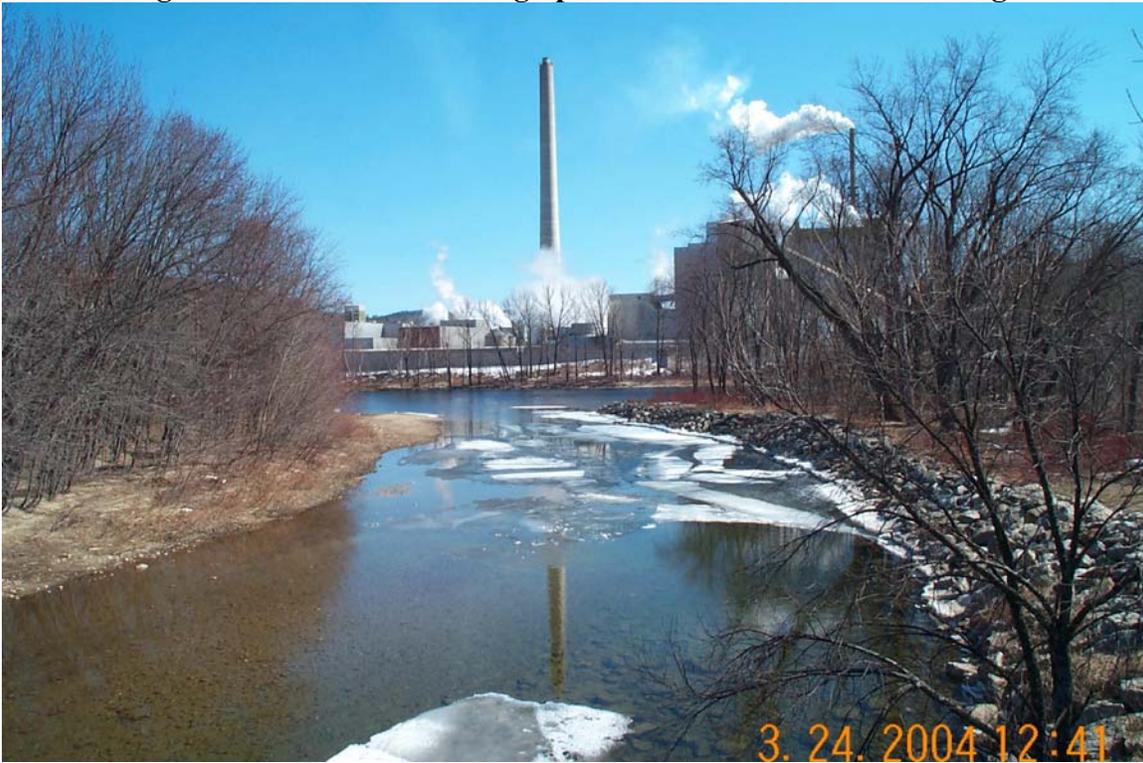
Figure 16. Looking downstream on the Swift River at the confluence with the Androscoggin, with paper plant on the right bank of the Androscoggin River

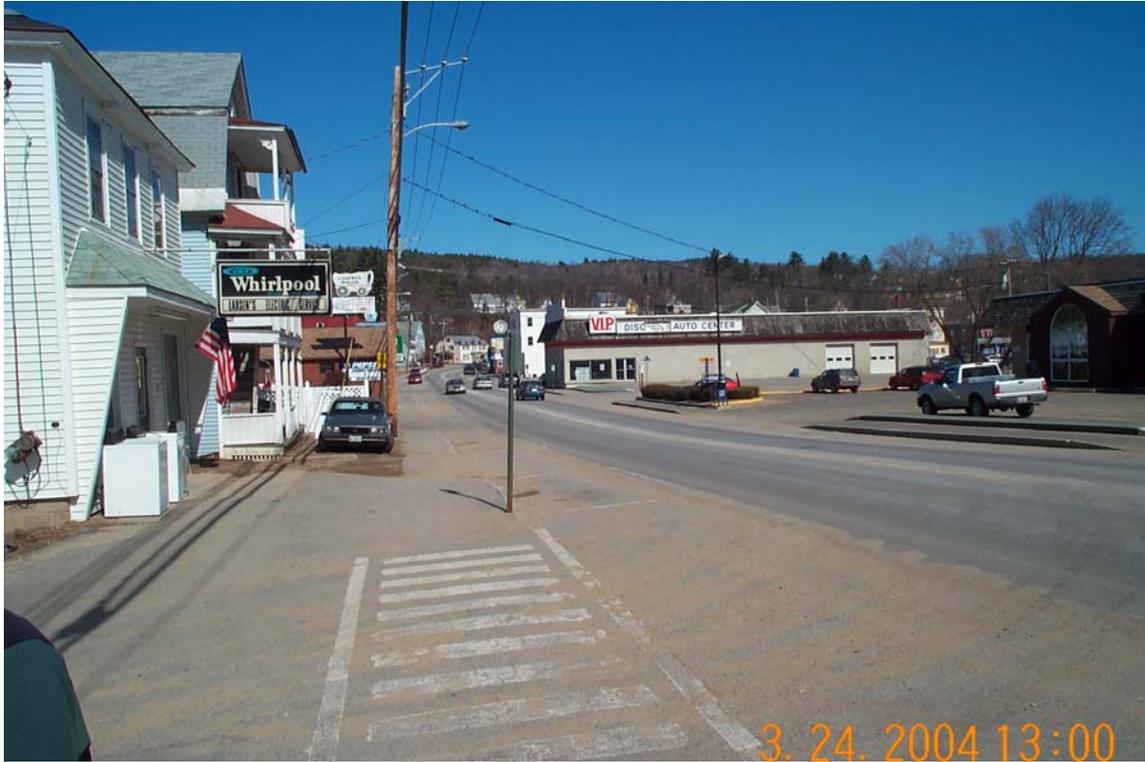
Figure 17. Main Street in Mexico, ME

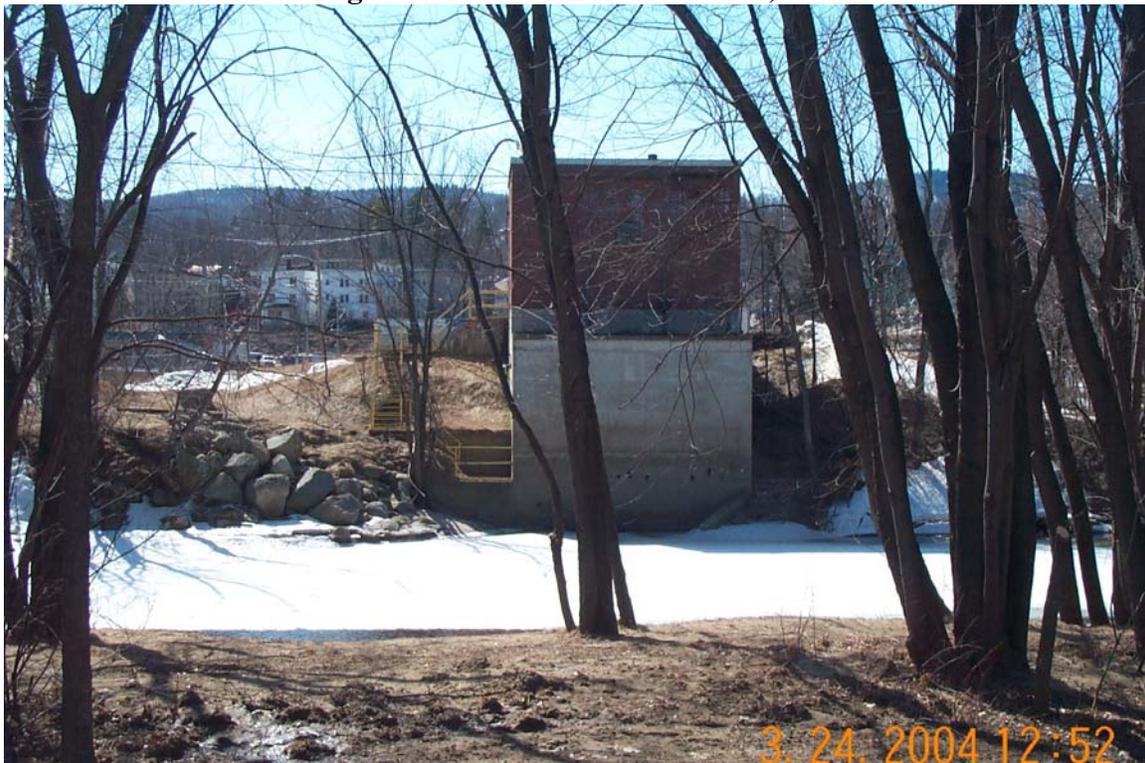
- a. Elevations taken from the riverbed to the Main Street low point indicate a 14-foot stage rise. Gary mentioned that a brick building at the far end of Main Street has had 1-2 feet of water above the sidewalk level. Measurements indicated that the base of this building was 3 feet higher than the lowest point on Main Street. Gary also noted that once the water level reached Carlton Street (approximately 12 feet of elevation change), the rate of rise on Main Street seemed to increase. A fenced-in pump house owned by the local paper company was located adjacent to the bridge and Gary and Dan felt that from past dealings with the company that they would be willing to provide access and allow instrumentation to be stored and mounted on the river side wall. The river channel adjacent to the building has been dredged in the past according to Gary, an indication of additional flow depth (Figure 18). Gary uses the top railing on the steps to the pump house as a flood level reference point.

Figure 18. Pump house upstream of the Main Street Bridge, Rumford

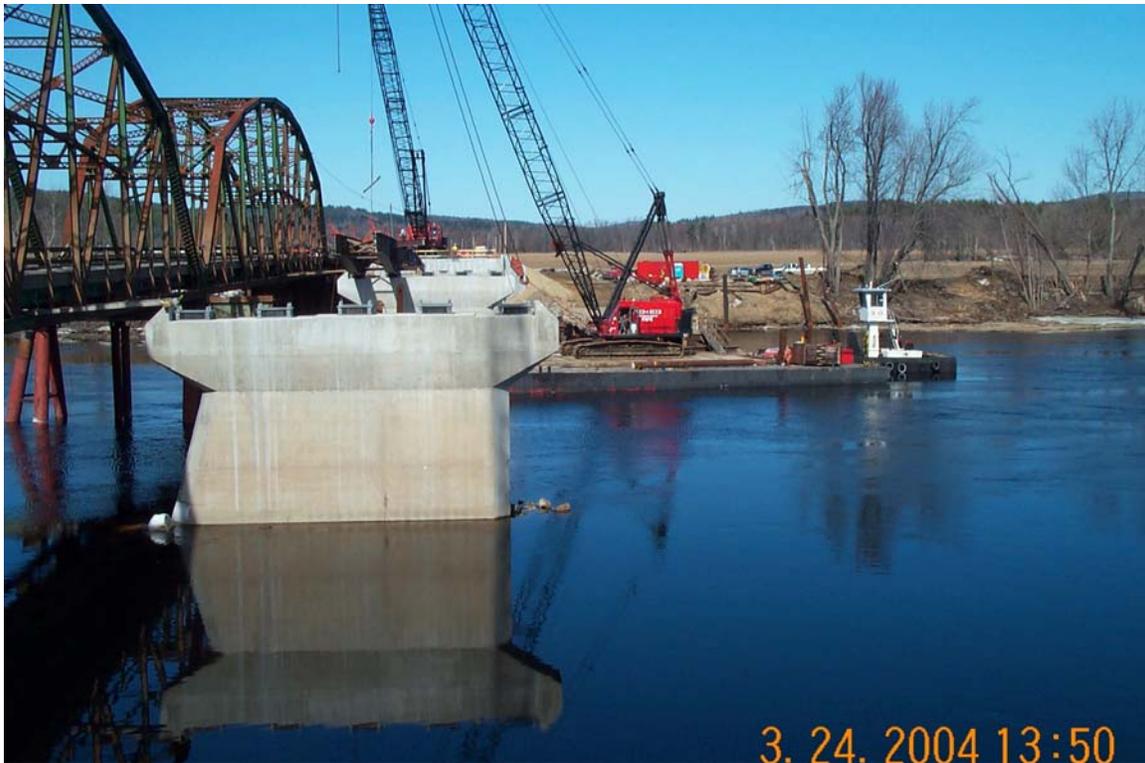
4. Site four was located downstream from Rumford approximately 15 miles, in the town of Canton. Construction of a new bridge was under way over the Androscoggin River (Fig 19). Although the estimated water depth for a submerged transducer was greatest at this site (4-6 ft), the bridge orientation and sharp edge design on the downstream face of the pier would make it difficult to attach conduit, and the base of the pier was protected by rip rap. Another option discussed was to locate the sensor downstream of the new bridge and trench the conduit 1.5 feet into the bed to the location of a cluster of rocks along the right bank (Figure 20). An existing phone pole at the site would be left to attach the instrumentation. The area is open and should provide good sunlight for a solar cell operation.

Figure 19. New bridge at Canton on the Androscooggin River, looking from right bank (flow is from left to right).

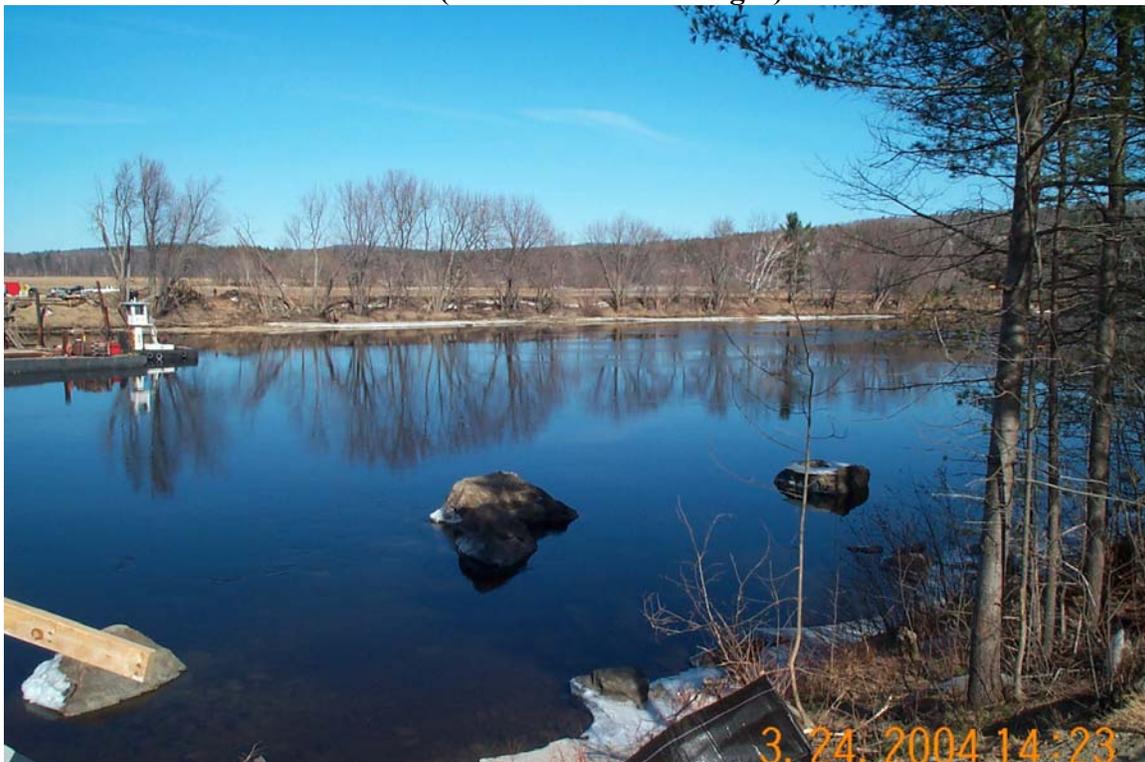
Figure 20. Downstream of the new Canton bridge looking from the right bank (water depth approximately 3 feet at the larger rocks).

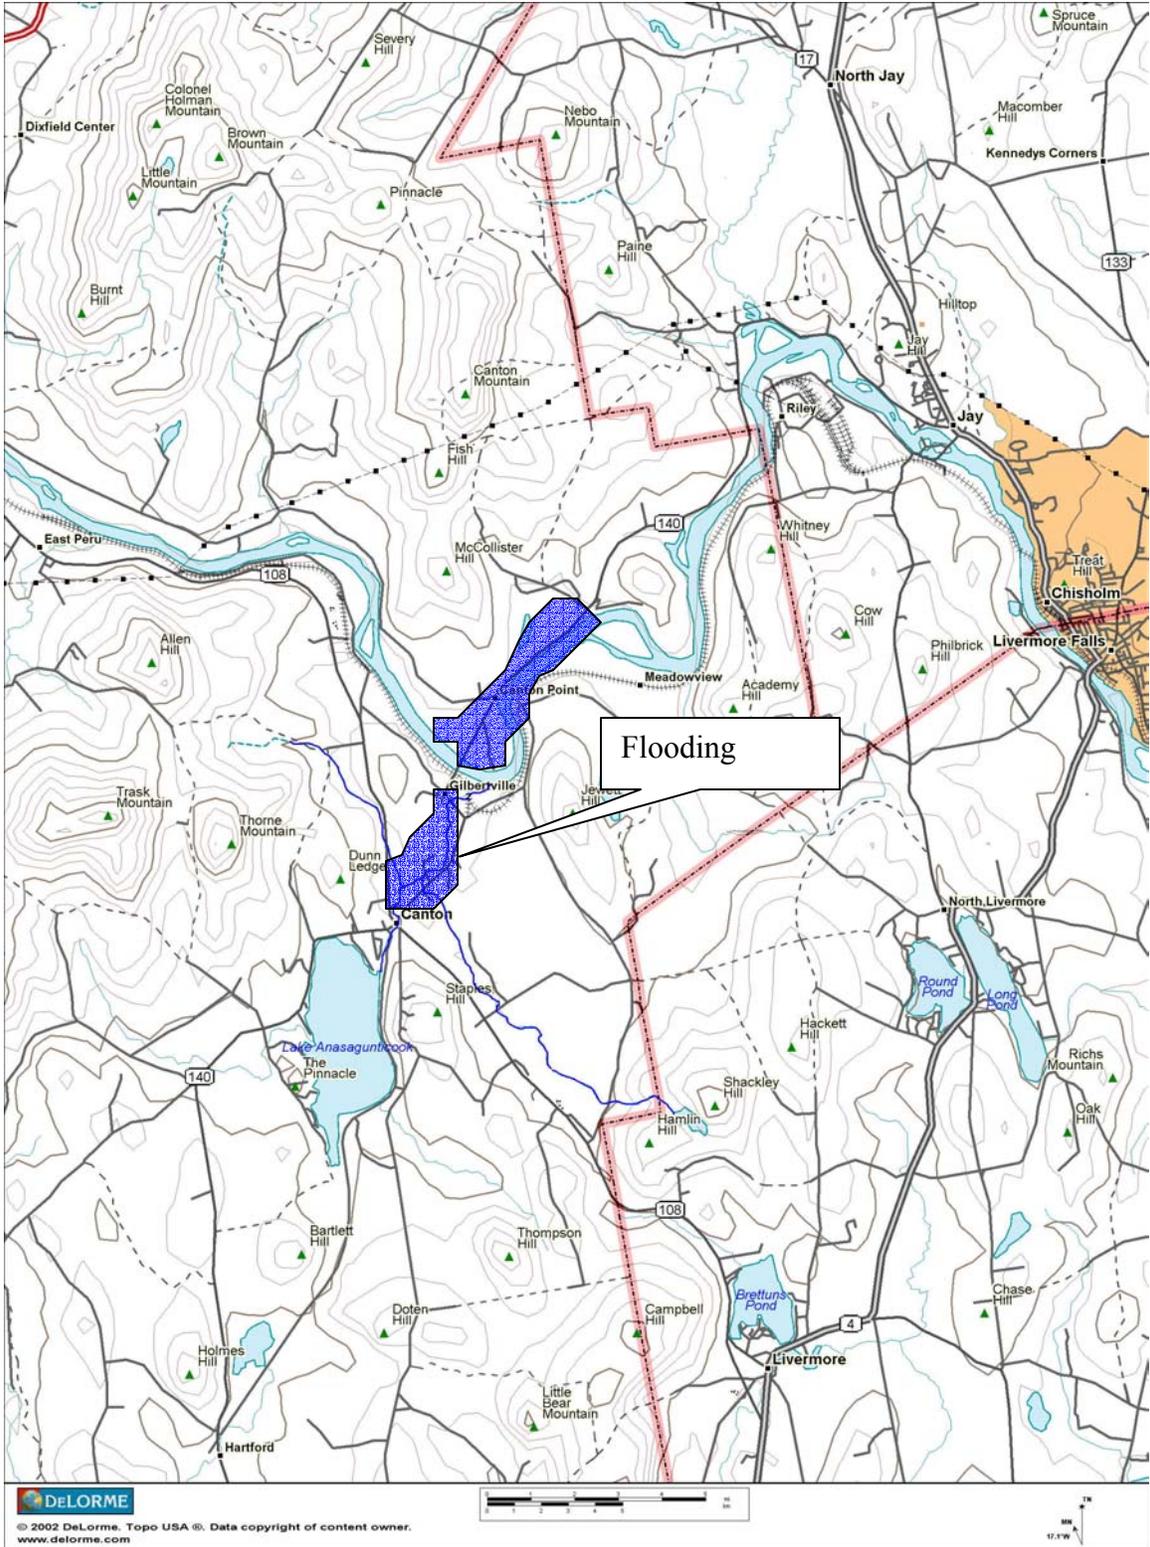
- a. We met with Jim Dymant, EMA director and LT. Fire chief of Canton. Jim pointed out past flooding areas on a map that included closing of Rt. 108 and Rt. 140 on the right bank of the Androscoggin where Whitney Brook overflows its banks. He also mentioned the 1976 and 1987 events

that caused flooding along Rt. 140 to Stevens Island on the Androscoggin River (Fig 21).

Fig 21 Map of Flooding along Whitney Brook and Androskoggin River Canton Maine

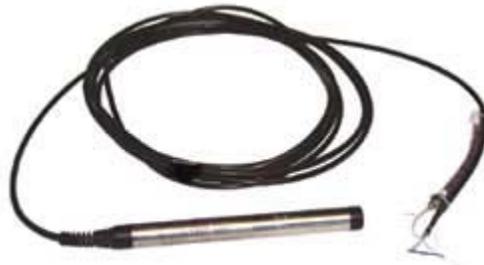
- i. Conduit attached to bridge pier with instrumentation cable connected to a submerged pressure transducer probe (Figure 22) (used by CRREL).
 - ii. Conduit attached to the bridge pier with a gas bubbler tube sensing system Figure 23, a more recent pressure transducer-based system used by NED and the USGS)

Figure 22 Submersible Pressure transducer.

5. The Bethel, Rumford Point, and Rumford-Mexico sites are limited in water depth if submerged water level probes are to be used (2-3 feet). Bed conditions around the piers are unknown and could provide additional time delays in the installation process. To reduce the possibility of freezing of the probe, we have been able to bury them in the bed sediments at a depth of 18 inches. This allows ground water that is slightly above the freezing point to infiltrate to the probe and prevents freezing. Use of SCH 80 PVC conduit rather than a metal conduit should reduce the amount freezing below the water level of the river and to the sensor. A perforated 3foot section of pipe with a filter fabric wrap has been used to allow water to infiltrate but restrict unwanted fine sediments from entering the pipe.
