MEMORANDUM FOR RECORD: Inspection of site conditions for flood early warning sensors at Bethel, Rumford Point, Mexico and Canton Maine, 24 March 2004

Project: FY04 Monitoring New England Ice Jams

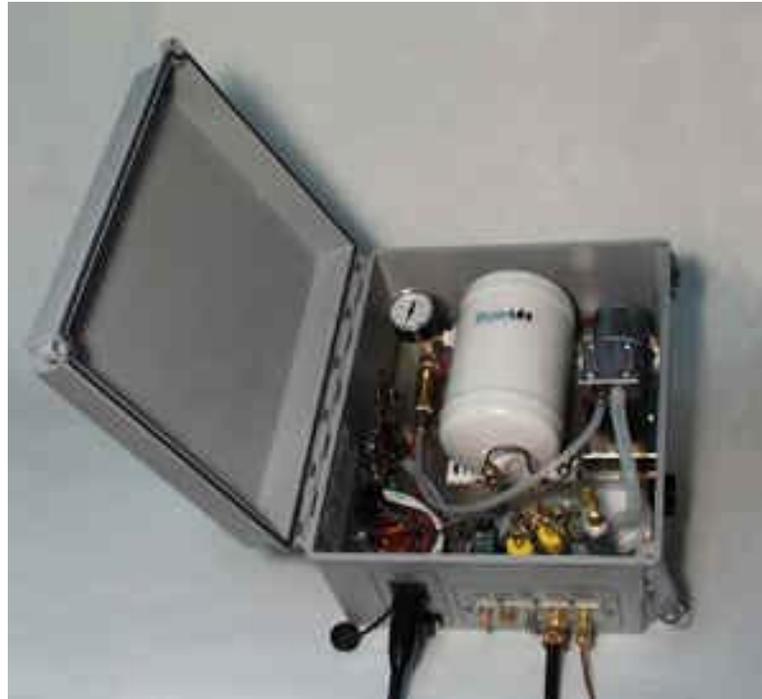
- i. Conduit attached to bridge pier with instrumentation cable connected to a submerged pressure transducer probe (Figure 22) (used by CRREL).
 - ii. Conduit attached to the bridge pier with a gas bubbler tube sensing system Figure 23, a more recent pressure transducer-based system used by NED and the USGS)

Figure23. Gas bubbler water level system.

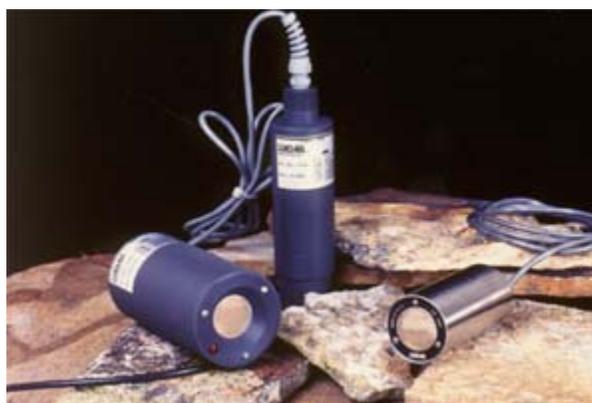
- iii. Ultrasonic and microwave sensor with no water contact (Fig. 24 and 25). These are used by Corps of Engineers New England District (NED) and CRREL. The sensing range of the ultrasonic sensor is 32 feet and should fall within the stage range at the three bridges on the Androscoggin River and one site on the Swift River in Rumford/Mexico.

Figure 24. Ultrasonic sensor

- f. The susceptibility of the monitoring sites to damage by ice, freezing, bed scour and debris damage throughout the year suggest that the **ultrasonic sensor** may be the most practical option. A separate report will be provided discussing this option.

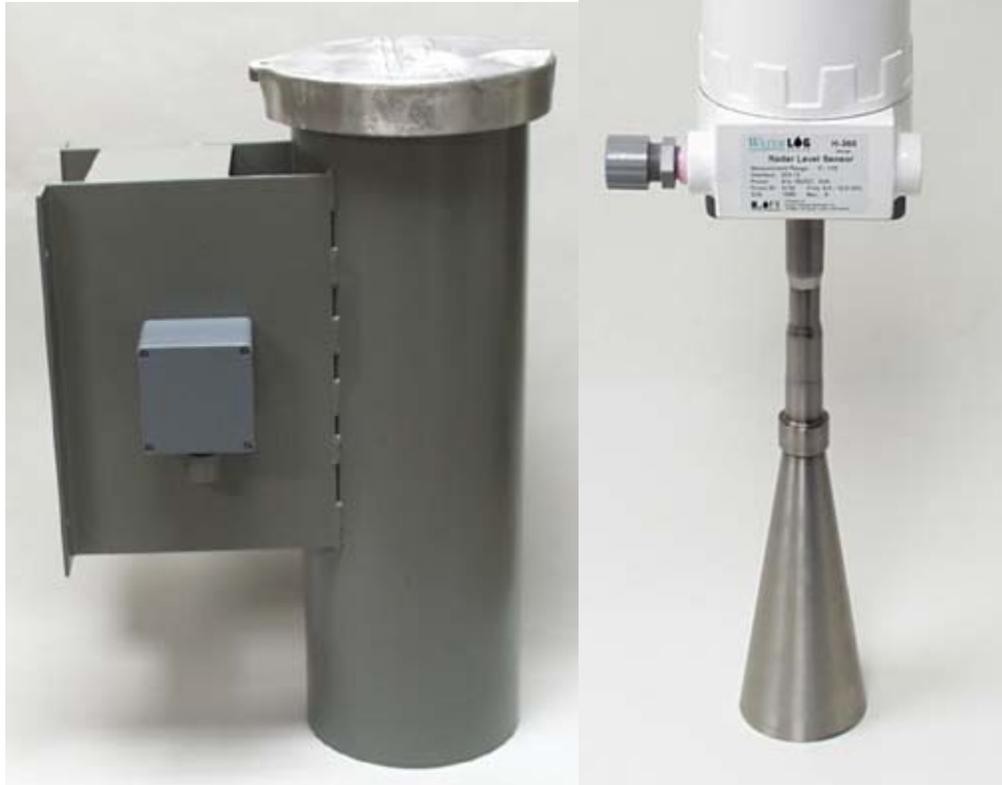
Figure 25. Microwave water level system, range 0-115 feet
