MEMO FOR RECORD

SUBJECT: Ice Conditions on the Pemigewasset, Kennebec, Sebasticook, Sandy and Androscoggin Rivers, 8-9 January 2004

Andy Tuthill inspected ice conditions by airplane on the above-mentioned rivers in NH and Maine on 8-9 January 2004. In addition to the aerial survey, Tuthill also met with Andy Straz of E-PRO Engineering and Bob Richter of FPL Energy in Augusta to discuss the Ft. Halifax Dam removal study and check ice conditions from the ground on the Kennebec and Sebasticook Rivers.

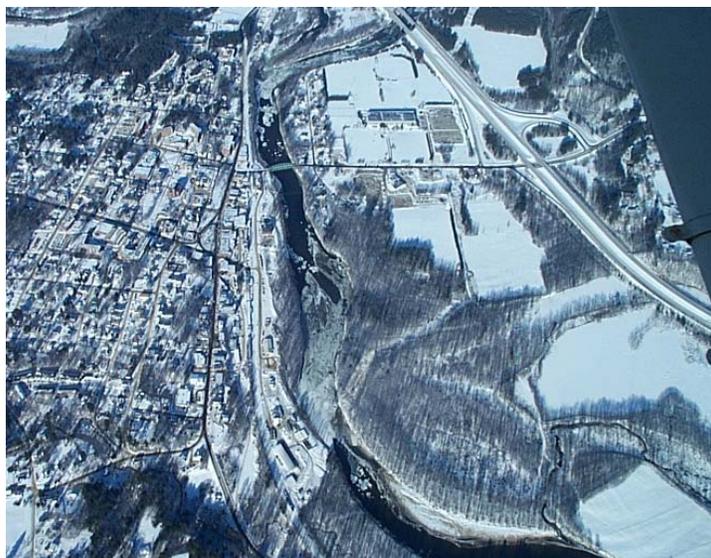
A freezeup ice jam had formed in the wide shallow reach downstream of the Plymouth-Holderness Bridge. Breakup ice jams, such as the one on Dec. 17-18, 2003, also form at this location. A frazil ice accumulation also filled the reach upstream of the bridge.

Fig. 1. Pemigewasset River at Plymouth NH.

An example is the freezeup jam observed on the Pemigewasset River, downstream of the Plymouth-Holderness Bridge. This ice accumulation likely obstructs the passage of the breakup ice run in this reach.

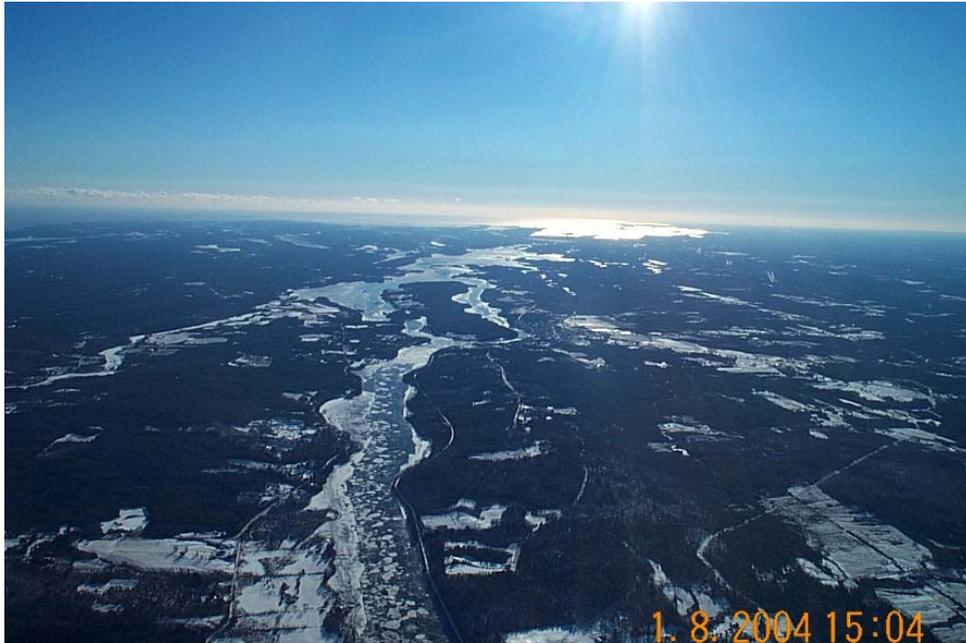
Downstream of Augusta, the tidal portion of the Kennebec conveyed large frazil pans, some over 50 ft in diameter. A more or less open channel still extended downstream past Swan Island to Merrymeeting Bay (Fig. 2), Surface ice concentrations were as high as 70% in bends and narrower sections (Fig. 3). Ice transport was aided by strong northwesterly surface winds that were gusting up to 30 knots while surface air temperatures were below 0°F.

Fig. 2. Frazil pans moving down the Kennebec River towards Swan Island.

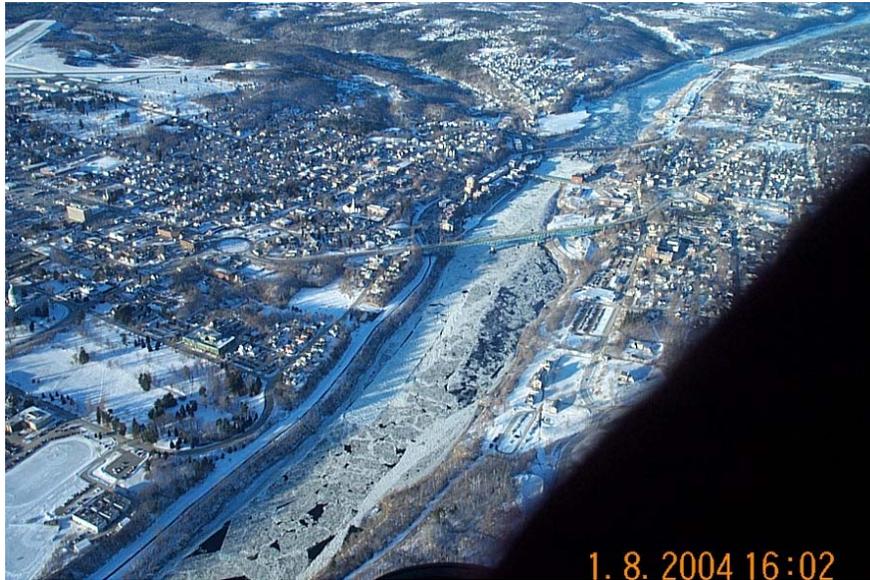
At Augusta, at 3:00PM, a freezeup ice jam was actively shoving its way down the western half of the channel with its upstream end located near the railroad bridge (Fig. 4). By the following morning (Jan. 9th), the jam had frozen in place and the head had moved upstream as far as the former Edwards Dam site. Several thousand feet upstream of here, a second ice cover had formed behind the piers of the new highway bridge under construction. This accumulation had cut off the frazil ice supply to the Augusta jam below (Fig. 5). Fig. 6 shows the Augusta jam downstream of the Father Curran Bridge on the evening of Jan. 8th, with ice rubble shoving its way down the eastern side of the channel. Ice pieces were 2-4 inches-thick, and the accumulation thickness appeared to be about 2 ft.

Fig. 4. Augusta ice jam actively forming on the afternoon of Jan. 8, 2004

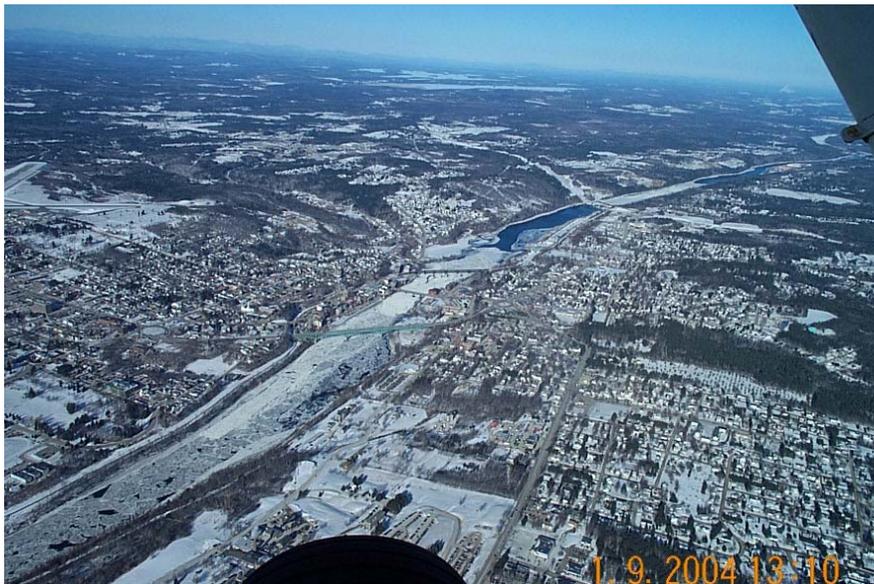
Fig. 5. Augusta jam frozen in place the following day. Note the second ice accumulation upstream of the new highway bridge.

At least this winter, the frazil ice supply to the Augusta freezeup ice jam on the Kennebec River is limited by the formation of two upstream frazil ice covers, the first at the new highway bridge and the second at Seven Mile Island. It will be interesting to see if breakup ice run also stalls at these two locations.

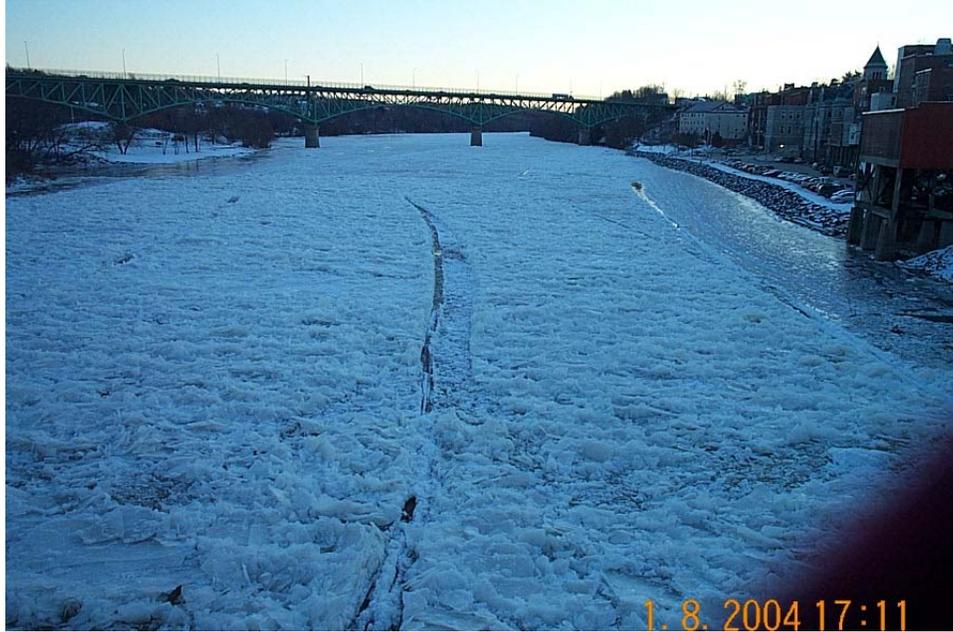
Fig. 6 Augusta jam viewed from the Father Curran Bridge looking downstream. At this time, the ice rubble in the left-hand half of the channel was shoving its way downstream.

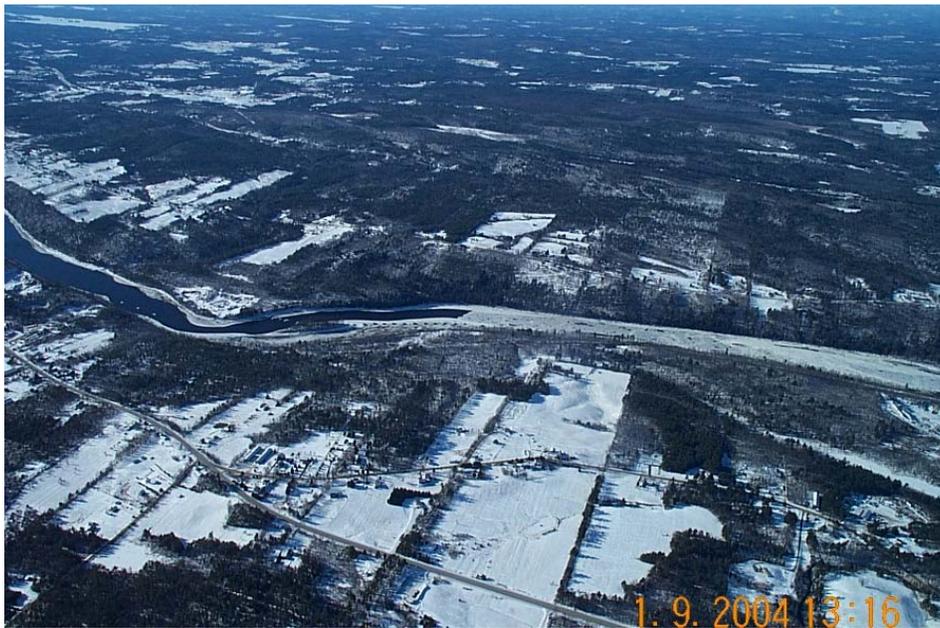
About 5 miles upstream of Augusta, on the afternoon of Jan. 8th, the ice was slowing at channel constriction near Seven-Mile Island. Just below this point is a fast section where the river bends sharply to the right and passes a row of rock-filled timber cribs. By the next day, the ice had jammed here creating a 2-mile long frazil ice cover that extended upstream past Sydney (Figs. 7&8).

Fig. 7. Freezeup ice accumulation at Seven Mile Island.

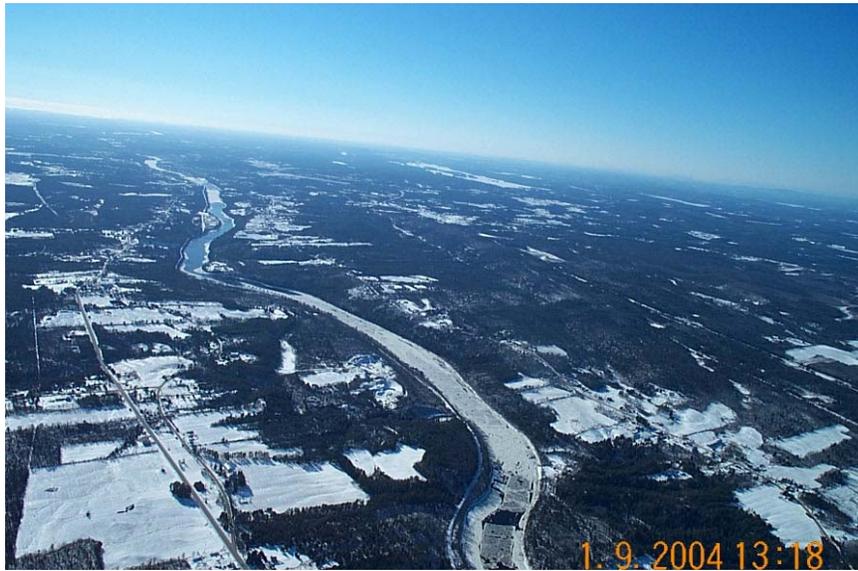
Fig. 8. View of the he Seven Mile Island ice cover looking downstream.

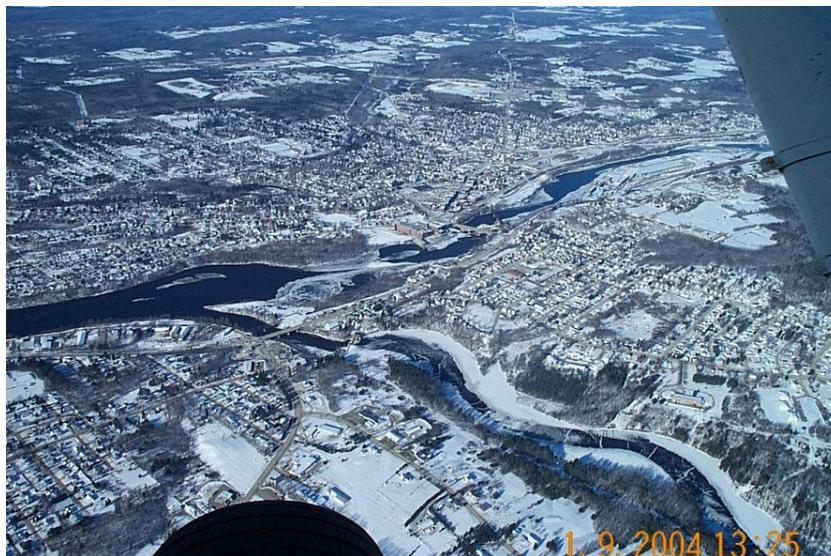
Black sheet ice also covered the Sebasticook for about 1 mile, from Fort. Halifax Dam up to the confluence of Outlet Stream (Fig. 9). This thermally-grown ice, which had formed since the thaw of Dec.24-25 was measured at 4-inches. The bordering snow covered sheet ice, which had survived both the meltouts of 17-18 and 24-25 Dec., was about 8-inches-thick.

Fig. 9. Kennebec and Sebasticook Rivers at Waterville and Winslow.

The freezeup ice cover behind the Fort Halifax Dam is extremely stable, having, for the most part, survived both December thaws and the associated high flows on the Sebasticook. At present, only half a mile of open water exists below the Benton Dam

A 2-mile-long sheet ice cover behind the second Waterville dam on the Kennebec, and the ice cover on the Sebasticook above the Ft. Halifax Dam retain all frazil ice produced upstream of these locations.

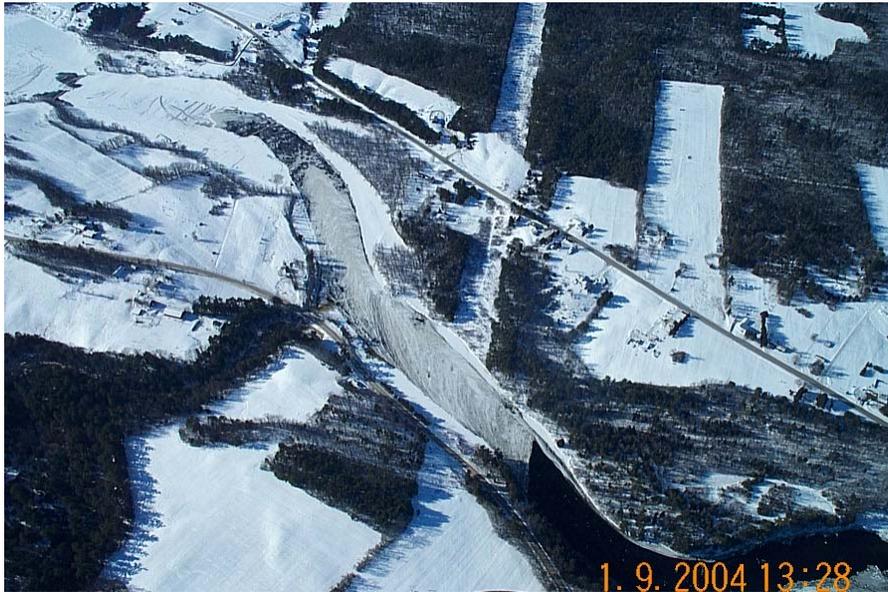
The snow-covered sheet ice extended to within about 1.5 miles of Benton Dam (Fig.10). The first half-mile below the dam was fast flowing and open. Slightly shoved frazil floes made up the upper-most several thousand feet of the ice cover. The frazil then graded into thermally-grown

black sheet ice similar to the ice cover near the Ft. Halifax Dam. Fig. 11 shows the frazil ice cover from Garland Road, the near the mouth of Pattie Pond Brook. The ice was too thin to measure thickness at this time.

Fig. 10. Upper end of Fort Halifax Dam Pool at Benton, showing the frazil ice cover grading into thermally-grown sheet ice.

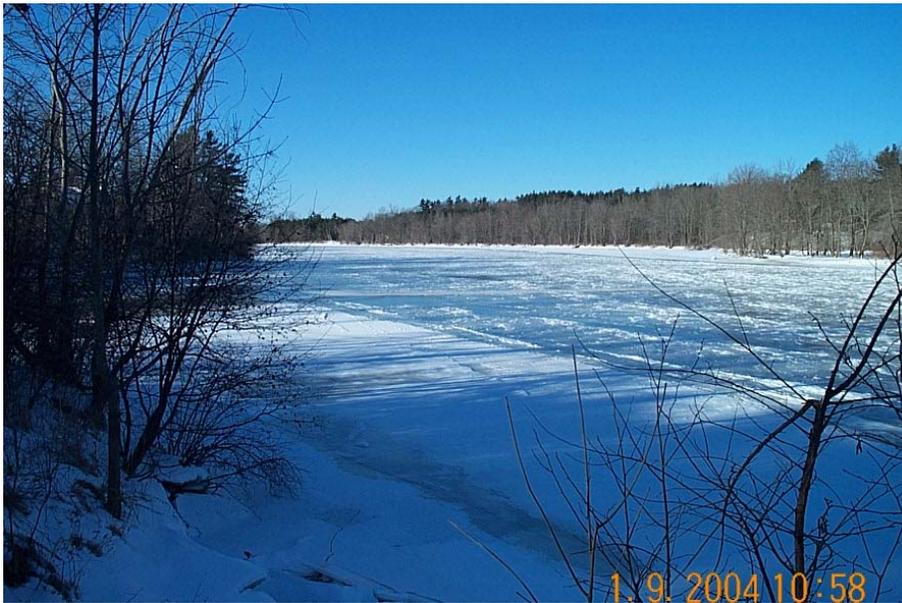
Fig. 11. Frazil ice cover at upstream end of Fort Dam Halifax Pool at Benton.

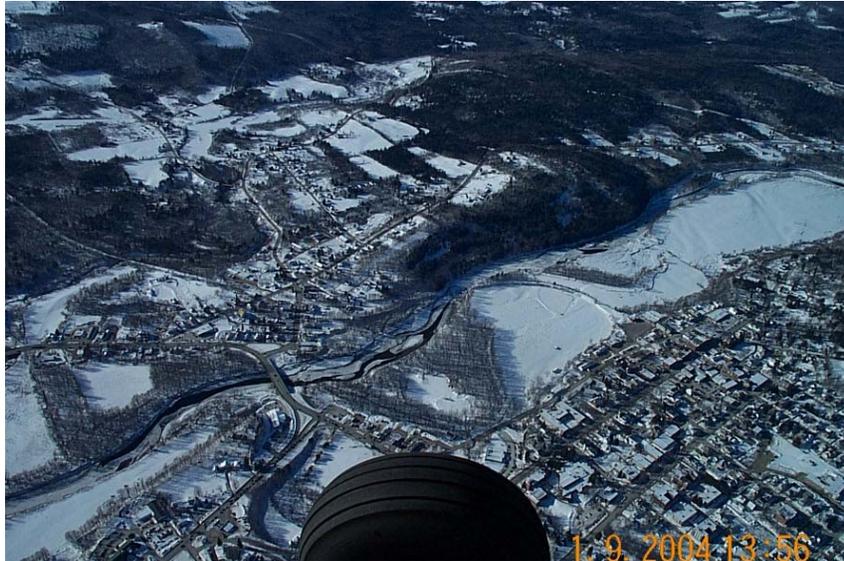
The frozen-in ice jams that were observed on Dec. 19 on the Sandy River, upstream and downstream of Farmington² had melted out, most likely during the 24-25 Dec. thaw. This is good since these jams might have obstructed breakup ice runs later on, increasing the chance of ice jam flooding.

Fig. 12. Sandy River at Farmington.

The 17-18 Dec. breakup ice jams on the Sandy River at Farmington and the Androscoggin River at Canton and Bethel melted out during the 24-25 December thaw. This reduces the threat of breakup ice jam flooding at these locations later in the winter and early spring.

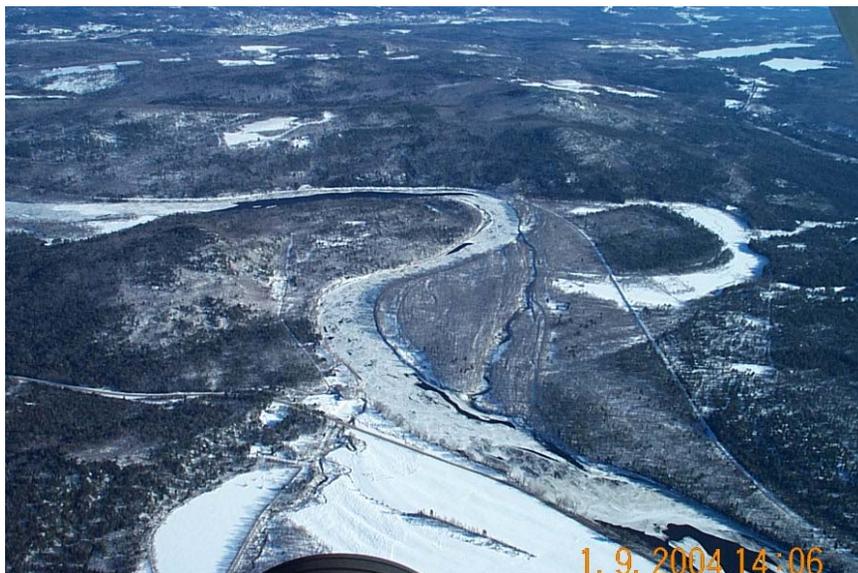
The Androscoggin River From Jay, ME to Gorham, NH was over half ice-covered, mostly in frazil ice accumulations of varying roughness and thickness. A frazil accumulation had formed in the bend below Canton along Stevens Island, the site of the Dec. 18th breakup ice jam (Fig. 13).

Fig. 13. Freezeup ice accumulation on Androscoggin River downstream of Canton, ME.

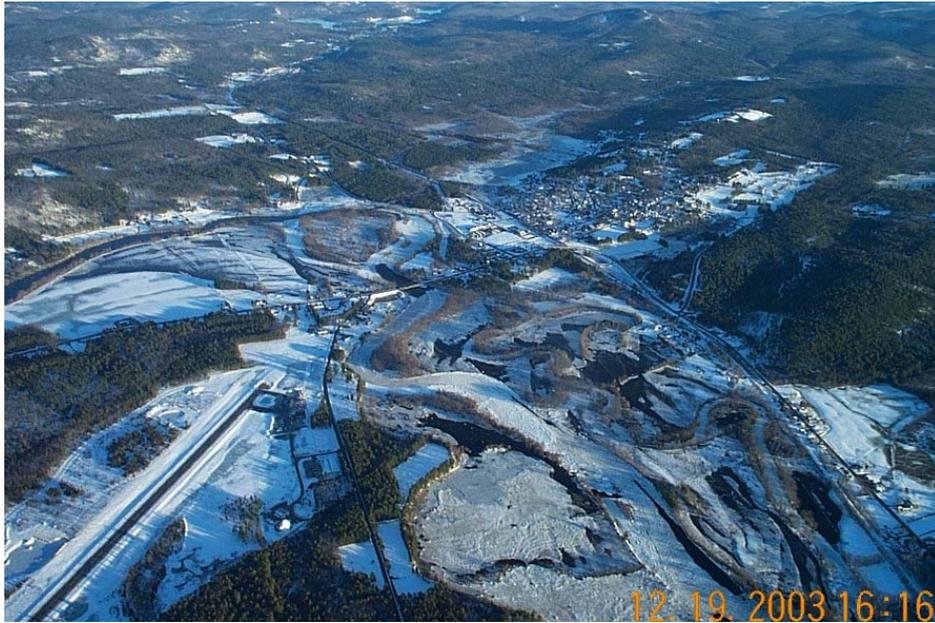
The Dec. 17-18 jams that had frozen in place at Bethel (Fig. 14) appeared to have melted out during the 24-24 Dec. thaw. Since then, a frazil ice accumulation had formed upstream of town near the airport (Fig. 15).

Fig. 14. Breakup ice jams on the Androscoggin at Bethel, frozen in place.

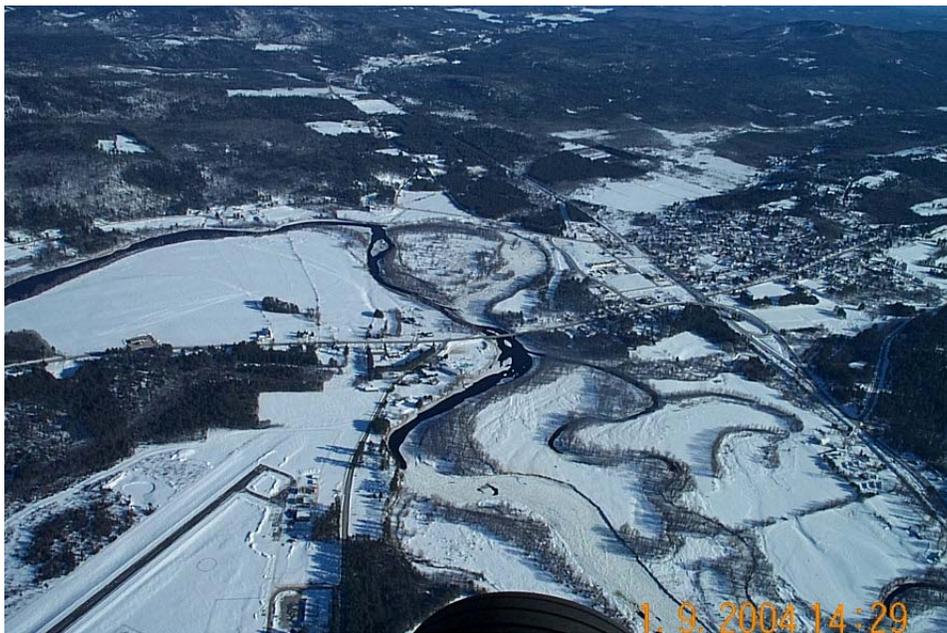
Fig. 15. Frazil ice accumulation upstream of Bethel on Jan. 9, 2004.

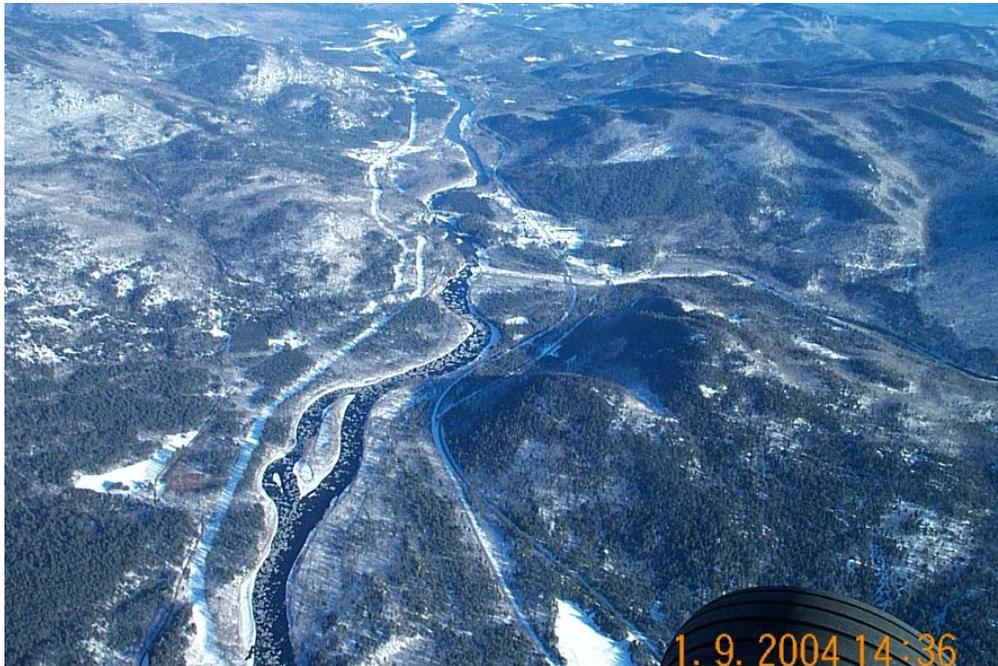
From about 4 miles upstream of Bethel to Gorham, NH, the Androscoggin was mostly open and carrying high concentrations of frazil, as seen in Fig. 16. The Wild and Peabody rivers were choked with anchor ice, and contributing little or no frazil to the Androscoggin.

Fig. 16. Androscoggin River at Gilead, ME, looking downstream.
