MEMORANDUM FOR RECORD: Inspection of Ice Conditions at Peterborough NH,
3 March 2004

Project: FY04 Monitoring Northeast Ice Jams

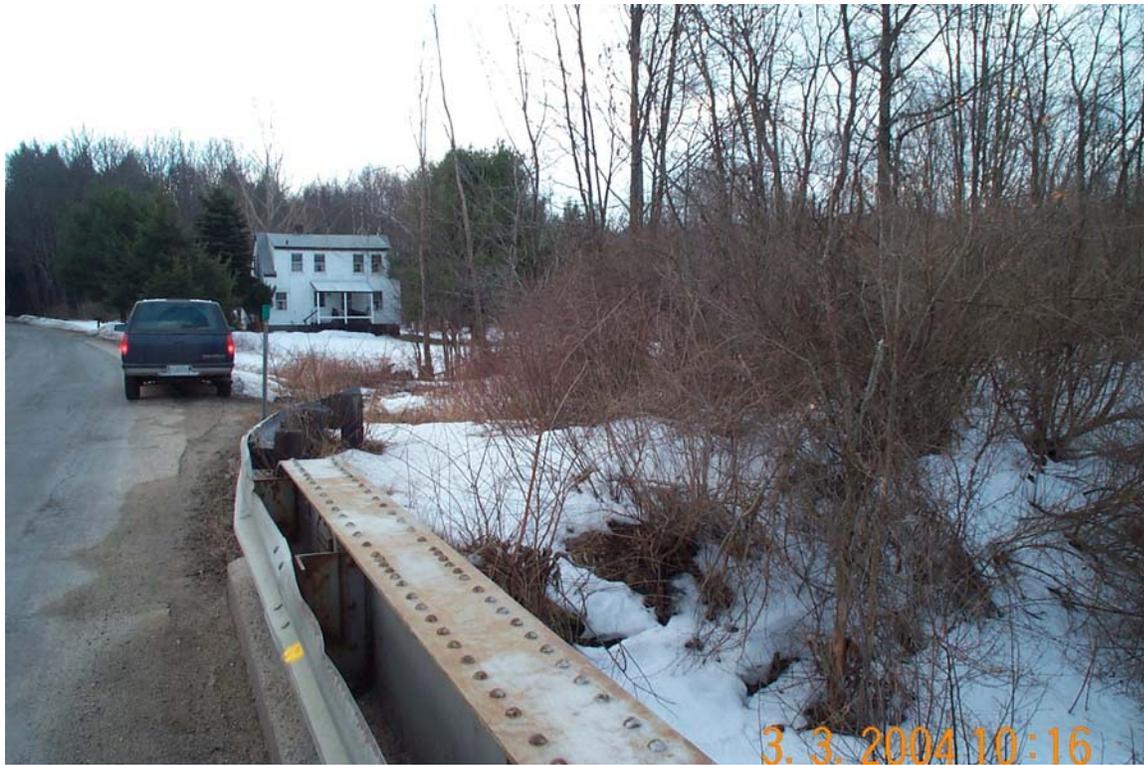
4. We met with Lorane Strang while we were at the Sharon Road Bridge and she gave us a detailed history of the flooding at this location and relayed her concerns about the water levels that often threaten her home. She has been forced to evacuate during extreme water levels from ice jams at the Sharon Road bridge located just downstream of her home. (Figure 2). High banks characterize the bridge approach, and there is a sharp 90-degree bend in the river approximately 50 feet up stream of the bridge. The clearance to the low steel was less than a couple of feet without any ice jamming and Ron mentioned that ice often hits the low steel. It is not surprising that ice and water conveyance is low at this location. (Figure 3 and 4). The river reach

Figure 3. Sharon Road Bridge and the Strang home

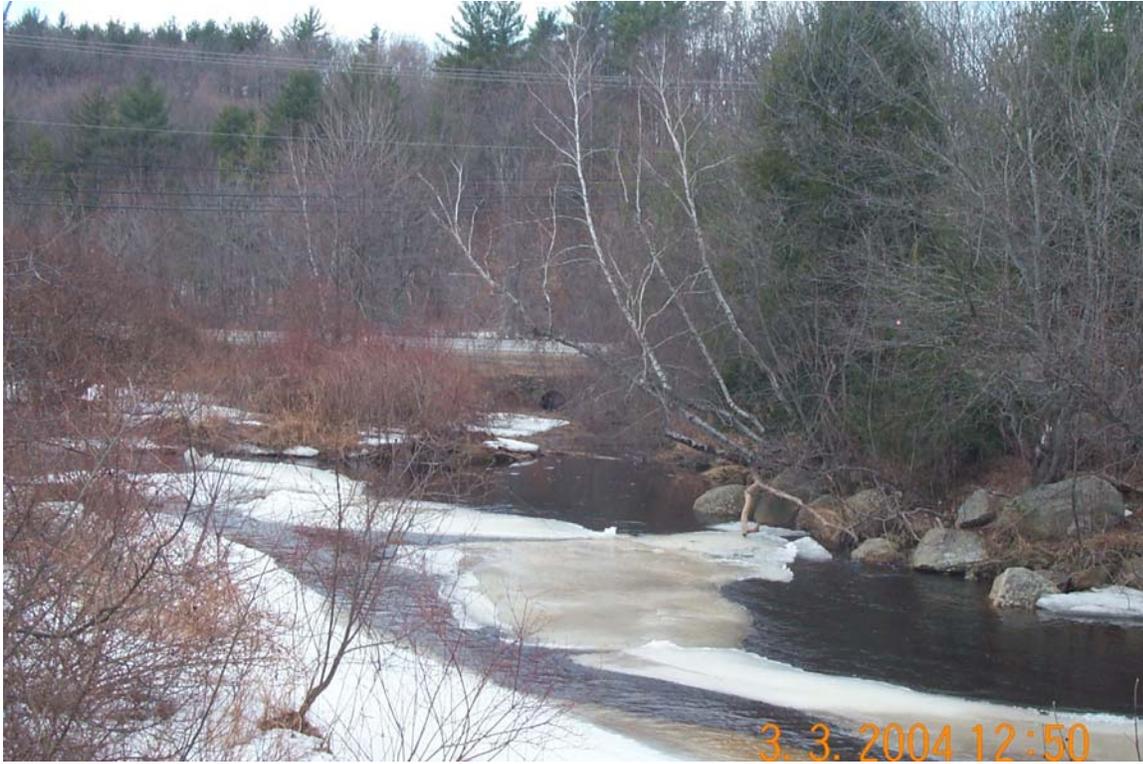
immediately upstream of this location had open water leads and appeared to be flowing at a moderate flow rate, probably due to snowmelt from the warm temperatures the previous week. Areas maps (Figure 5) indicate that several tributaries exist that could contribute to the ice supply that eventually makes its way to the town of Peterborough. According to Jim Holbrook, the main flow for the Contoocook River flows from the town of Jaffrey where a matchstick factory and a low head hydro dam are located.

Figure 4. Looking upstream of the Sharon Road Bridge

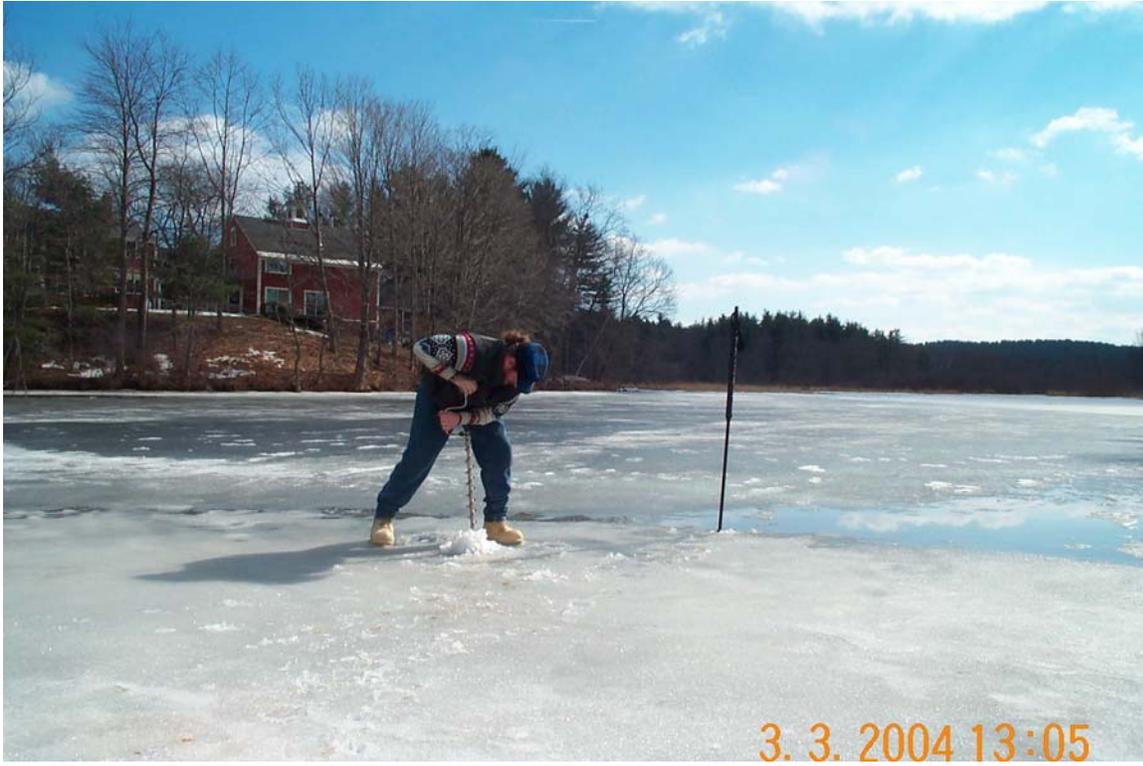
5. Our next stop was a hydro dam at the Noon Falls Café approximately half a mile downstream of the Sharon Road Bridge where we made several ice thickness measurements. (Figure 6 and 7). The ice thickness at this location measured 16 inches thick with the top 1-inch soft from the warming temperatures. If the water level could be lowered in the winter months, this impoundment could provide a good storage location for ice discharging from upstream locations and also provide additional area for ice to pass under the Sharon Bridge. Open water was observed for approximately half a mile downstream of this dam. The river then comes to the backwater of the Main Street Dam (Figure 8) where a second ice sheet was observed.

Figure 6. (Hydro Dam Pool) Ice thickness measurement looking upstream of Old Sharon Road Bridge

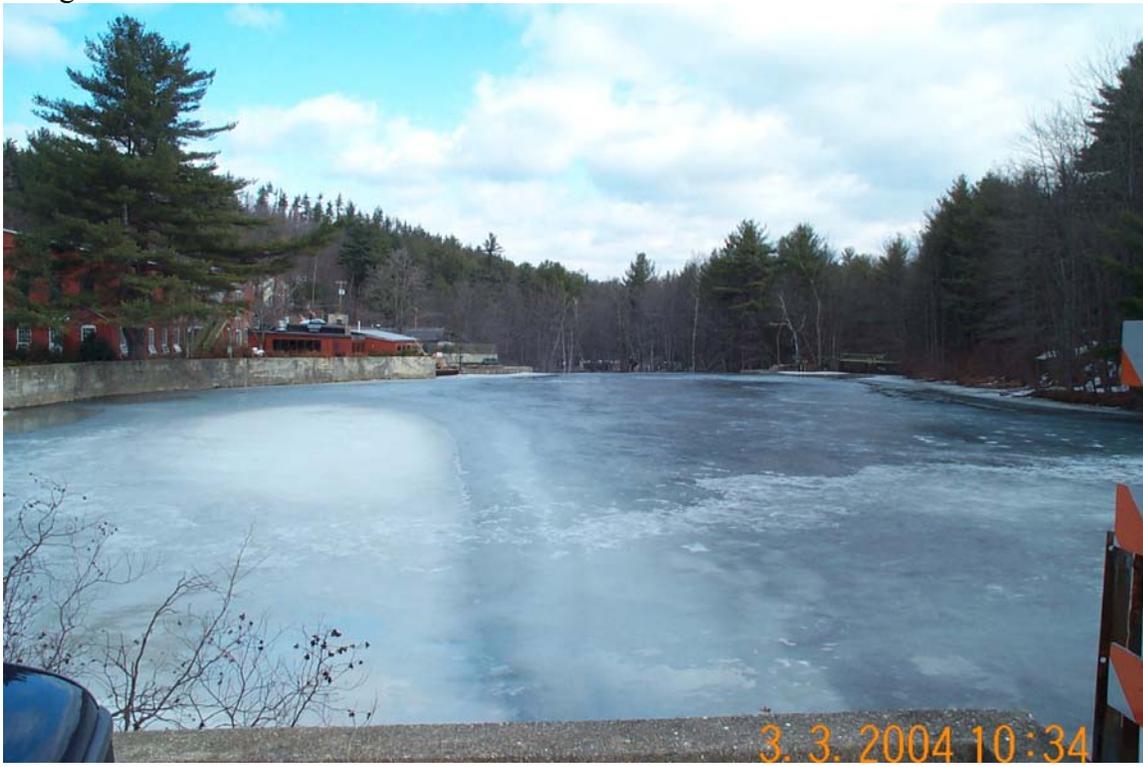
Figure 7. Looking downstream hydro dam at the Noon Falls Café

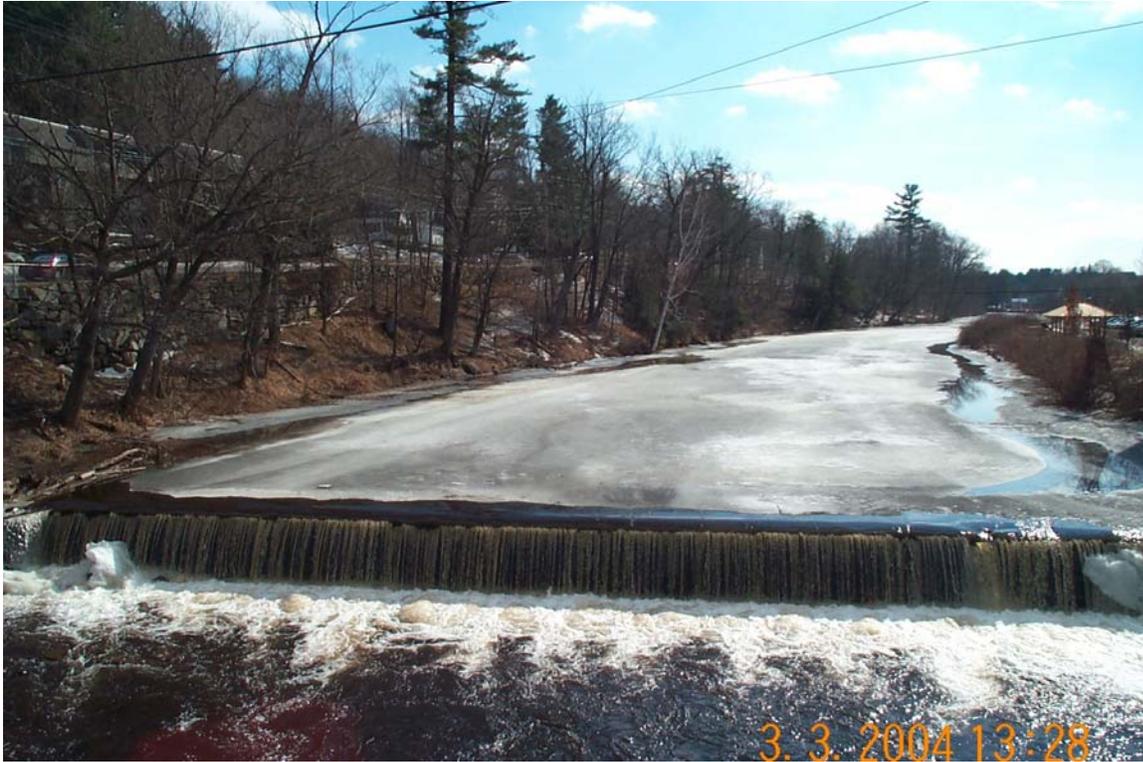
Figure 8. Main Street Dam and intact ice sheet

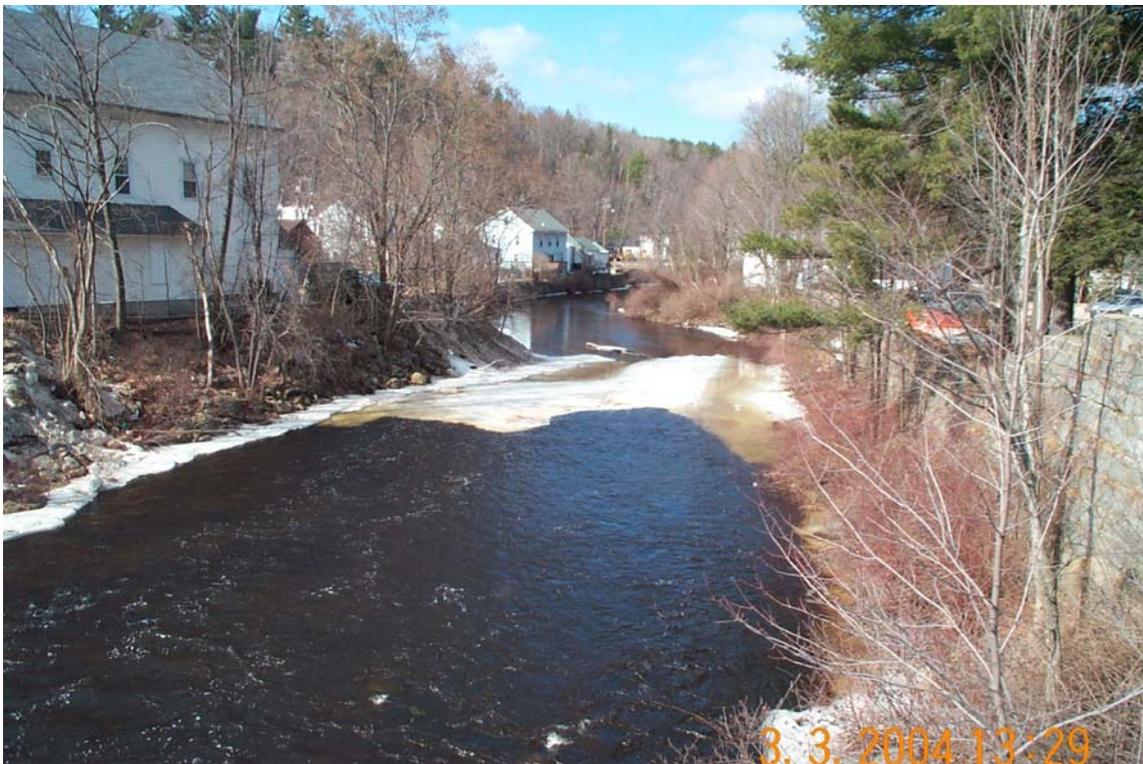
9. The ice conditions in Peterborough consisted of three intact ice sheets extending to the upstream extent of the backwater reaches of the three dams on the Contoocook River. The river above and below the Main Street Dam ice sheets was open approximately 80-100% of the width of the river reaches observed. (Figure 9 and 10) Ice thickness at the most upstream dam at Old Sharon Road Bridge measured 16 inches. The river upstream of the Sharon Street Bridge was in advanced stages of melting with open water area approximately 30 % of the flow surface. Ice

Figure 9. View looking downstream of Main Street Bridge

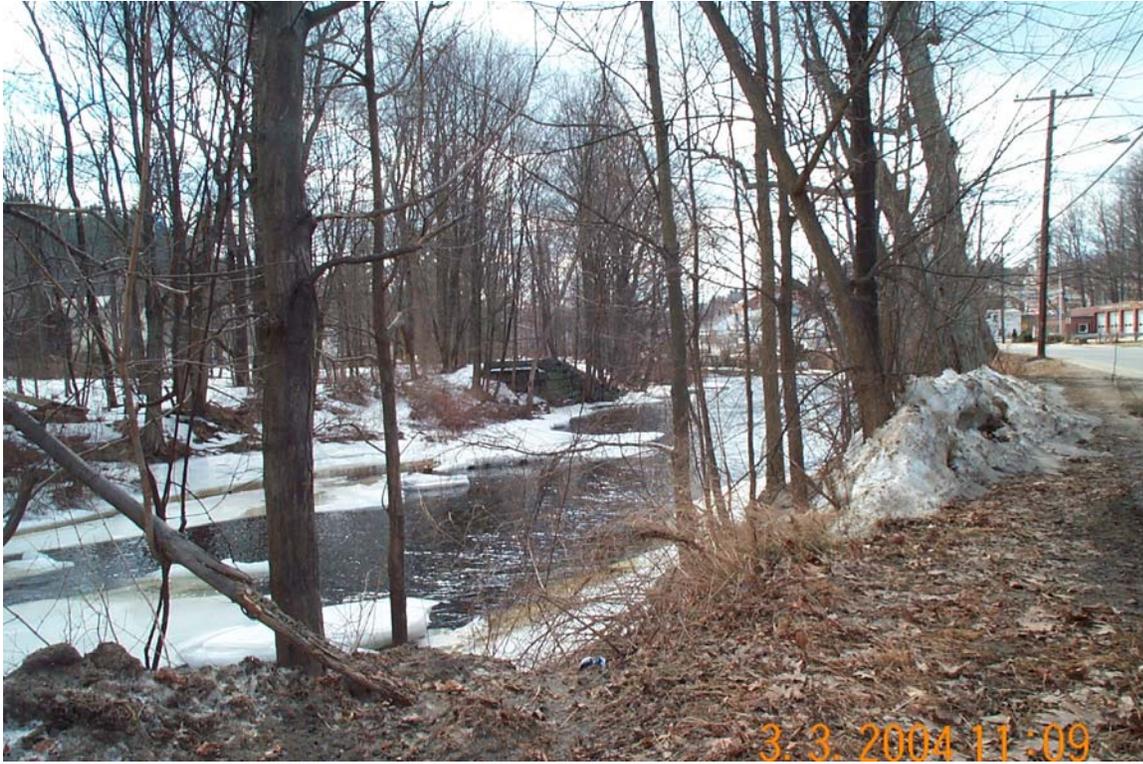
Figure 10. Downstream of Main Street Dam Looking upstream

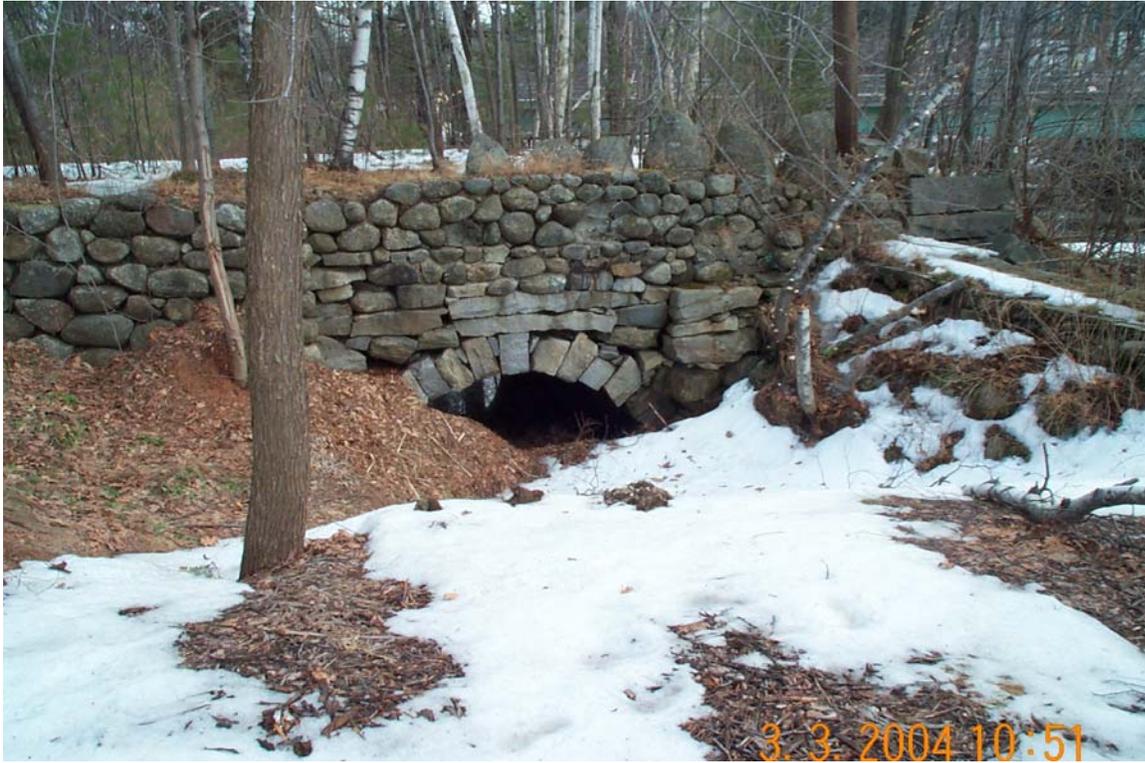
6. We then drove to the location of previous flooding along the Route 202 on the right bank of the Contoocook River and then crossed over the river and drove along Summer Street. Ice jams at this location are likely caused by the change in slope of the river from steep to mild that occurs where the Contoocook meets the backwater caused by the Hunt Road Dam, which is the most downstream dam in the town of Peterborough. (Figure 1) According to Ed Betz the town of Peterborough has hired a consultant to look into the feasibility of lowering this dam by 2 feet. (Figure 11) I asked why this amount was chosen and he said that the town water wells were located in the backwater of this dam and any additional reduction could cause adverse effects on water well levels. He also mentioned that additional benefit would be gained in the creation of more useable land due to the shift in the water surface elevation for flood plain regulations. While we were at this dam site, I observed an old sluiceway (Figure 12) on the left bank of the dam that had been obstructed by a fill area. Ron informed me that they put in a clay barrier to prevent water seepage at this location. He mentioned that this sluiceway had been used during their last ice jam event to aid in the lowering of the water level upstream.

Figure 12. Old Sluiceway adjacent to Hunt Road Dam

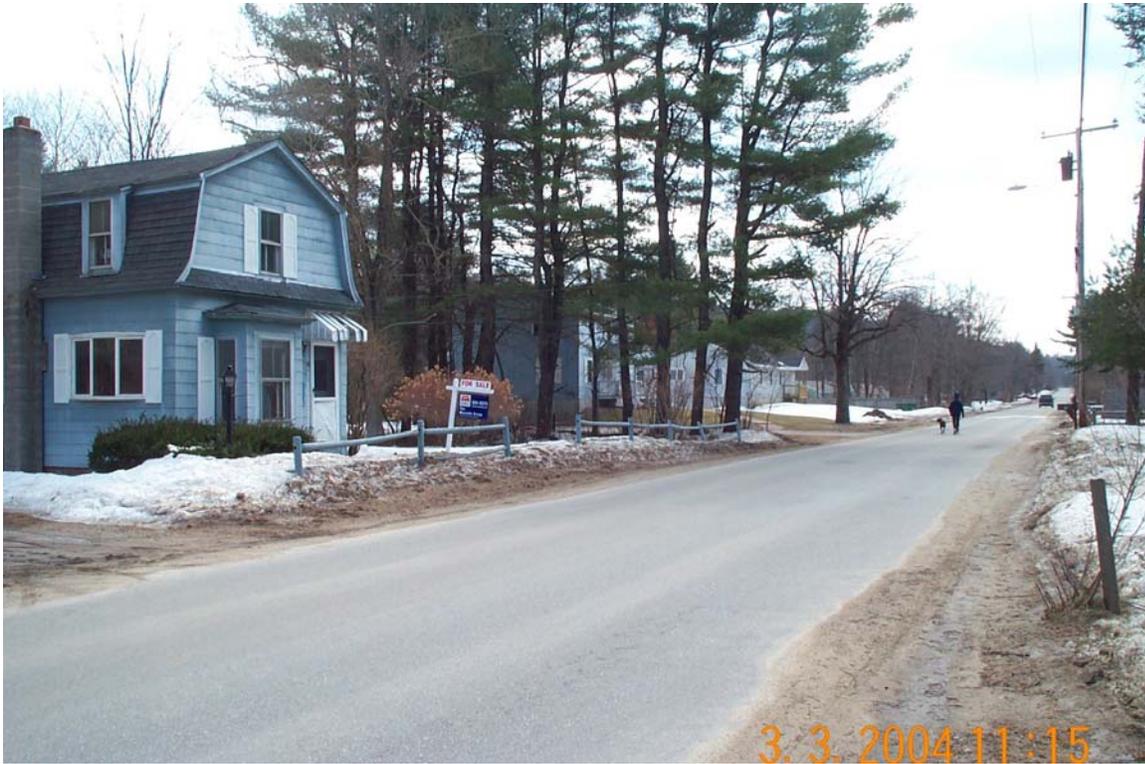
7. We then drove along Summer street and observed the low lying areas on the left bank of the Contoocook River, where two new homes were build according to current 100 year flood level elevations in contrast to the older homes that were several feet lower in elevation. (Figure 13)

Figure 13. Summer Street
