Ice Engineering

U.S. Army Cold Regions Research and Engineering Laboratory, Hanover, New Hampshire

Ice Jams, Winter 1998–1999

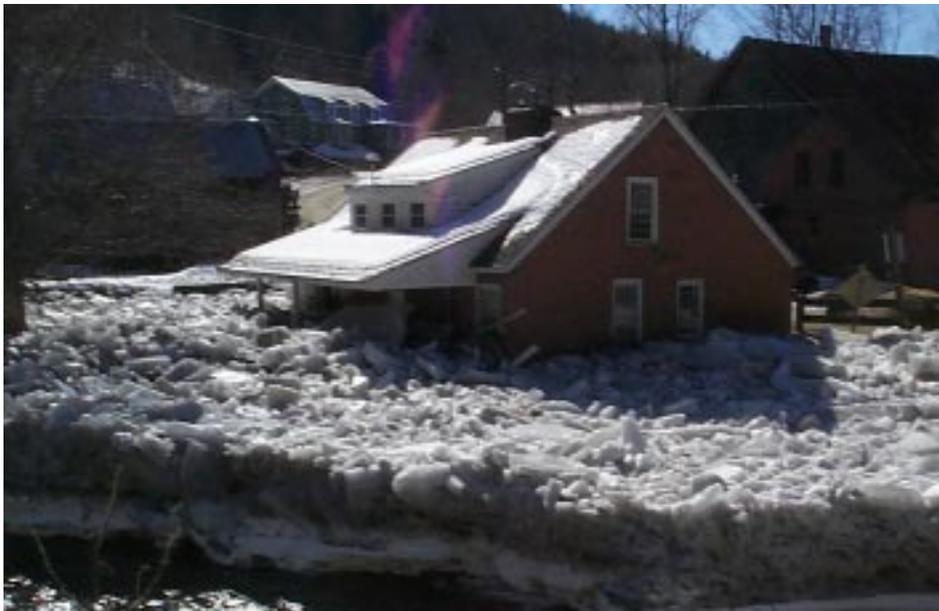
Figure 1. Surrounding areas were flooded when ice destroyed the Tunbridge Mill covered bridge in March 1999.

Probably the most devastating ice jam of water year 1999 occurred on the first branch of the White River in Tunbridge, Vermont. On 4 and 5 March, the 116-year-old Tunbridge Mill covered bridge was destroyed by ice, and the surrounding areas were flooded. The problem on the White River actually began in the middle of January when upstream ice broke up near Chelsea and jammed at the Tunbridge Fairgrounds downstream from the historic covered

bridge. This jam caused no problems, but remained in place. During subsequent cold weather, additional ice grew upstream. This ice broke up and moved during the March rainfall and thaw. The ice was stopped by the existing jam and was forced under the bridge. The structure was pushed off its abutments, and an adjoining building was surrounded by ice and flooded (Fig. 1). Sheep, oxen, and dairy barns at the fairgrounds also were knocked off their foundations by the flooding (Herrin 1999).

Experts were called in to devise a plan to try to rescue the bridge, but the necessary equipment was not available. On the morning of Friday, 5 March, the bridge was resting partially on its old abutments and partially on the ice. Attempts were still being made to save the bridge, but soon after noon the ice jam began to settle and move, carrying the bridge with it. A last-minute rescue was attempted, but much of the equipment had still not arrived and the bridge crashed into the frozen river (Farnham 1999). The bridge was insured for \$100,000; although total damages have not been calculated, it is known that this amount is not enough to replace the historic structure (Herrin 1999).
