CRREL REPORT

# Enhanced Natural Remediation of White-Phosphorus-Contaminated Wetlands through Controlled Pond Draining

Michael R. Walsh, Marianne E. Walsh,  
and Charles M. Collins

November 1999

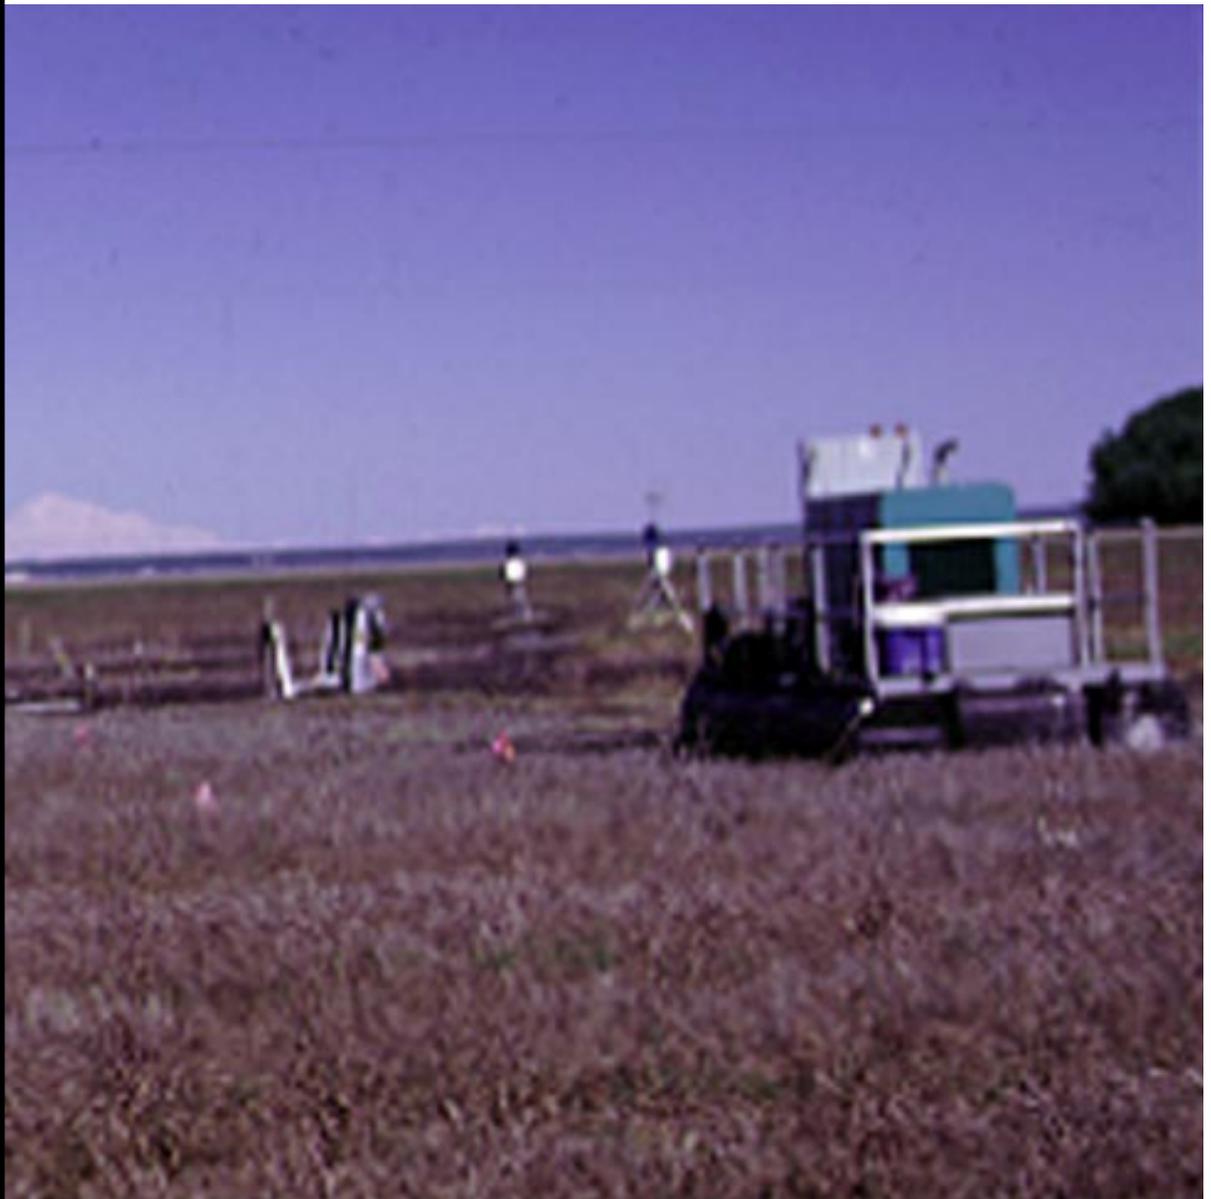
*Cover: Pump system 2, located in Pond 730, Area C/D, June 1999. In background are two data acquisition systems used to monitor remediation parameters. (Photo by M.R. Walsh, CRREL.)*

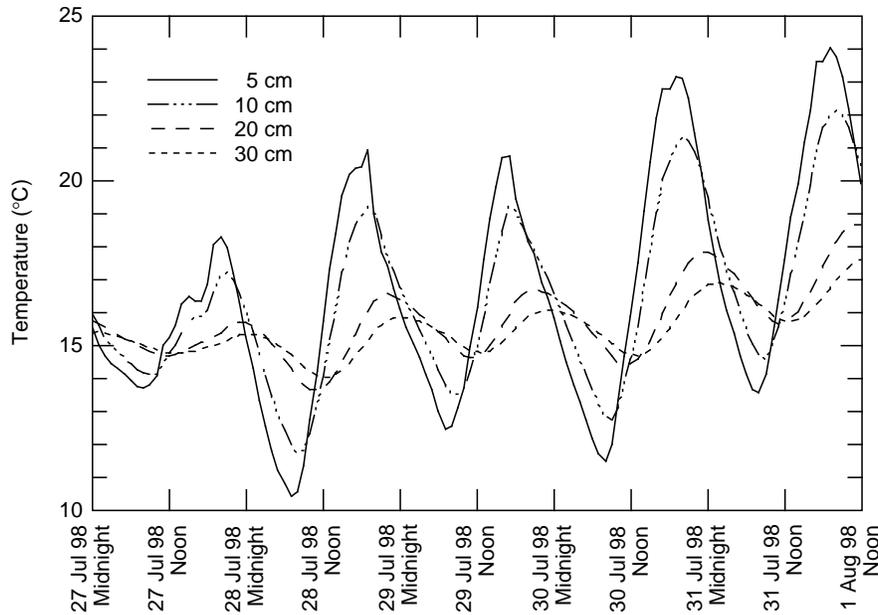
Figure 2. Diurnal temperature variations of surface sediments at ERF.

Temperature is the other major factor that determines persistence in unsaturated sediments, because vapor pressure decreases exponentially with temperature. During summers at ERF, typical surface (top 5 cm) sediment temperatures average around 15°C with a diurnal variation of approximately 10°C (Fig. 2). At these temperatures, sublimation of a 2-mm-diam. particle buried in unsaturated sediment is predicted to take about 90 days. Oxidation will presumably hasten the loss. At ERF, the sediments of contaminated permanent ponds could be decontaminated if they were allowed to desaturate. Desaturation requires that either the sediments be removed to an upland site (dredging) for treatment or water from the pond be removed to allow in-situ drying (draining). Given the enormous expense involved in removing contaminated sediment for treatment, such as is the case in dredging (Walsh and Collins 1998), an in-situ approach is preferred.

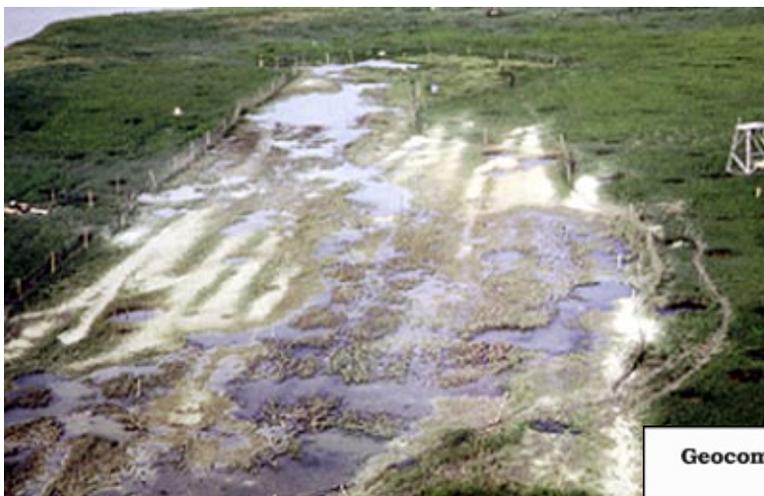
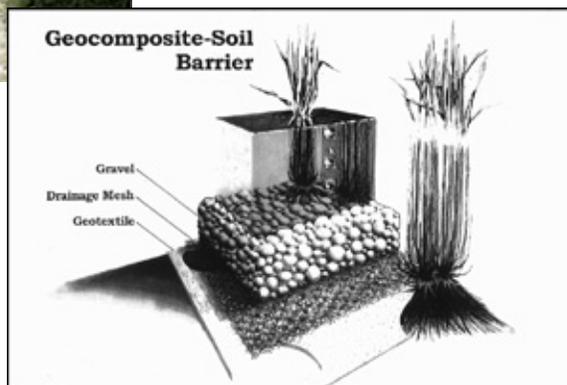
Figure 3. Physical barrier technologies tested at ERF.

a. AquaBlok® applied to Racine Island.

b. Geotextile barrier concept.

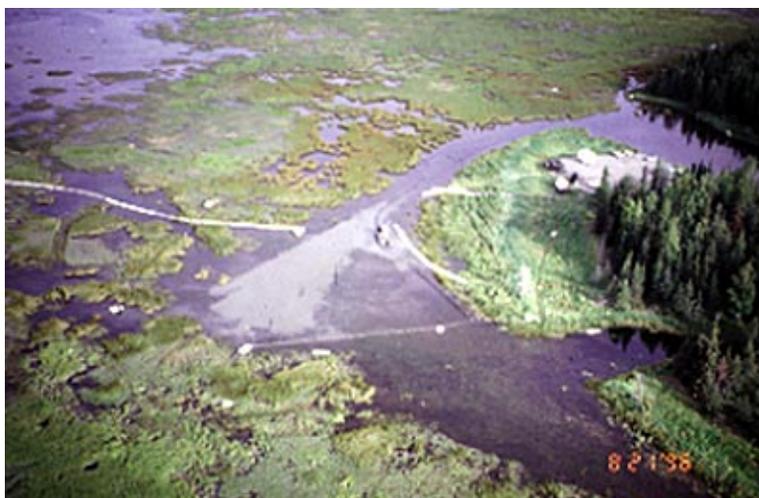
Figure 4. Remote dredge operation in Pond 146.

Use of a remote controlled dredge offered the possibility of physical removal of the white-phosphorus-contaminated sediment from the pond bottoms and the deposition of the sediment at an upland treatment site where the sediment can be allowed to dry and the white phosphorus allowed to sublime and oxidize (Fig. 4). Additionally, the deepening of the pond by dredging would place

any remaining contaminated sediments below the depth that dabbling waterfowl can reach. The presence of unexploded ordnance dictated the use of a remote-controlled dredge to reduce the danger to the dredge operator. A system was tested by CRREL in 1994 and 1995 and operated by a contractor in 1996 (Walsh, M.R., et al. 1996, Walsh and Collins 1998). The dredge and associated

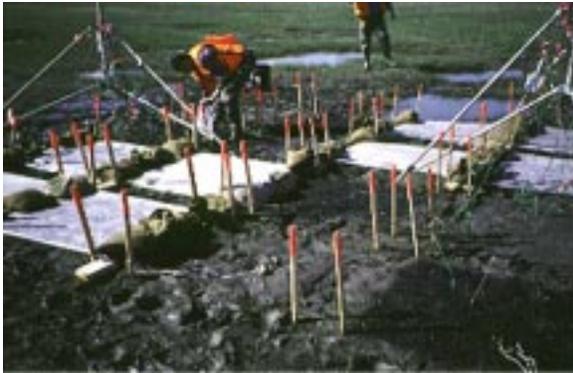
Figure 5. Field trials of surface treatments to enhance in-situ attenuation of WP.

*Enhancement of in-situ processes.* Enhanced in-situ natural attenuation of white phosphorus is considered the least-invasive remediation methodology for areas conducive to this type of treatment. Natural attenuation of white phosphorus contamination through sublimation and oxidation was identified as occurring in intermittent ponds in ERF (Walsh and Collins 1995) that would lead to the eventual decontamination of these ponds. A treatability study was undertaken to see if enhancing the natural attenuation process was possible through surface warming. Various surface modifications and cover treatments were implemented to change the albedo and warm the soil (Fig. 5). The results showed soil moisture to be the controlling factor affecting

attenuation and that large-scale surface treatments would be difficult and only partially effective unless the water could be drained out of the ponds. Although the concept of in-situ natural attenuation was ideal, another method of implementation was required.

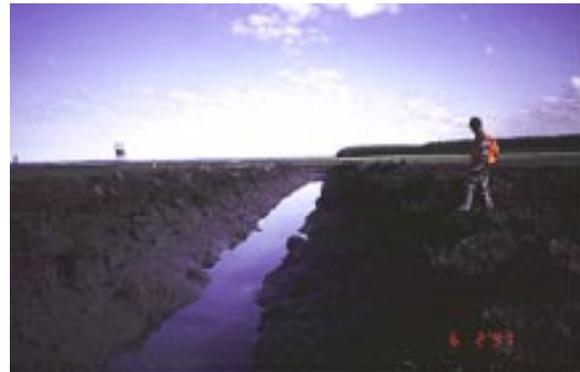
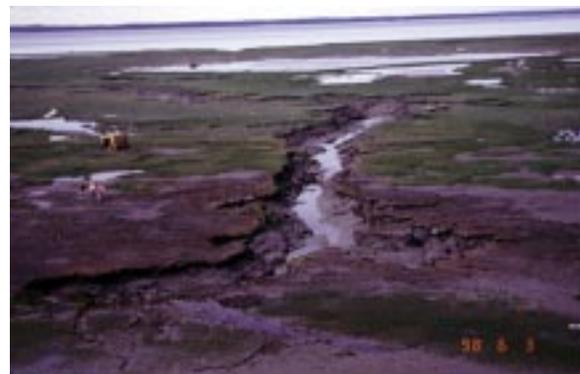
Figure 6. Explosively excavated ditches for draining of ponds.

Permanent draining of contaminated ponds through explosive excavation of drainage ditches was successfully done for Pond 109 (Bread Truck

Pond) and Pond 293 (Racine Island). These ponds were two of the most contaminated ponds in Eagle River Flats. The excavation of ditches to these ponds, in April 1996 and April 1997 respectively, resulted in the permanent draining of most of the pond areas (Fig. 6). This removed them as habitat during periods of nonflooding tides, keeping the birds from feeding in the contaminated sediments of the areas drained. Permanent draining has been less successful in the removal of the white phosphorus through in-situ oxidation. Because the drainage ditch connecting the pond to the nearby tidal gullies has lowered the threshold flooding elevation into the pond basin, the former ponds are subjected to more frequent tidal inundation. This results in more frequent wetting and slower drying of the sediments and a much slower sublimation and oxidation rate of the white phosphorus (Collins et al. 1996, 1997,

a. Racine Island (Meek's Canyon).

b. Bread Truck Pond (Pond 109).

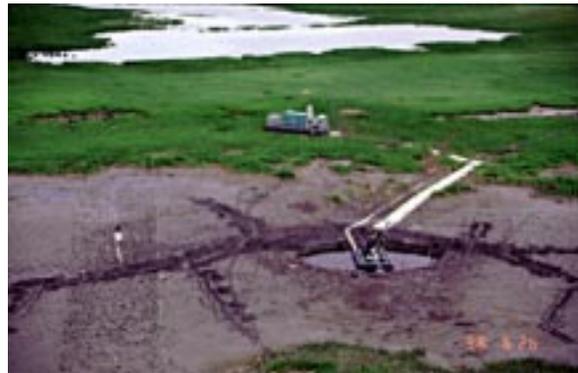
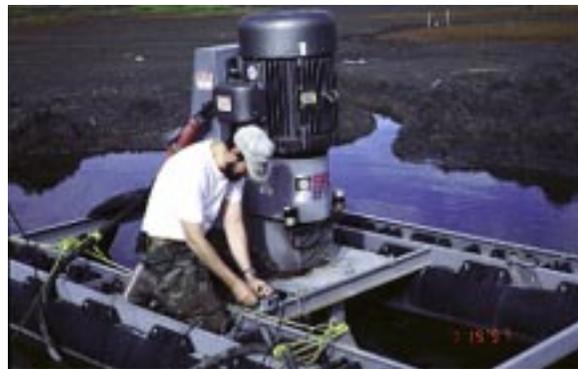
Figure 7. Autonomous pumping system for Eagle River Flats.

A 126-L/s pump system had been built to specification for Eagle River Flats in 1995. This is the system mentioned above that had originally been designed to operate in Pond 109. This pump system is composed of two major components: a pump unit consisting of a 15-cm (6-in.) open-impeller centrifugal pump on floats and an 80-kW generator set (genset) with fuel tanks, also on floats (Fig. 7). The two units are connected together by a four-conductor power cord, 70 m in length, and a control wire. The control wire interfaces between the genset control and float switches mounted on or near the pump.

The pump is separated from the genset to pre-

a. System installed in Pond 290. Note datalogger (left).

b. Close-up of floating pump in sump.

vent damage to the genset and the possible spill of fuel and lubricant in case of ingestion and detonation of unexploded ordnance by the pump. Originally, the pump was to be placed in the deepest section of the pond to be treated. The pump would then scour a small sump while drawing down the pond. Prior to deployment, however, we decided to blast a sump and place the pump within the preformed sump. The sump serves as a deep reservoir for the pump, reducing cycling of the system and thus conserving fuel.

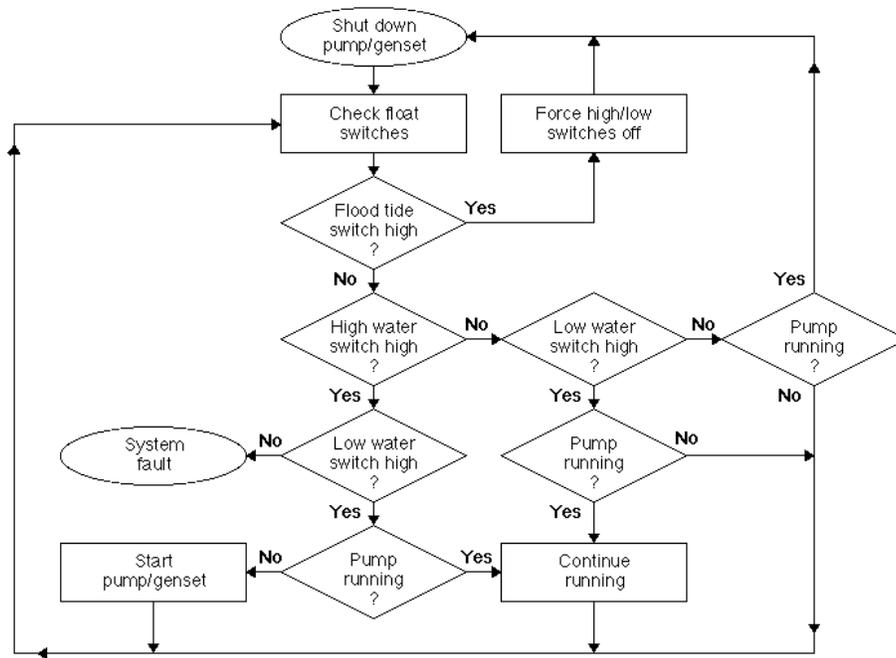
Figure 8. Switch logic diagram for pump operation.

was mounted above it; this would switch on the genset and then the pump when the water level rose in the sump, floating the pump. In operation, the reed-type switches were subject to being clogged by the fine-grained silt in the muddy water. Problems with these switches precluded operating the pump overnight during the first phase of testing. Replacement of the reed switches and modification of the control circuitry improved the system reliability to the point that it was operational by 21 May. The area continued to slowly dewater, and by 22 May, Pond 183 was essentially drained. Only isolated pockets of water remained in depressed areas not draining into the sump. These areas eventually dried through evaporation.

The reed switches were replaced with fully enclosed float switches, a more robust arrangement. Consideration of flooding tides led to the incorporation of a third float switch to shut the system down during flooding events. Circuitry needed to be added and the existing control circuitry needed modification. In July, the third switch was added for the detection of flood tides. The flood tide switch was mounted away from the pump near the rim of the sump to better detect the rising tides. The modifications were tested and operational prior to the flooding tide. On 21 July, a 9.7-m tide inundated Pond 183, triggering the flood tide switch and shutting down the system. The flood tide switch was set to trigger off when the natural drainage after the tide was nearly complete. This maximizes fuel conservation by taking advantage of the natural drainage of the area. Pumping resumed on 25 July. Drawdown of Pond 183 occurred over the next three days. The configuration worked so well during testing that the highwater switch was also mounted off-pump near the sump rim. This further reduces cycling by delaying the resumption of pumping until the sump completely fills. A diagram of the final switch logic is shown in Figure 8.

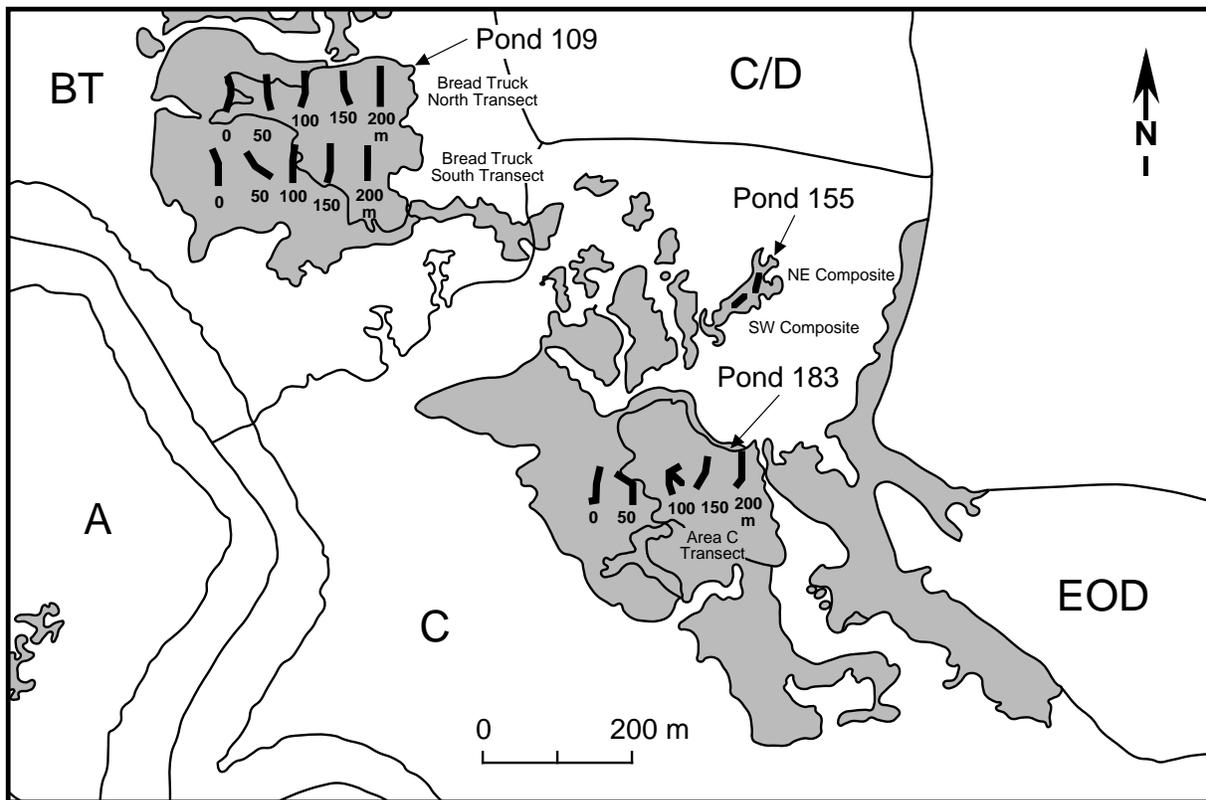
Figure 9. Map of composite sampling transects in Pond 109 (BT) and 183 (Area C).

To determine if the contaminant is present in a given area, composite sampling is conducted. We established transects bisecting ponds to monitor sublimation/oxidation conditions and for baseline and verification sediment sampling (Walsh et al. 1998). Transects were up to 200 m long, and at evenly spaced intervals, composite samples were collected to determine if hot spots (localized areas containing white phosphorus particles) were present (Fig. 9). Each composite sample was made up of sediment cores obtained at the nodes of a 1.82-m square grid covering a 5.46-m-wide area extending up to 20 m perpendicular to the bisecting transect. The grid spacing is based on

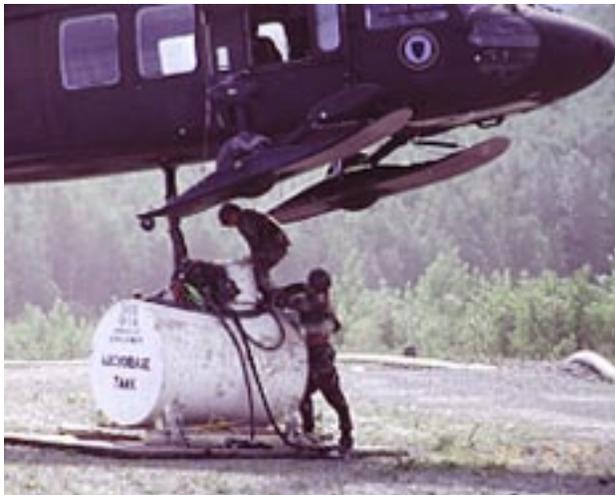
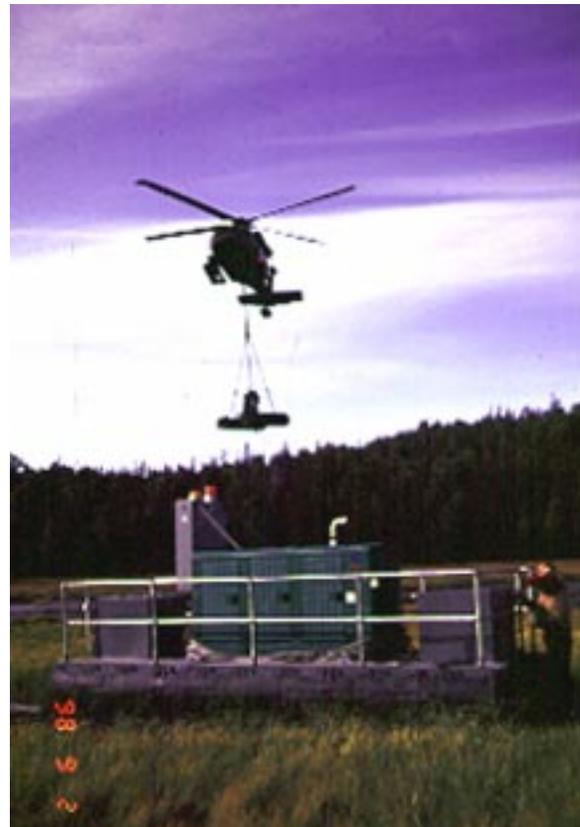
Figure 10. Airlifting pump equipment.

a. Riggers hooking up fuel transfer tank.

b. Airlifting pump.

Overall performance of the pumping system in Pond 183 during the 1997 field season was much better than originally predicted. Post-flooding drawdown time after some natural drainage is approximately three days. If two days are allowed for natural drainage and another day is allowed for residual drainage, total time required for drainage is less than a week following the last flooding event in a series. Flow between Pond 146 and Pond 183 via the dredge channel was minimal after drawdown, and during part of the summer, there was no flow at all between the two pond systems. It was hoped that with the tide gate deployed, some flooding events could be avoided altogether, thus eliminating subsequent flooding and pumping of the area being treated. Proof of this hypothesis would have to wait until the following season,

as the tides in September did not allow sufficient testing of the concept. The discharge rate for the system was 13% below the theoretical rate, due primarily to the length of the discharge line. Results from the installation of the tide gate indicated that marginal flooding tides may be prevented from infiltrating into the treatment areas, but further study was required.

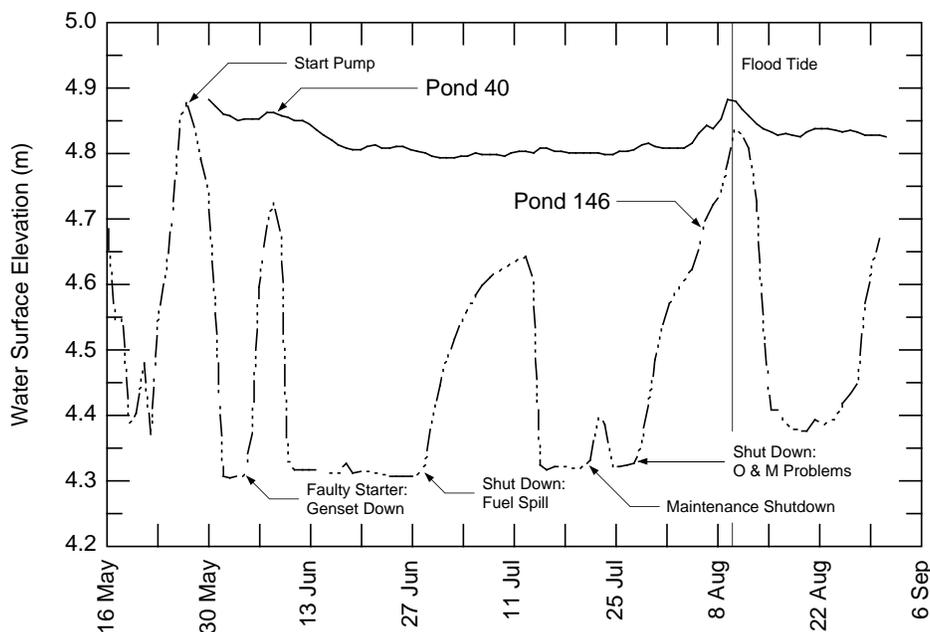
Figure 11. Water level relationships between Area C and Area C/D.

water flowed from the direction of C/D to Pond 146 along the border of ERF, the water does not seem to originate from C/D, but rather as inflow from the uplands adjacent to ERF between C and C/D. The hydrologic separation of these two areas was previously surmised, but has now been demonstrated. Isolation of these areas results in faster drawdown times and more effective drying.

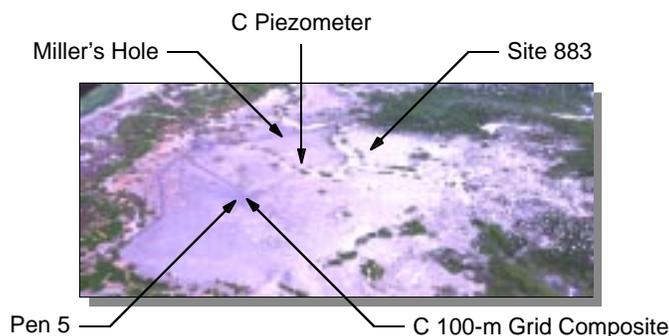
Figure 12. Data station locations, Pond 183, Area C.

Sediment temperature and moisture conditions were monitored within Area C at three sites in 1997 and at two sites in 1998 (Fig. 12). The most important condition for attenuation of white phosphorus particles in ERF is the desaturation of the sediments, which takes place naturally in intermittently wetted areas of ERF in summer during long periods between flooding tides. Pumping of permanent ponds was tested to see if sediments

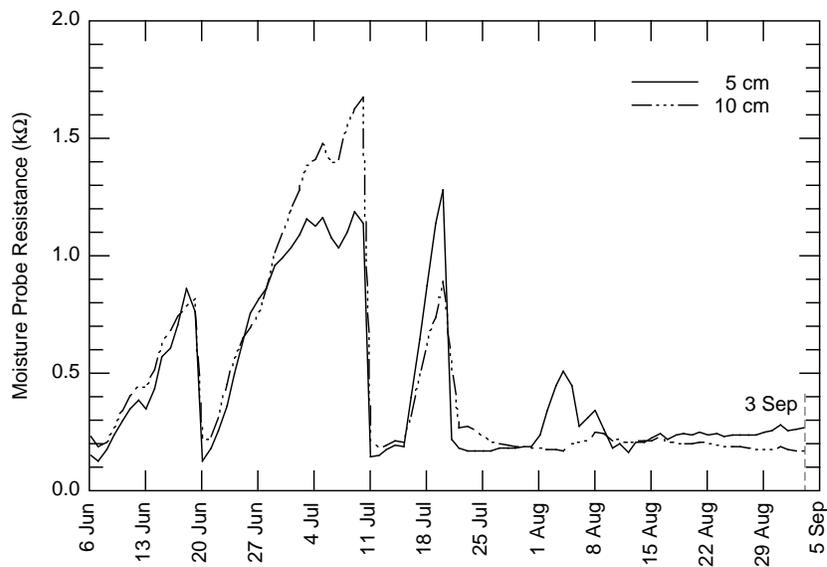
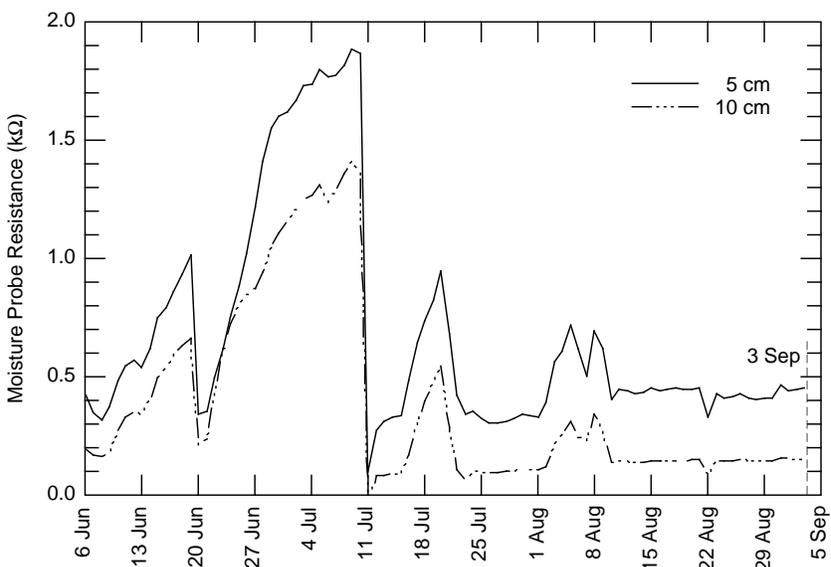
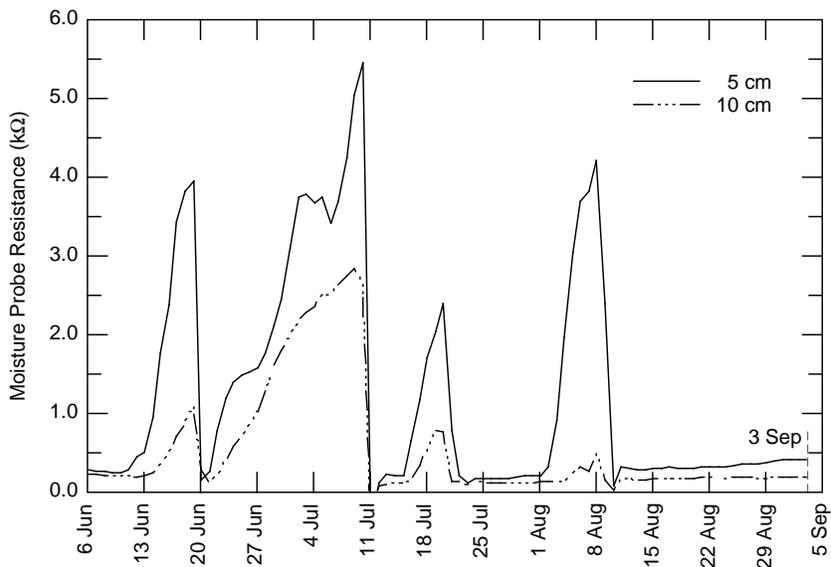
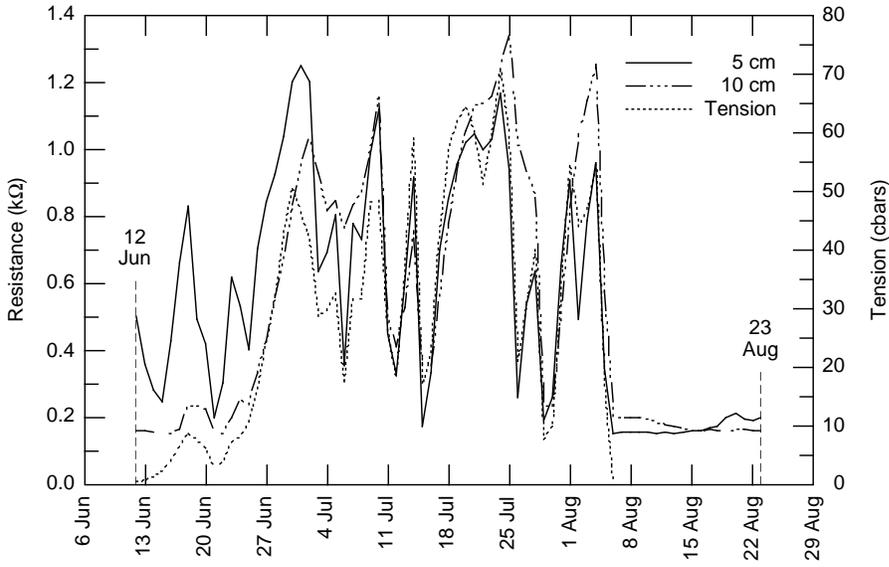
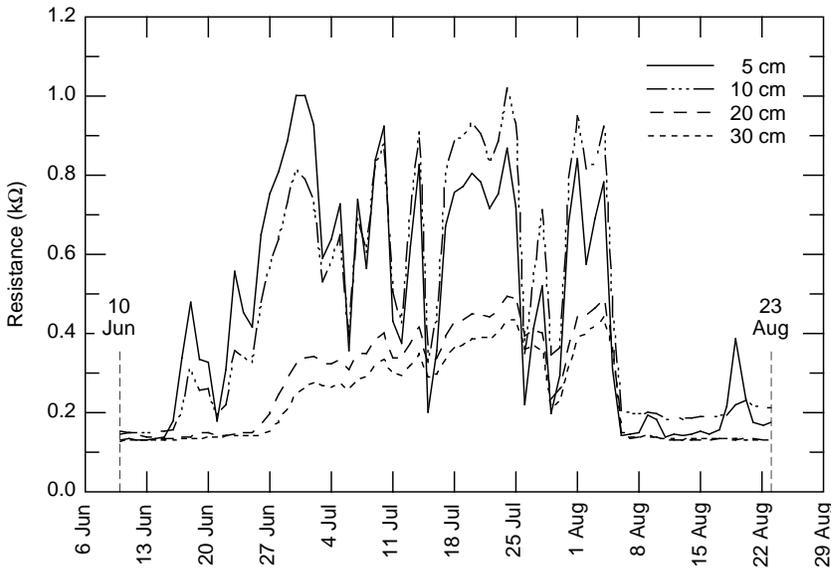
Figure 13. Area C moisture probe sensor output (1997–98). Note: Increasing resistance denotes drying of sediment.

would desaturate, and based on the output of moisture sensors in Area C, was quite successful at achieving this goal (Fig. 13). Even the station (C 200 m) that is located adjacent to the bulrush marsh dried.

a. 1997 – Transect location 0 m.

b. 1997 – Transect location 100 m.

c. 1997 – Transect location 200 m.

d. 1998 – Transect location 100 m.

e. 1998 – Area C piezometer site.

Figure 13 (cont'd). Area C moisture probe sensor output (1997–98). Note: Increasing resistance denotes drying of sediment.

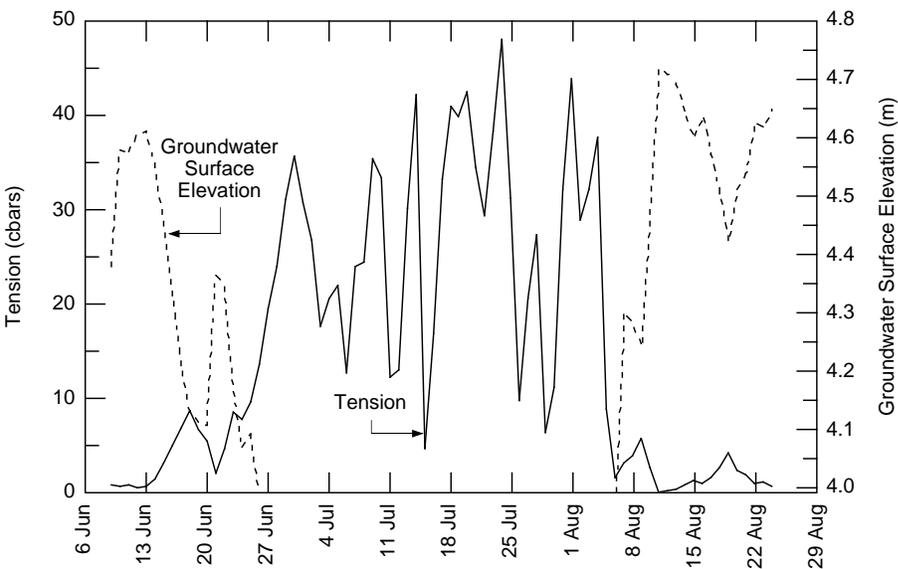
Figure 14. Groundwater elevation and surface moisture content in Area C (1998). Note: Surface elevation is 4.77 m.

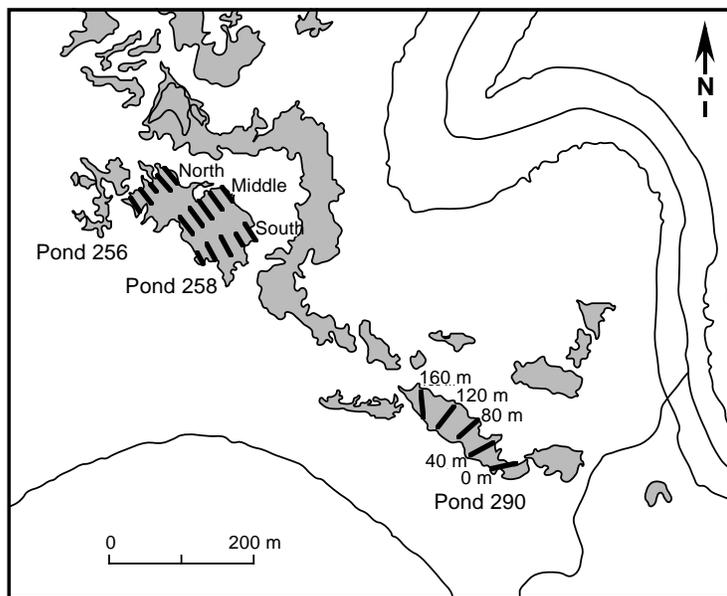
Figure 15. Composite sampling transects in Area A.

15). Confirming previous discrete sampling, we did not find white phosphorus in this pond.

Pond 258 is located on the west side of ERF in Area A. It is a large pond (1.72 ha [4.25 acres]) where over 50 discrete samples were collected between 1991 and 1994. Sampling was prompted by the large number of waterfowl carcasses that have been found in this pond (e.g., 70 carcasses in August 1992). Only four of these discrete samples were positive; the highest concentration found was 0.04  $\mu\text{g/g}$ . Several positive samples were collected just north of Pond 258, but again concentrations and frequency of detection were much lower than in Ponds 183, 109, and Racine Island. In August 1998, we established three west to east transects labeled 258 south, 258 middle, and 258 north. The lengths of these transects were 90, 80, and 75 m. Composite samples were collected from the nodes of grids extending south and north of the east-west transects. We also collected several composite samples by combining subsamples taken at 2-m intervals along lines. Five composites were formed from sediment collected along a drainage ditch along the southwest side of the pond. One composite was formed from samples taken in a circle around the only target in this pond. Two composites were formed from samples taken along lines running through datalogger stations in Ponds 258 and 256 (labeled A1 and A2). Additional samples were taken between line A1 and the sump hole in Pond 258 and around the rim of the sump hole after a sandpiper died while feeding

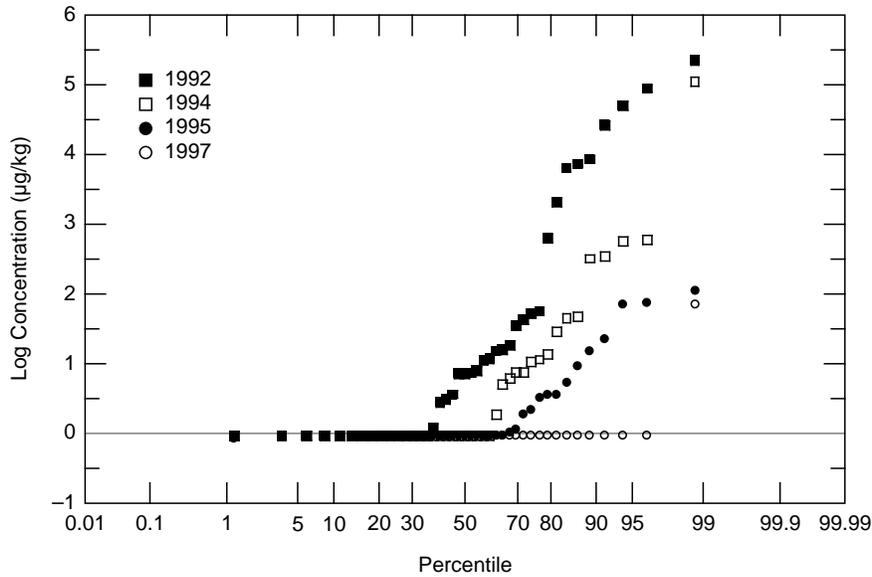
The first location was initially sampled in 1992 and given the designation "Site 883," southwest of the edge of Pond 183. The white phosphorus concentration found here was one of the highest concentrations found in ERF, over 200  $\mu\text{g/g}$ . When 270 mL of sediment from this site was sieved, over 100 white phosphorus particles were isolated. Located within the intermittent pond on the west side of Pond 183, this location was ideal for monitoring the persistence of white phospho-

Figure 16. Percentile plot of WP contamination of an intermittent pond site (Site 883).

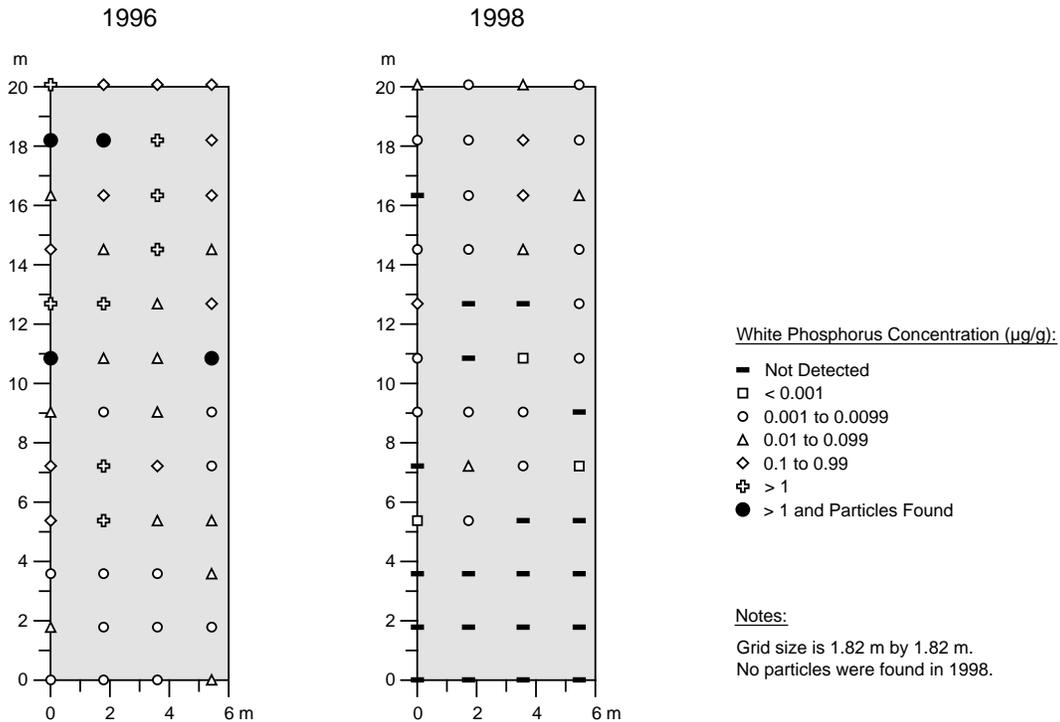
Figure 17. Plot of WP concentrations in DWRC pen 5, Pond 183, Area C.

The location of the DWRC pen 5 is within the permanent pond of Area C and the sediments have been covered by water since the cessation of firing of WP munitions. We intensively sampled this location in 1996 by taking discrete samples at the nodes of a 1.82-m square grid four columns wide

and 12 rows long (Fig. 17). In 1996, all 48 samples contained detectable white phosphorus concentrations ranging from 0.0024 to 421  $\mu\text{g/g}$  (Table 6). Over 300 white phosphorus particles were found, one of which weighed 150 mg (Walsh et al. 1997). In the fall of 1998, white phosphorus was undetectable in 20 of the 48 samples. The concentration range in the positive samples was 0.00062 to 0.84  $\mu\text{g/g}$ . In all cases where white phosphorus

was found, the concentrations were lower in 1998 than in 1996, and no white phosphorus particles were found.
