**ERDC/CRREL TR-00-4**

# **Evaluation of Photovoltaic Panels at the South Pole Station**

Christopher R. Williams and John Rand

April 2000

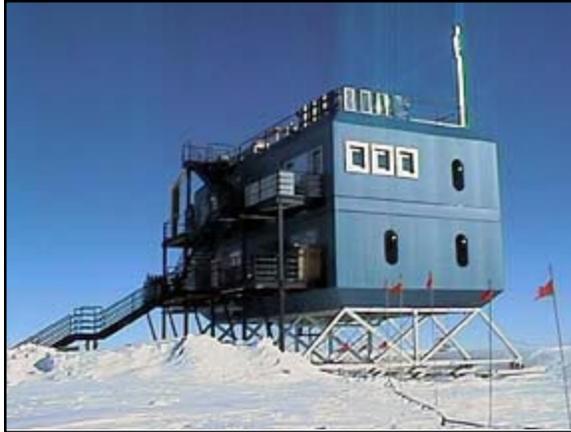
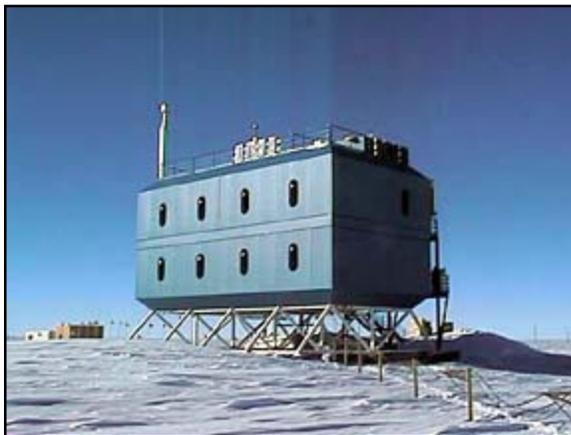
Figure 1. Atmospheric Research Laboratory (25 November 1997).

a. Southeast corner.

b. Northwest corner.

The evaluation platform was the four sides of the new ARO building (Fig. 1) at the South Pole Station, Antarctica. The PV panels from the four manufacturers are approximately the same physical size and shape, which facilitated easy comparison. In addition, the method of attachment to the exterior surface of the ARO building allowed for easy installation, removal, and structural evaluation.

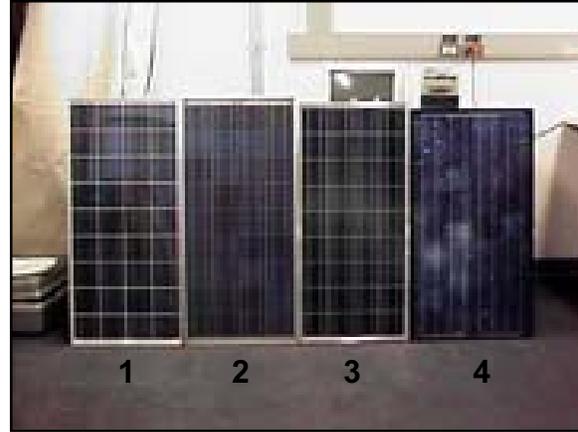
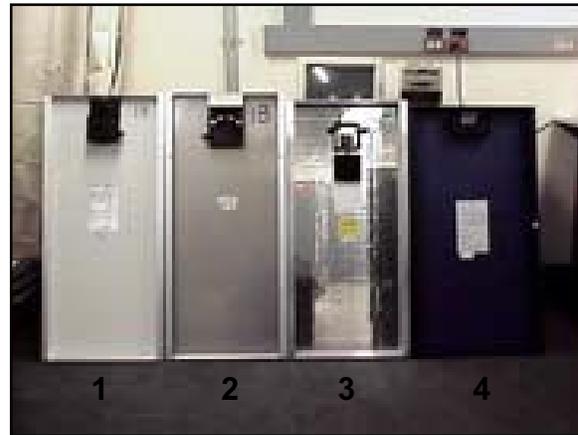
Figure 2. PV panels that were evaluated (1—KYOCERA; 2—PhotoComm; 3—ASE Americas; 4—Solarex).

a. Front view.

b. Rear view.

The PV panels (Fig. 2) selected for the test were purchased from four manufacturers—KYOCERA, PhotoComm, Inc., ASE Americas, and Solarex. The following PV panel mechanical and electrical specifications came directly from the manufacturers' data sheets (Table 1).

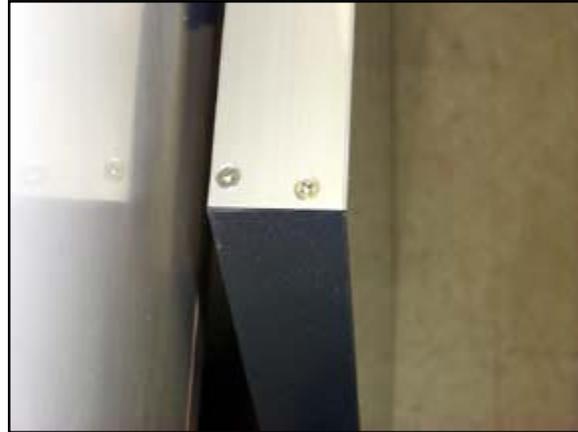
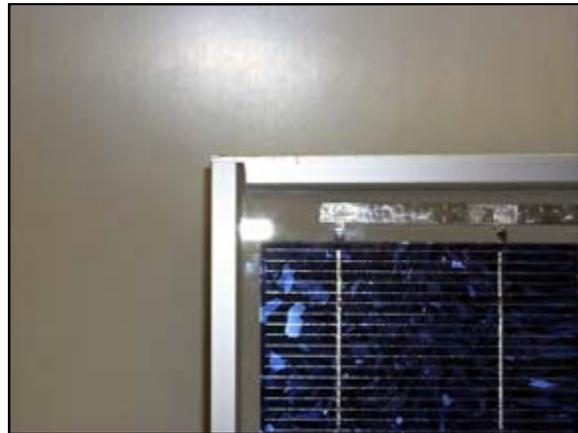
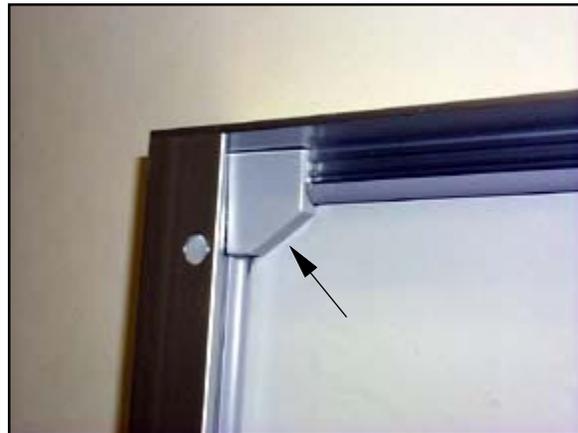
Figure 3. Details of KYOCERA panel.

a. Top view of corner connections (flat head sheet metal screws).

b. Front view of corner connections.

c. Back view of corner connections (arrow points to plastic environmental seal cap; extruded channel is closed).

Each of the four manufacturer’s PV modules is surrounded by a frame. The frame consists of four pieces of extruded aluminum fastened at the top and bottom corners by sheet metal screws. Figures 3–6 depict the various styles of corner connections surrounding the PV modules.

No obvious defects were found in the KYOCERA PV panel. The aluminum frame surrounding the PV module and glazing exhibited great strength. When a twisting motion was applied to this PV panel, the aluminum frame barely flexed. The glazing, panel back, and junction box were all free of defects.

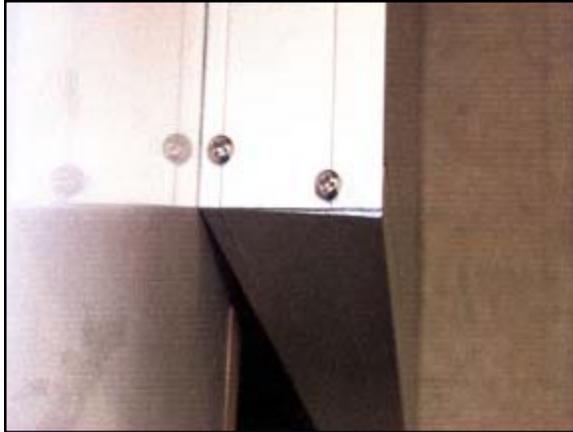
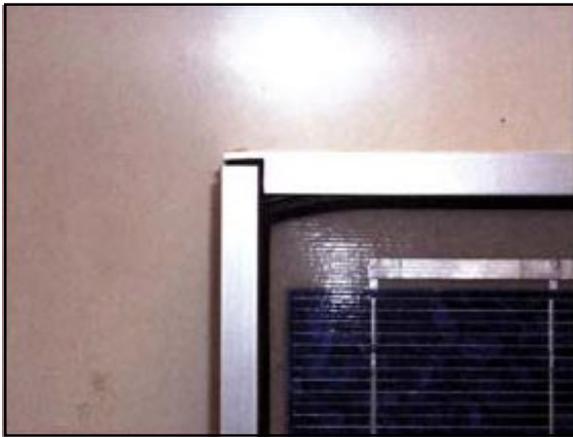
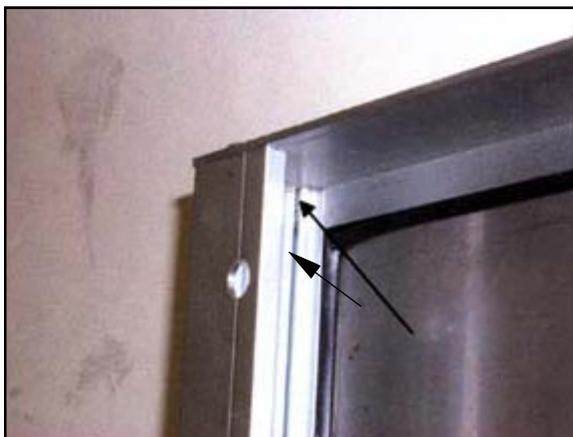
Figure 4. Details of PhotoComm, Inc., panel.

a. Top view of corner connections (pan head sheet metal screws).

b. Front view of corner connections.

c. Back view of corner connections (arrow points to sheet metal screw in open extruded channel).

On all four of the PhotoComm, Inc., panels that we inspected, the gasketed seal between the glazing and aluminum frame showed signs of failure. The gasketed seal was pulling out of the corners between the glazing surface and aluminum frame. Each panel showed some signs of aluminum frame weakness. The corner connections of the frame were loose and allowed considerable movement when a twisting motion was applied. Three of the frames showed signs of abuse; they had dents and or were bent. The glazing, panel back, and junction box were all free of defects.

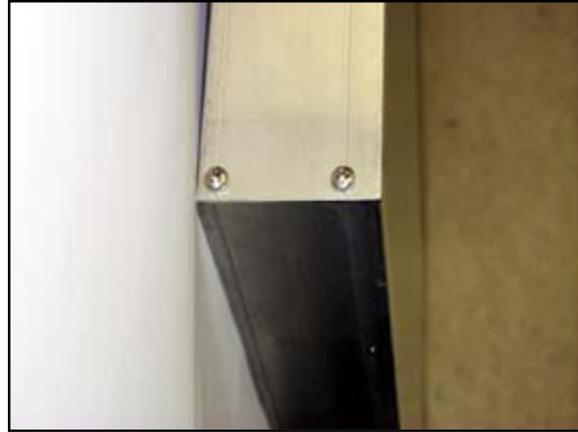
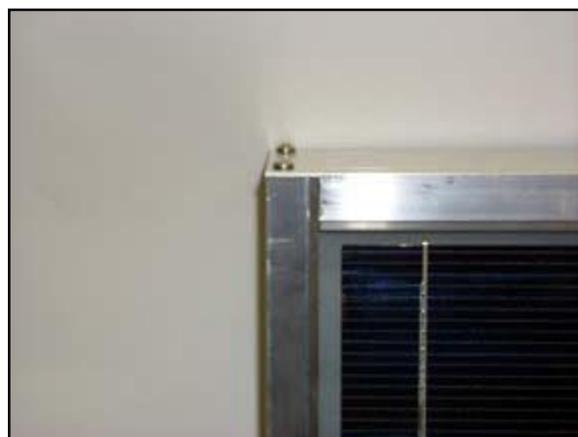
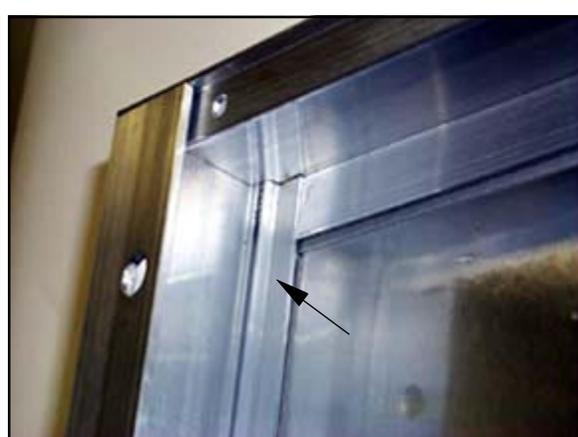
Figure 5. Details of ASE Americas panel.

a. Top view of corner connections (pan head sheet metal screws).

b. Front view of corner connections.

c. Rear view of corner connection (arrow points to sheet metal screw in open extruded channel).

The ASE Americas' panels are well built. No defects were detected from a visual inspection. The aluminum

frame surrounding the PV module and glazing was very tight and had only slight movement when a twisting motion was applied. The glazing, panel back, and junction box were all free of defects.

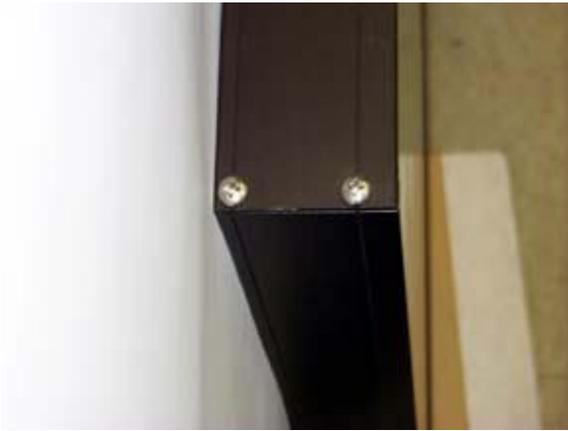
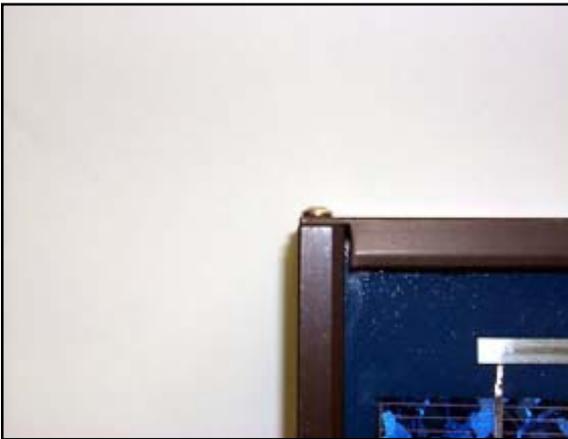
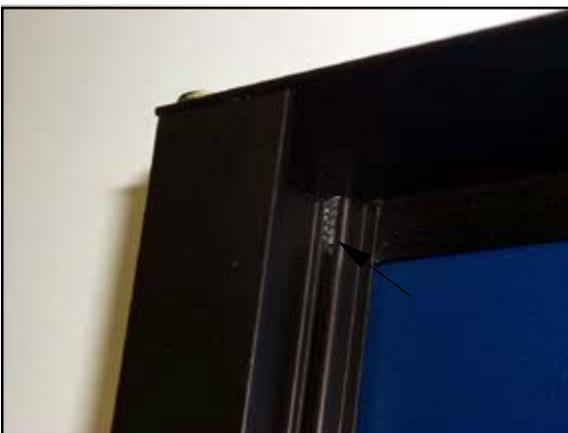
Figure 6. Details of Solarex panel.

a. Top view of corner connection (pan head sheet metal screws).

b. Front view of corner connection

c. Back view of corner connection (arrow points to sheet metal screw in open extruded channel).

The Solarex panels also showed no signs of any structural defects. The aluminum frame experienced very little flex when a twisting motion was applied. The aluminum frame was tight to the PV module and glazing surface. The glazing, panel back, and junction box were all free of defects.

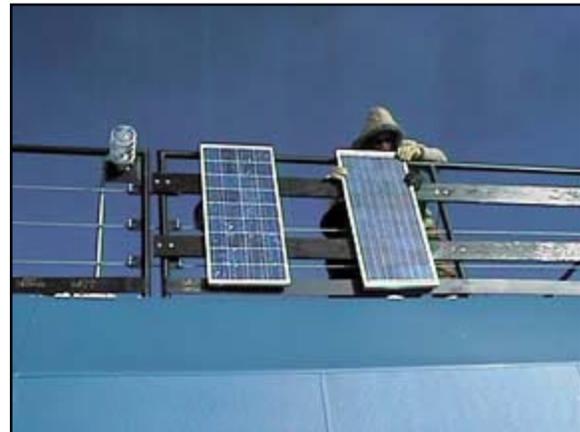
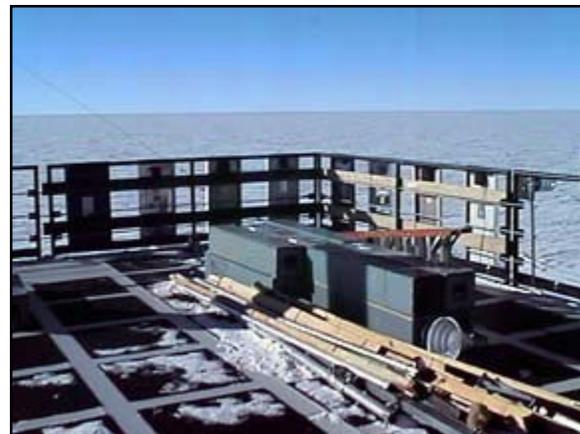
Figure 7. Mounting PV panels on ARO roof top handrails.

a. Work in progress.

b. Mounted panels.

Each PV panel was mounted vertically on the ARO roof top handrails (Fig. 7). Predrilled plywood strips were added to the handrails to make it easier to install and remove them. The panels were bolted to the plywood strips using holes in the aluminum frame provided by the manufacture. Each side of the ARO building received one PV panel from each manufacturer. Table 2 gives PV panel numbering and placement on the ARO roof handrails.

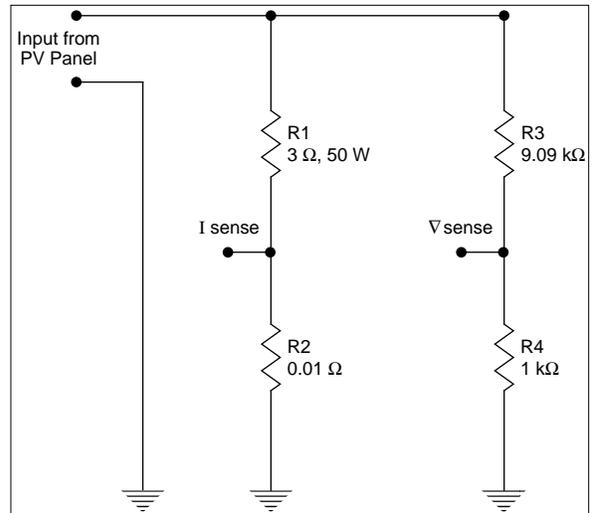
**Figure 8. Half bridge network.**

The signal conditioning circuitry is an interface between the PV panel and the input channels of the datalogger. This circuitry consists of two half bridge networks (Fig. 8) for each PV panel. The half bridge networks are used to scale the PV panels' output voltage to an acceptable range for the datalogger input channels. One half bridge is used to determine the PV panels' output power by measuring current through a 3-Ω load via a sense resistor, while the second is used to determine the PV panels' output voltage potential.

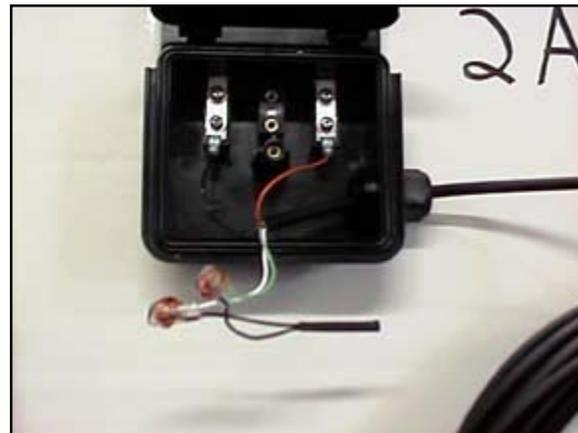
**Figure 9. PV panel junction box (note panel output terminals, splices, and thermistor).**

Connected from the data acquisition system to each PV panel is a 20-awg four-conductor wire. Two of the conductors (red, black) are attached to the PV panels' output terminals, which are located in the junction box on the back of the panel (Fig. 9). The remaining two conductors (green, white), terminating in the same junction box, are attached to a thermistor (107B temperature sensor) that senses the PV panels' temperature.

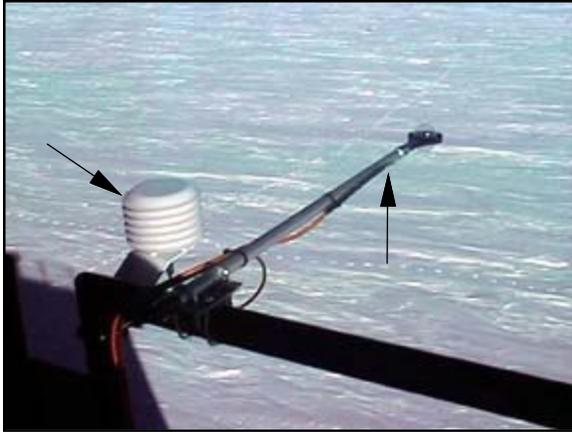
**Figure 10.** Temperature sensor with radiation shield (left arrow) and Q-7 net radiometer in horizontal position (right arrow).

A net radiometer (Fig. 10), manufactured by Radiation and Energy Balance Systems Inc., model Q-7, was used to sense the net radiation values present at the ARO building. The Q-7 is a high-output thermopile sensor. The thermopile sensor measures the algebraic sum of incoming and outgoing all-wave radiation (i.e., short- and long-wave components). Incoming radiation is made up of three components—direct beam and diffuse solar radiation plus long-wave irradiance from the sky. Reflected solar radiation plus the terrestrial long-wave radiation make up the outgoing all-wave radiation. Net radiation has the units of  $W m^{-2}$ .

The ambient air temperature sensor (Fig. 10) uses the same thermistor (107B temperature probe) as does the PV panel temperature sensor. Like the PV panel heating sensor, the ambient air temperature sensor was polled by the CR10X's P4 instruction. Unlike the PV panel temperature sensor, a solar radiation shield has been added to ensure that the true ambient temperature was measured.

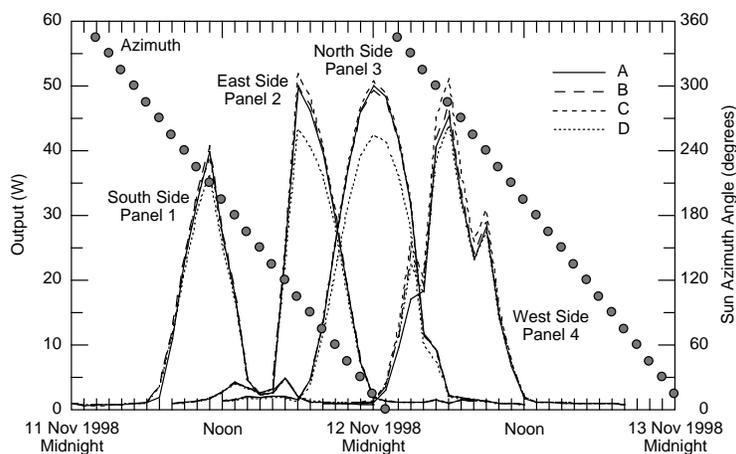
**Figure 11. PV panel performance on the high-visibility day (11 to 12 January 1998) over 24 hours.**

A 24-hour period on a high-visibility day (11–12 January 1998) was selected to compare the PV panels’ performance (Table 4). Figure 11 begins with the south side of ARO receiving the unobstructed sunlight. As the 24-hour period progressed, peak PV panel performance changed as each side of ARO received direct sunlight (Table 5). The available PV power output levels listed in Table 4 were chosen when the sun azimuth angle was approximately perpendicular to the sides of ARO. For three out of the four peak periods, PV panel C produced the highest available output power. PV panel D consistently produced the lowest available PV output power, while panels A and B flip-flopped between second and third, with the exception of the south side of ARO, when PV panel B was first and A was second.

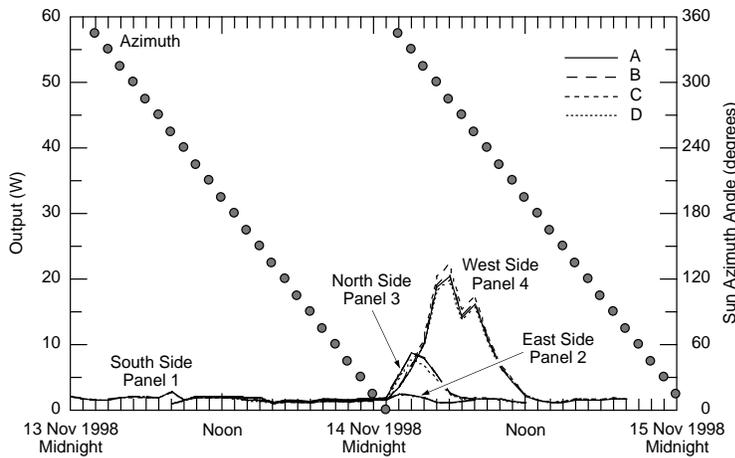
**Figure 12. PV panel performance on the low-visibility day (13 to 14 January 1998) over 24 hours.**

A 24-hour period on a low-visibility day (13–14 January 1998) was also selected to compare the PV panels’ performance (Table 6). During this 24-hour period, the visibility at the south pole was recorded as being 0.25 miles or less. Figure 12 begins with the south side of the ARO receiving the obstructed sunlight. The available output power of all the PV panels remained low during this period. Because of the low visibility, it was difficult to identify any particular PV panel as outperforming the next. At the end of the 24-hour period, when the visi-

bility increased and sun faced the north side of ARO, there was greater available output power from the PV panels. PV panel C produced the highest available output power, while PV panel D produced the lowest. PV panels B and A came in second and third.

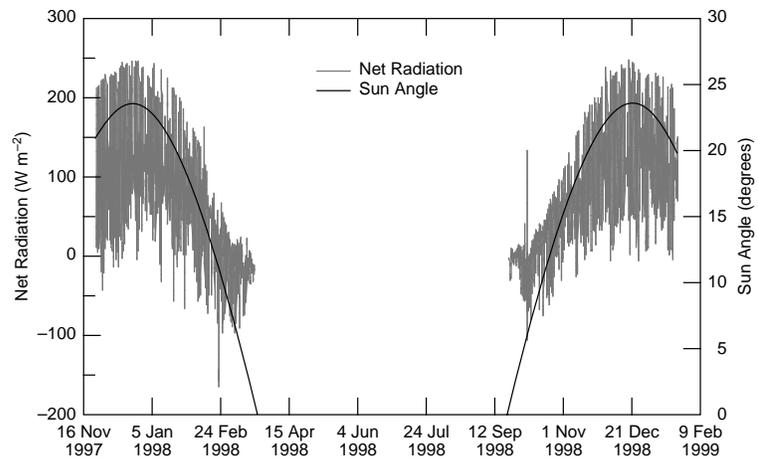
**Figure 13. Net radiometer readings from 25 November 1997 to 23 January 1999.**

To get an understanding of the amount of potential power available for the PV panels, the net radiation values were measured. The intensity of the available potential power depends on the sun declination angle and visibility. At the highest sun declination angle, net radiation values reached a potential of  $250 \text{ W m}^{-2}$  in the horizontal position. Figure 13 shows the net radiation values during the austral summers.

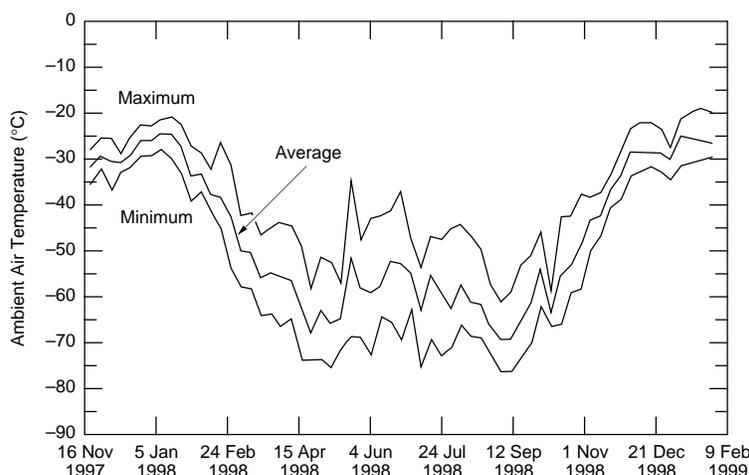
Figure 14. Temperatures experienced by ARO from 16 November 1998 to 9 February 1999.

The source of the SITREP98 data was the South Pole weekly climatological summary, which provides uninterrupted temperature and wind speed data from 22 November 1997 to 12 December 1998. Figure 14 depicts the extreme temperatures to which the PV panels were exposed. Temperatures ranged from approximately  $-20$  to  $-70^\circ\text{C}$ .

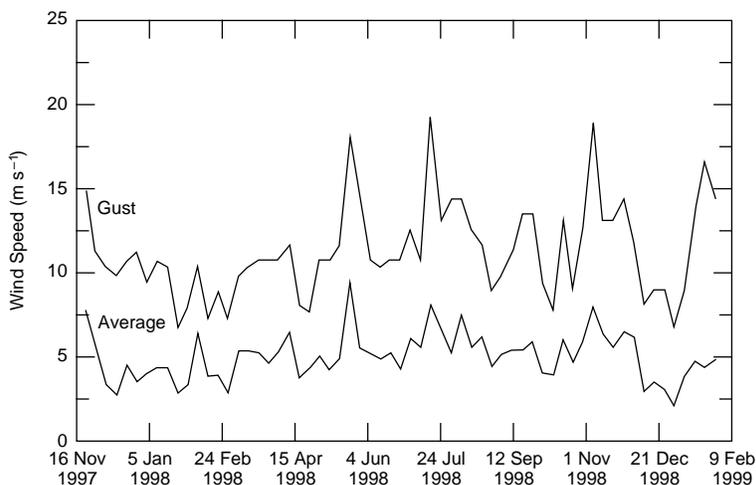
Figure 15. Wind speeds experienced by ARO from 16 November 1998 to 9 February 1999.

Figure 15 shows the average wind speed and gusts that the PV panels had to endure. The PV panels were exposed to a constant wind speed of approximately 5 m/s, with gusts up to 20 m/s.

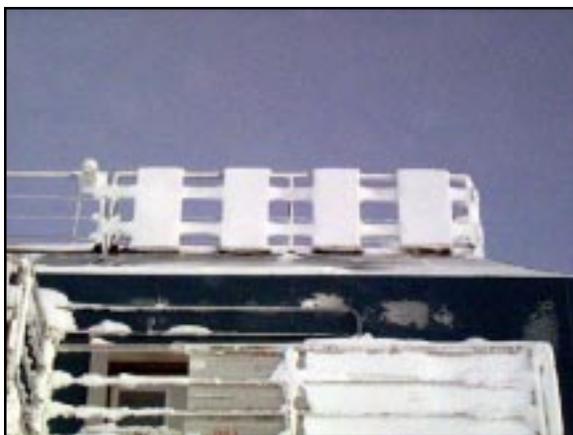
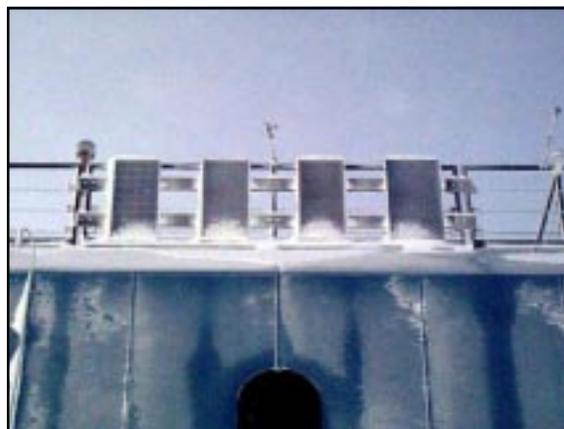
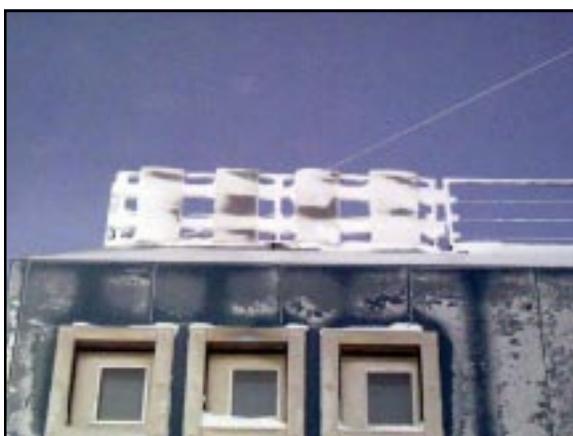
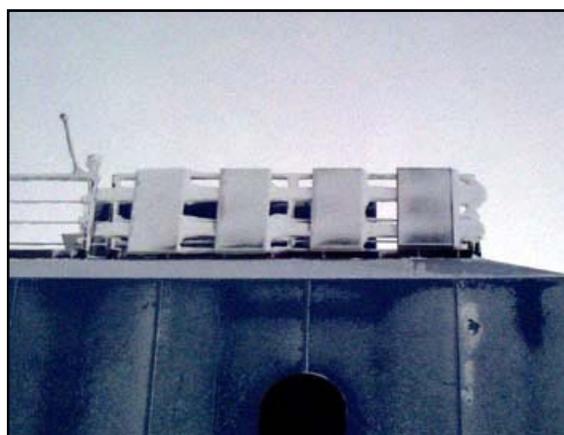
Figure 16. Conditions at ARO on 22 September 1998.

a. South side.

c. North Side.

b. East side.

d. West side.

On 21 September 1998, John swept away the accumulated snow from the PV panels with a broom. Remaining on each was a light frosting of ice. On 1 October 1998, John reported that the ice layer had been removed by the sun and drying wind.

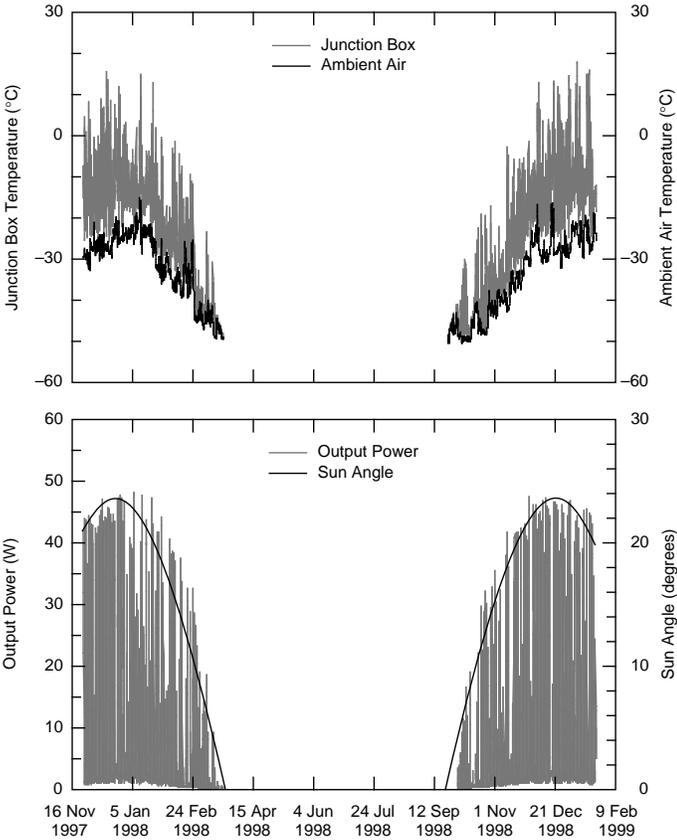
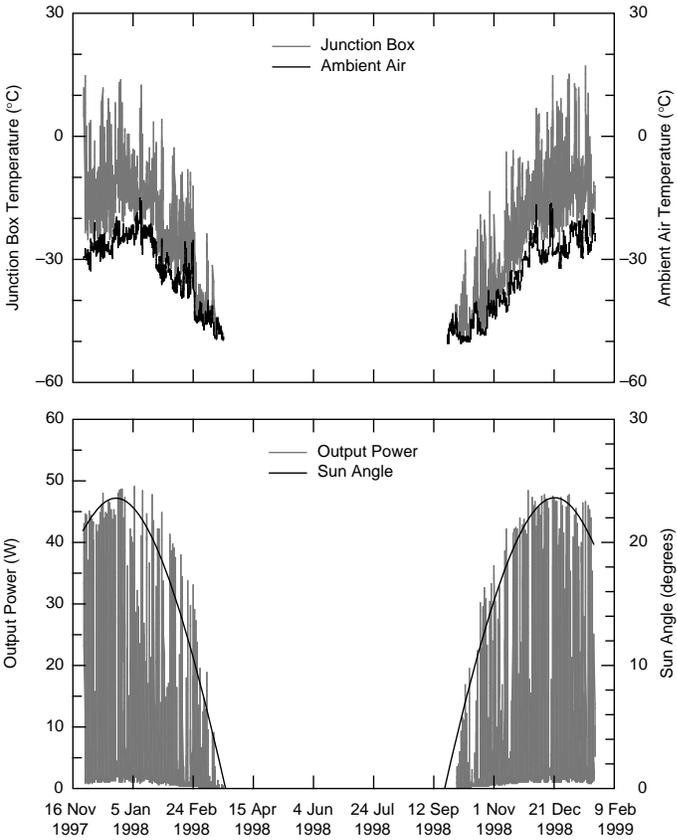
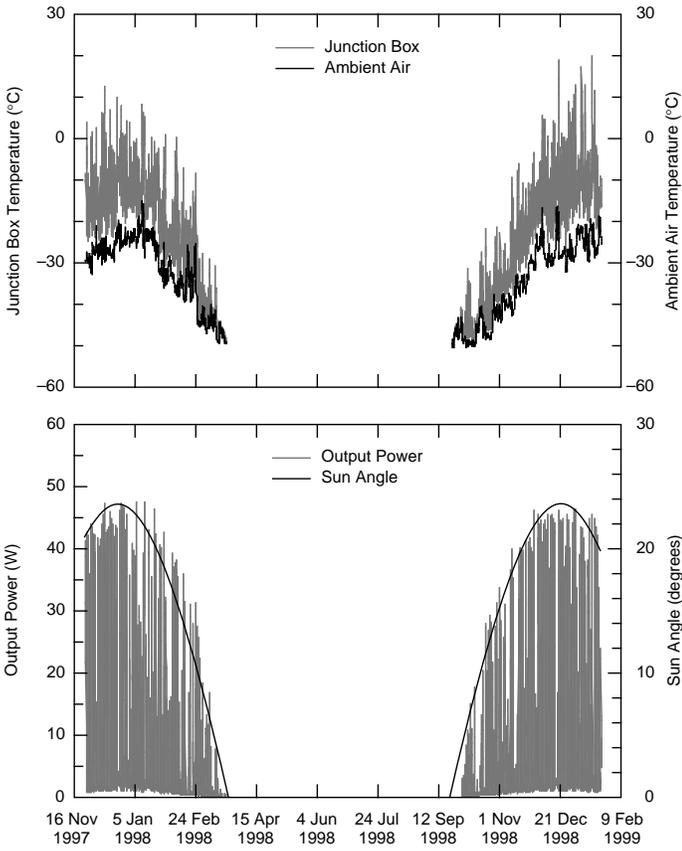
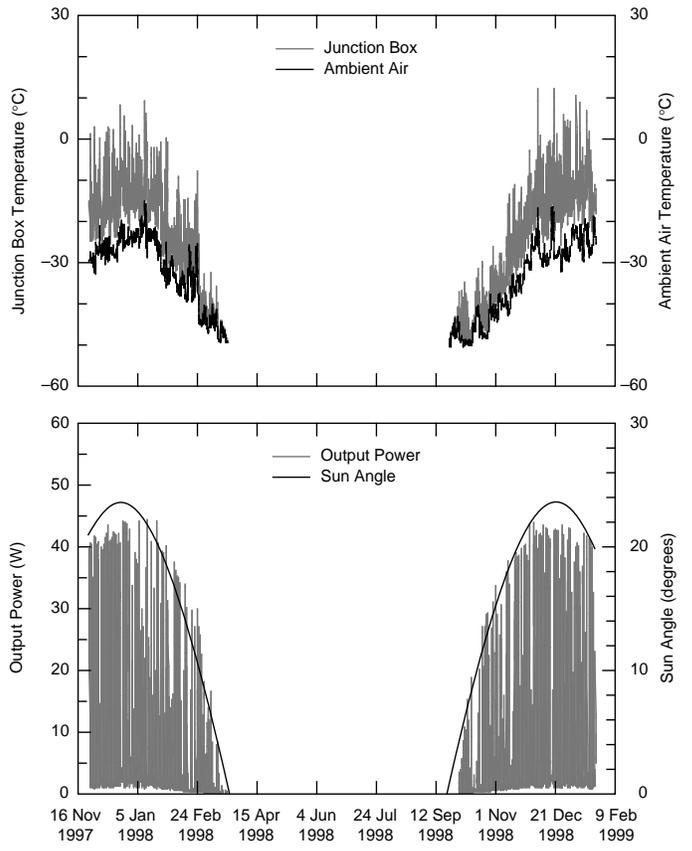
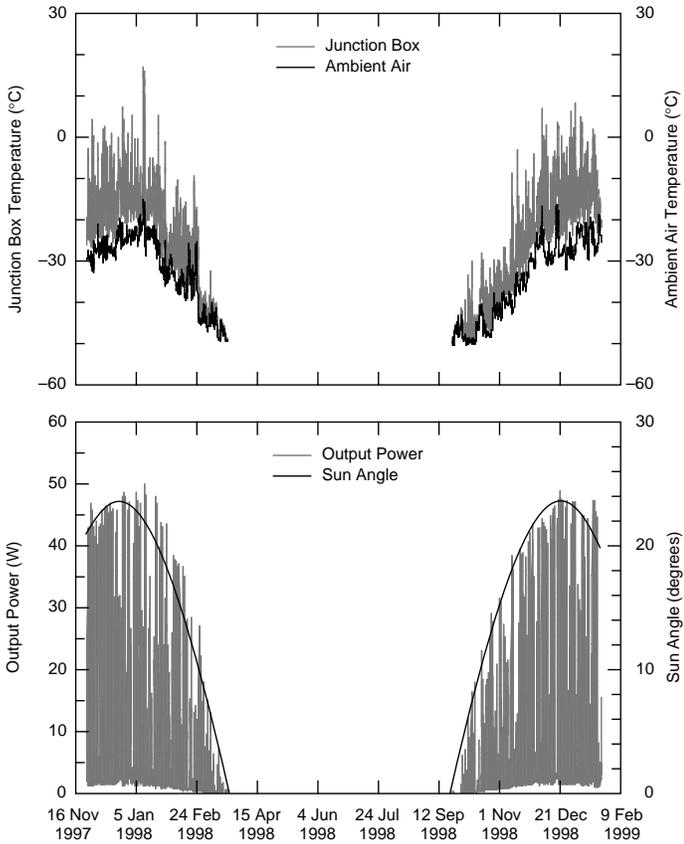
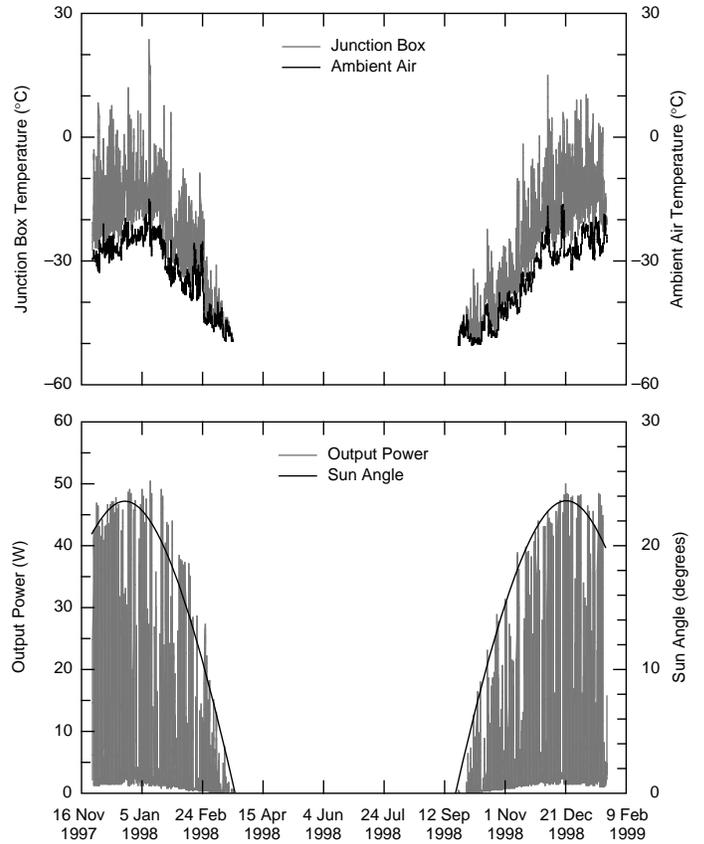
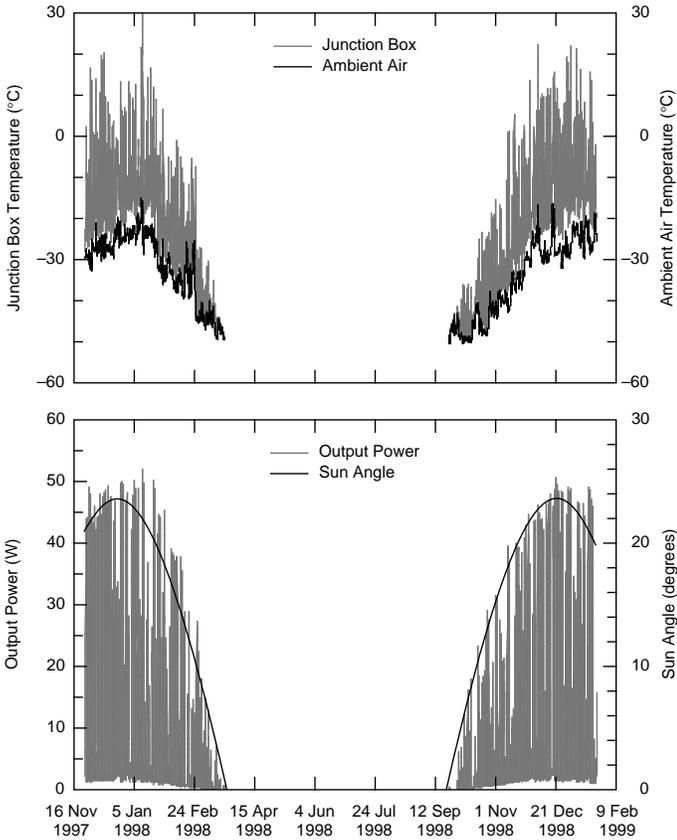
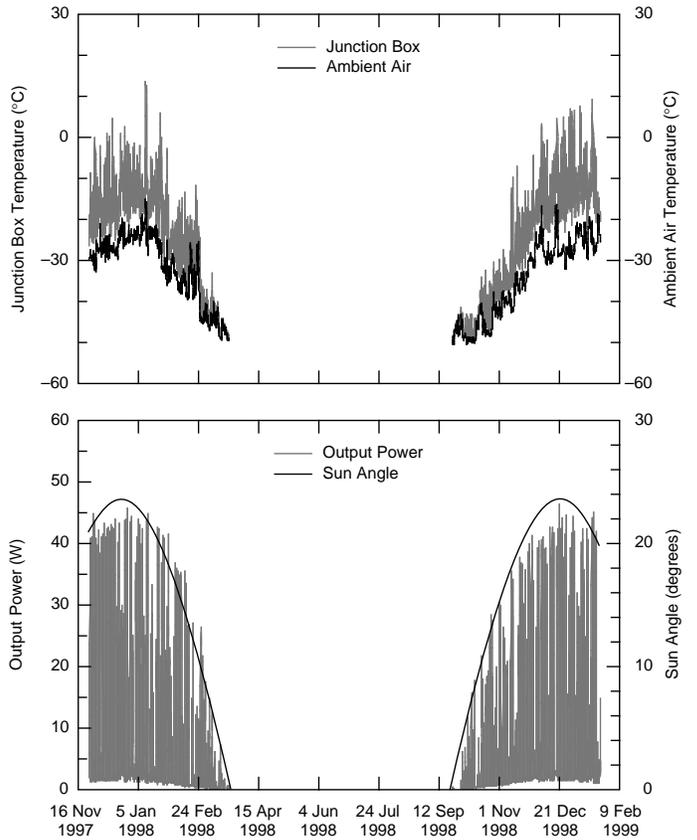
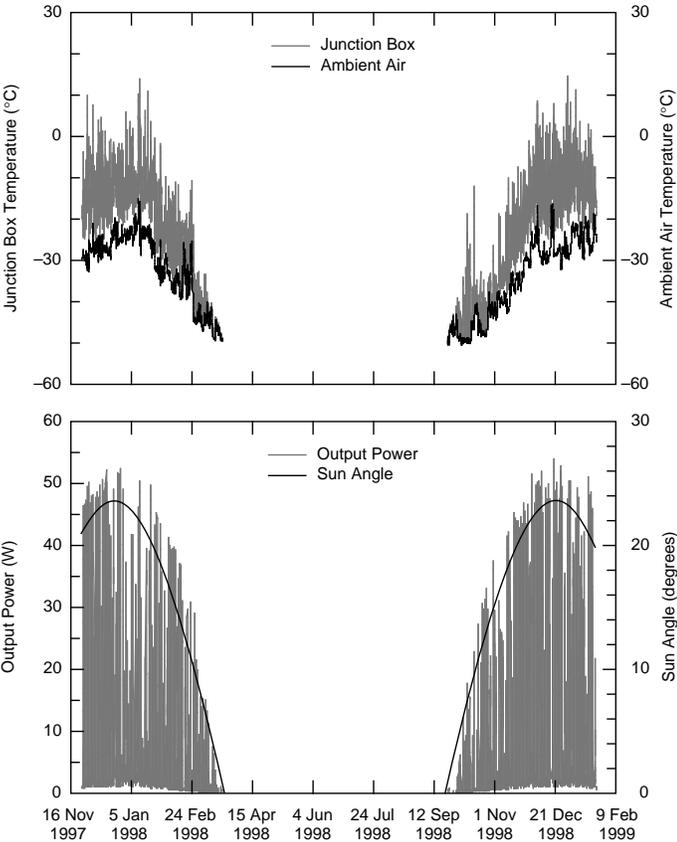
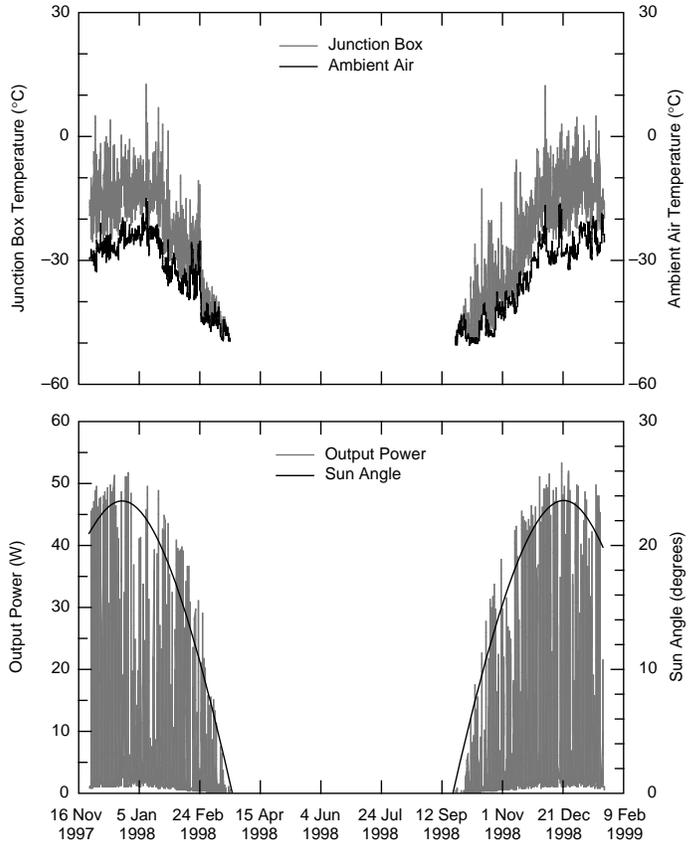
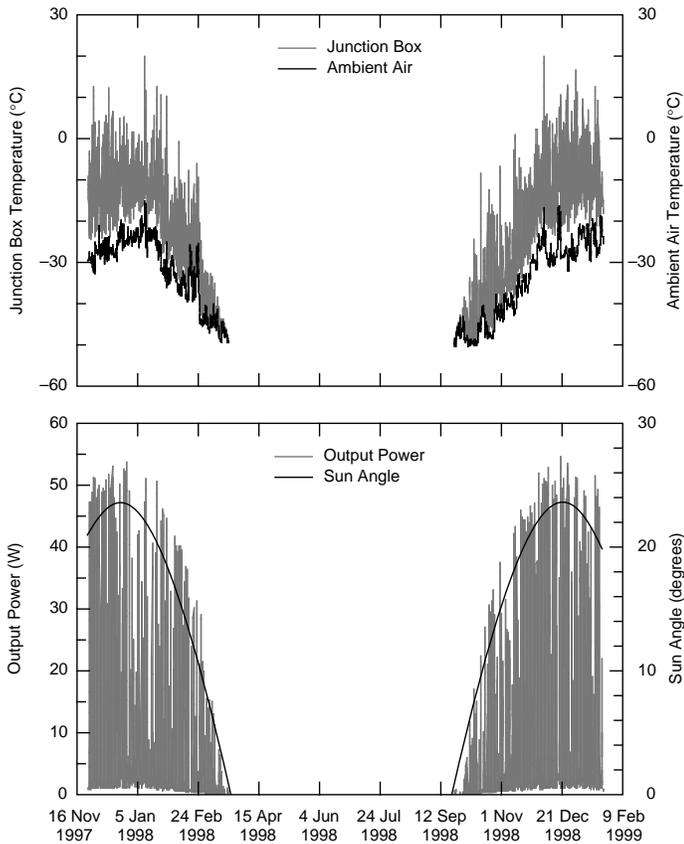
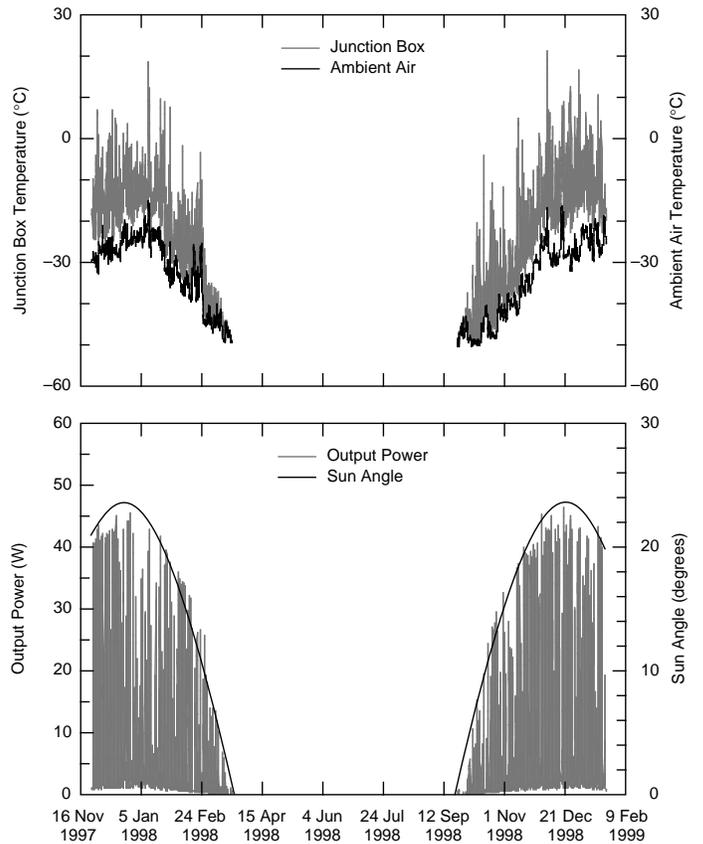
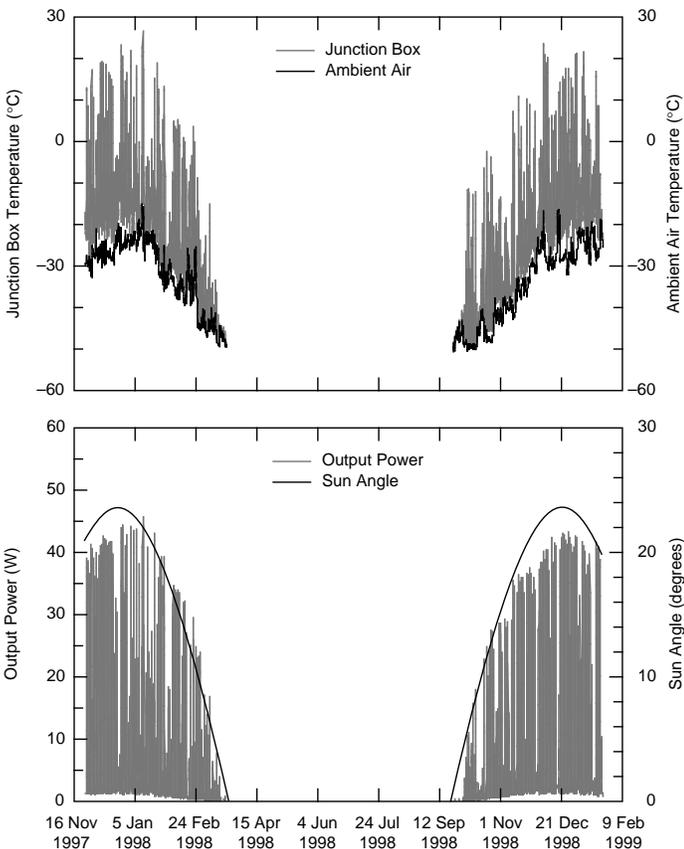
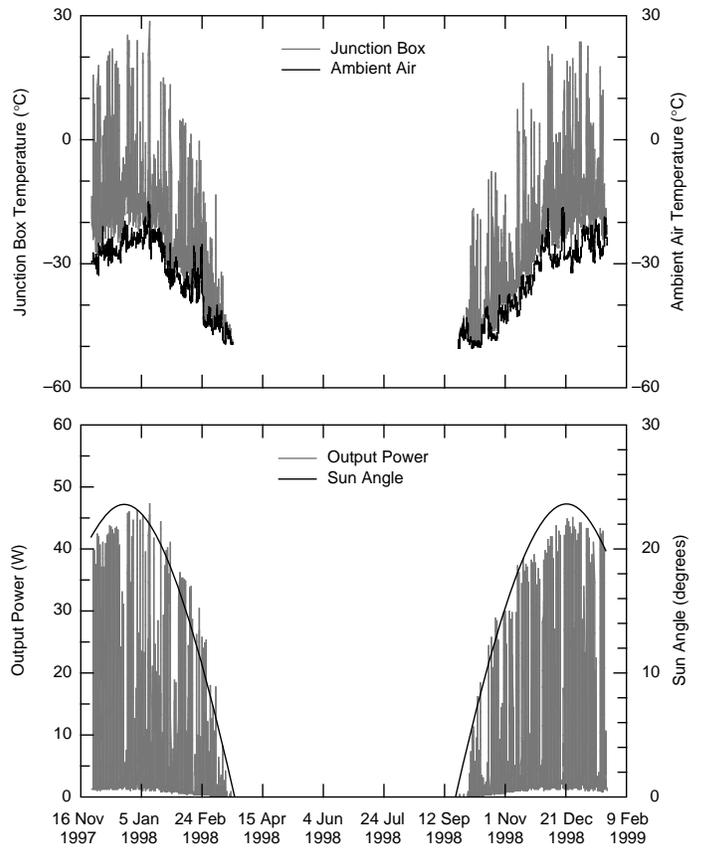
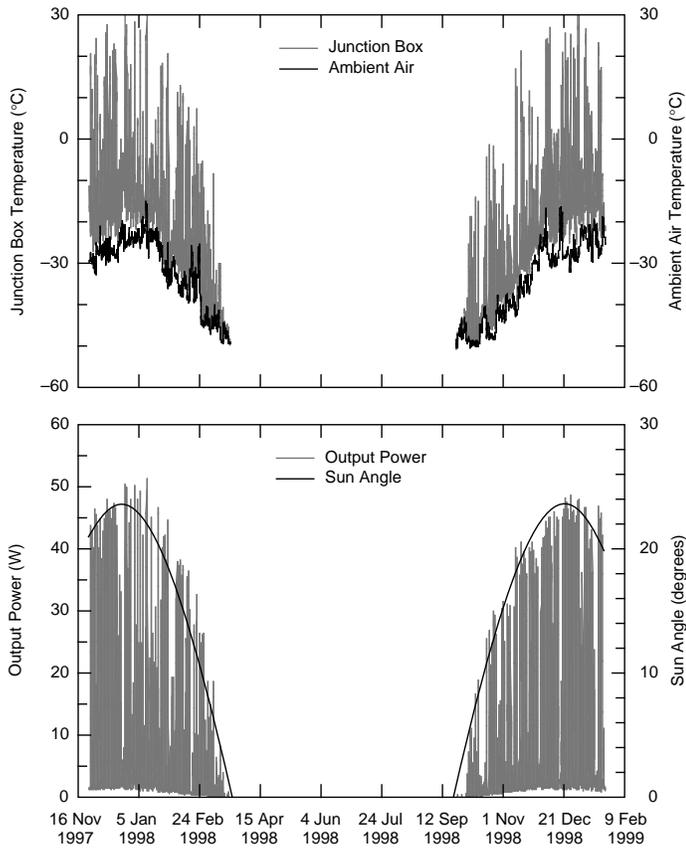
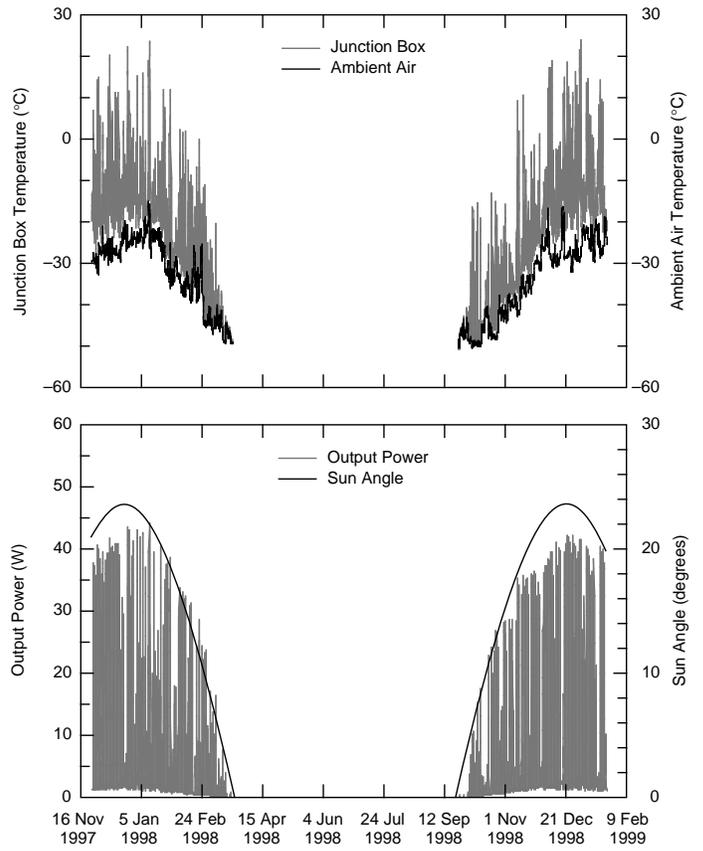
**Figure A1. Performance of PV panel 1A from 25 November 1997 to 23 January 1999.**

**Figure A2. Performance of PV panel 1B from 25 November 1997 to 23 January 1999.**

**Figure A3. Performance of PV panel 1C from 25 November 1997 to 23 January 1999.**

**Figure A4. Performance of PV panel 1D from 25 November 1997 to 23 January 1999.**

**Figure A5. Performance of PV panel 2A from 25 November 1997 to 23 January 1999.**

**Figure A6. Performance of PV panel 2B from 25 November 1997 to 23 January 1999.**

**Figure A7. Performance of PV panel 2C from 25 November 1997 to 23 January 1999.**

**Figure A8. Performance of PV panel 2D from 25 November 1997 to 23 January 1999.**

**Figure A9. Performance of PV panel 3A from 25 November 1997 to 23 January 1999.**

**Figure A10. Performance of PV panel 3B from 25 November 1997 to 23 January 1999.**

**Figure A11. Performance of PV panel 3C from 25 November 1997 to 23 January 1999.**

**Figure A12. Performance of PV panel 3D from 25 November 1997 to 23 January 1999.**

**Figure A13. Performance of PV panel 4A from 25 November 1997 to 23 January 1999.**

**Figure A14. Performance of PV panel 4B from 25 November 1997 to 23 January 1999.**

**Figure A15. Performance of PV panel 4C from 25 November 1997 to 23 January 1999.**

**Figure A16. Performance of PV panel 4D from 25 November 1997 to 23 January 1999.**

Figures A1–A16 were created to show the performance of each PV panel. PV power output and PV panel temperature are parameters of interest. The readily available PV power coincided with the sun declination angle. At the highest sun declination angle (23.5°), the PV panels exceeded or approached their rated PV power output. As available PV power increased, PV panel heat-

ing followed. Like PV power, PV panel heating coincided with the sun declination angle. PV panel temperatures experienced tens of degrees increases above ambient South Pole temperatures at the highest sun declination angle.
