# **Use of Military Demolition Explosives in a Remediation Project**

ERDC/CRREL TR-03-21

*Cold Regions Research and Engineering Laboratory  
72 Lyme Road  
Hanover, New Hampshire 03755*

Prepared for U.S. ARMY ENVIRONMENTAL CENTER  
and  
U.S. ARMY ALASKA

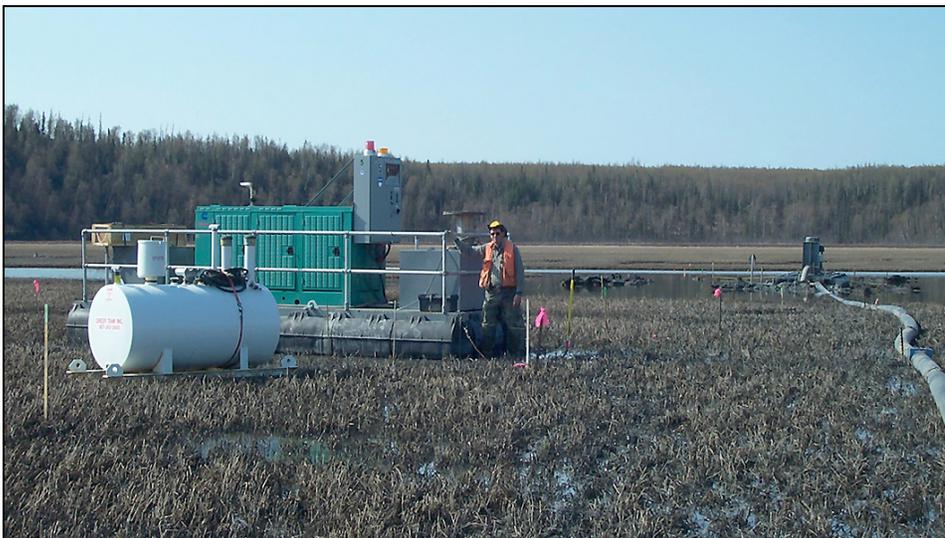
**Figure 2. Pump system deployed at ERF.**

The second pond treatment method involves temporary pond draining using a large-capacity pump. The pump removes the water from the ponded area, quickly removing the habitat from use by dabbling waterfowl and allowing the sediments to dry and the remediation process to initiate (Fig. 2). The pumping has to be repeated periodically, either as the basin starts to refill from surface water and groundwater inflow from the surrounding areas, after a rain event, or during one of the periodic flooding high tides. The greatest advantage of temporary pond draining is that it is easily reversible. After the pond bottom sediments dry sufficiently to sublime and oxidize the white phosphorus, the pond environment can be restored by removing the pump and allowing the natural periodic flooding tides to refill the pond basin and restore the aquatic and emergent vegetation. An autonomous pumping system consisting of a float-mounted centrifugal pump and a separate float-mounted generator set (genset) connected by power and control cables was designed and built for testing purposes in 1995 (Collins et al. 1996, Walsh et al. 1999b, 2000). In the initial planning phase of the project, it became

obvious from the relatively low relief of the shallow ponds that a sump in the middle of the pond is needed for the pumps to operate effectively. Without a sump, the pumps will cycle frequently as the water is repeatedly drained down around the pump. In addition, shallow drainage ditches are needed to connect scattered low points in the pond area to the sump. Ditches are also useful in treating adjacent contaminated ponds without the need of additional pump systems and sumps. All this needs to be accomplished with minimum human exposure to unexploded ordnance (UXO).

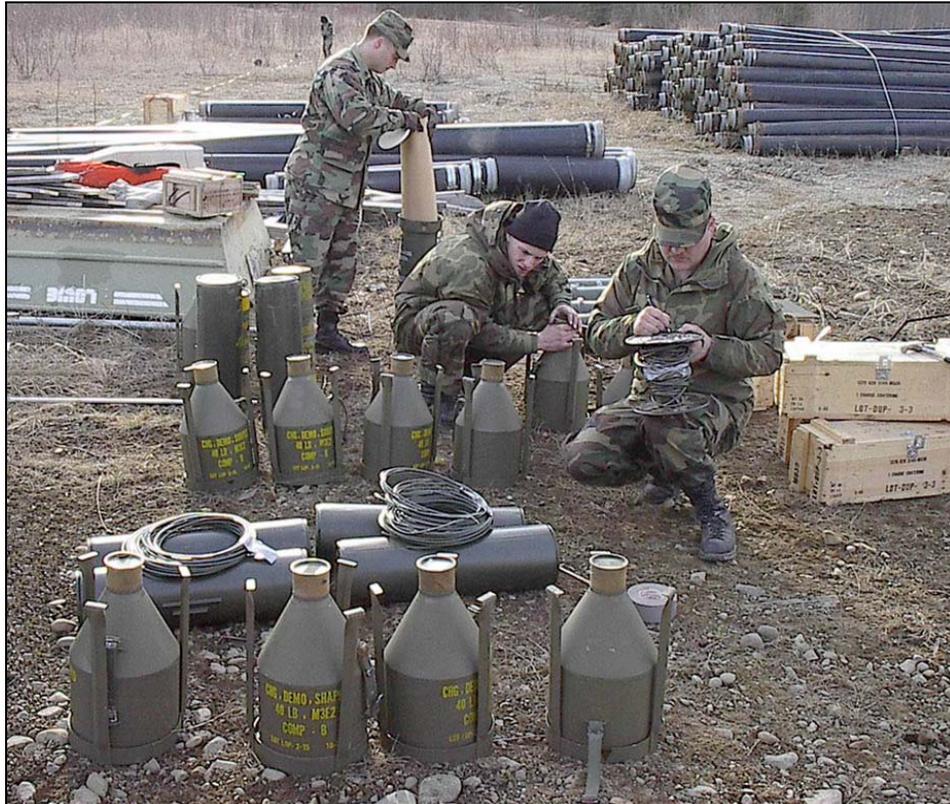
**Figure 4. Preparation of shaped (foreground) and cratering charges.**

The Bread Truck ditch was excavated in two stages (Fig. 4). The first stage used seventeen 18-kg shaped charges to explosively form boreholes into the sediment. The charges were spaced every 5 m along the centerline of the planned ditch. Type 1 M45 line main detonation cord (29.5 g/m, 6.4 lb/1000 ft) connected all seventeen shaped charges together. A dual detonating firing system consisting of two fuse igniters, two lengths of time fuse cut to 7-minute lengths, and two blasting caps was used. When detonated, the shaped charge produces a plasma jet that will punch a 30-cm-diameter hole straight down into the ground. The total

amount of explosives detonated in this first explosion was approximately 320 kg (700 lb). Following a sweep of the area for UXOs, the second stage of the explosive excavation was set up. An 18-kg cratering charge was placed in each of the boreholes created by the shaped charges. The charges were wired together in a similar manner to the shaped charges. One or more sandbags were placed in most of the boreholes on top of the cratering charges. The number and way the sandbags were placed varied from hole to hole, depending on the soldier who did the placement. Since all the boreholes were filled with water from the pond, it was difficult to determine how effective the sandbags were in tamping the underlying charge.

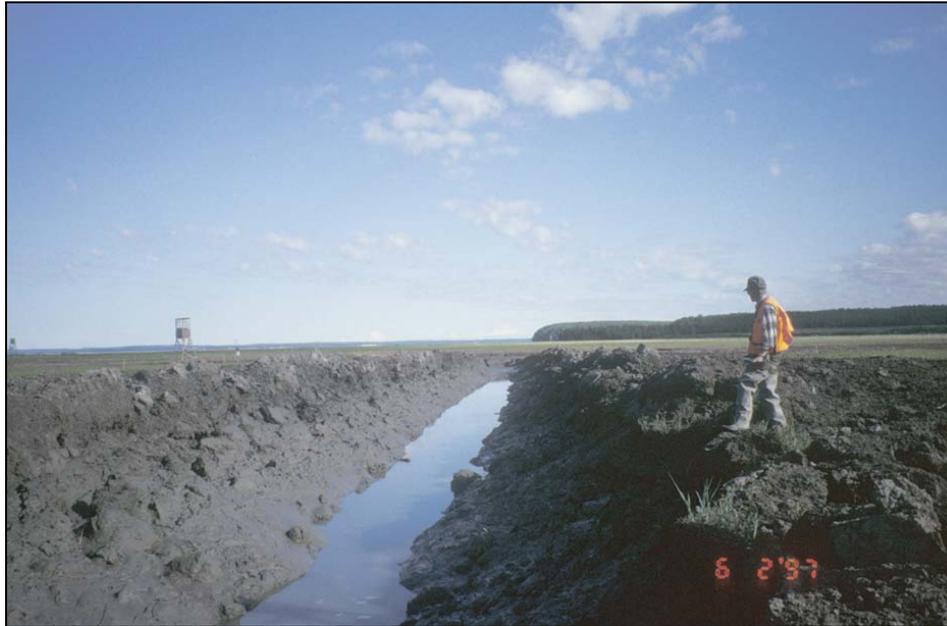
**Figure 6. Drainage ditch at Pond 293 (cratering charges).**

The detonation of all forty cratering charges produced a large explosion that threw material several hundred meters into the air. The explosion formed a nearly straight 120-m-long ditch, 2 m deep and 4.7–5 m wide, leading from the pond to the gully (Fig. 6). The problems encountered the previous year with the Pond 109 ditch with various sizes of craters and with some craters not overlapping were completely avoided. The closer spacing of cratering charges and the tamping of the boreholes containing the cratering charges with sandbags produced a more constrained explosion and a more consistent lateral excavation of ground material. Immediately following the blast, water started flowing into the newly excavated ditch from Pond 293. The first crater at the north end of the ditch was a

meter and a half deeper than the pond where it was located, resulting in a cascade of water down into the crater. Water continued to flow into and fill the ditch for about twenty minutes. After the ditch filled with water, it began to erode the berm thrown up around the last crater at the end of the ditch and flow out of the south end of ditch into the ice-filled gully and hence into the river. Water continued to flow out of Pond 293 and the surrounding sedge marsh for several weeks until the area drained.

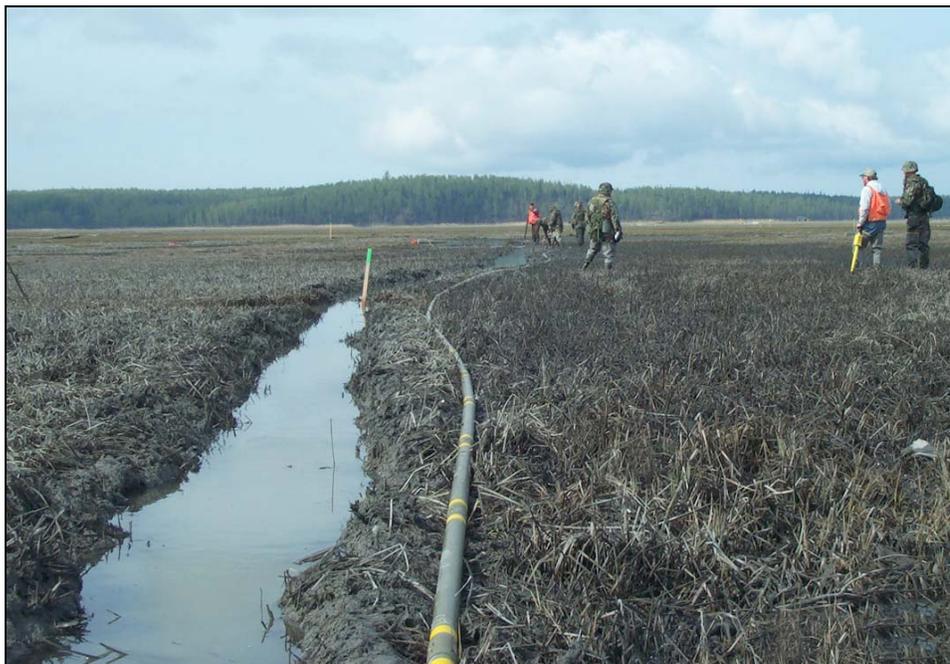
**Figure 7. Laying out Bangalore torpedoes.**

cratering charges to lessen the impact. Bangalore torpedoes are cylindrical demolition charges 1.52 m in length and 54 mm in diameter. The primary explosive component is Comp B4 (4.76 kg), with a 0.46-kg Comp A3 booster (U.S. Army 1998). The M1A2 Bangalore kit consists of 10 sections of torpedoes that can be assembled end-to-end using supplied sleeves to create a line charge. Any number of Bangalores can be assembled in this manner. The line charges used for ditching Pond 285 were initiated using M45 Type 1 detonation cord, a time fuse, and blasting caps placed in the detonator well of the Bangalore. Tests conducted in terrain in the Flats similar to that to be encountered between Pond 285 and the south channel of the Eagle River indicated that Bangalores placed on or cut slightly into the unfrozen surface of the sedge meadow characteristic of this area will create a ditch approximately 1 m wide by 70 cm deep.

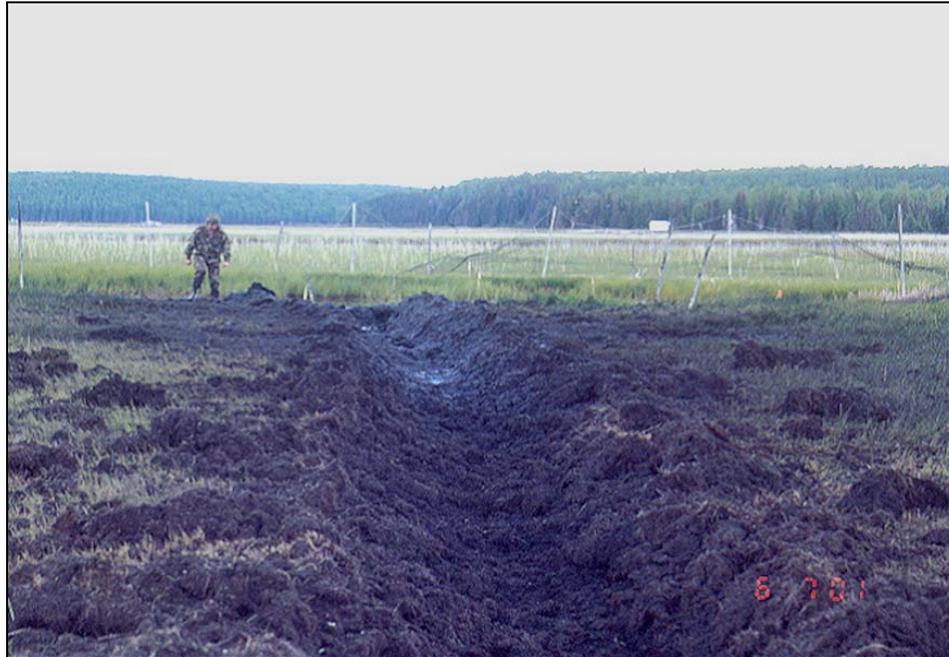
**Figure 8. Drainage ditch at Pond 285 (Bangalores).**

To form the ditch to drain Pond 285, a 46-m-long string of Bangalore torpedoes was laid from the edge of the central area of the pond, across the higher vegetated levee area, to the right channel of the Eagle River (Fig. 7). The final 4 m of Bangalores was cut 15–20 cm into the levee to deepen the ditch. At the pond end, two sections of five-stranded Type-1 detonation cord were used to branch into the two arms of the pond. The detonation of the Bangalores formed a ditch approximately 55 cm deep by 1 m wide (Fig. 8). Water drained into the ditch after breaking down the ejecta rim at the pond end, but it was evident that

because of the higher ground of the levee next to the river, the river end of the ditch was not deep enough to allow effective drainage. An additional 12 sections of Bangalores (18 m) were used at the river end to further lower this end of the ditch for drainage into the river. The ditch is large enough to effectively drain the pond yet small enough to allow easy restoration of the pond if necessary.

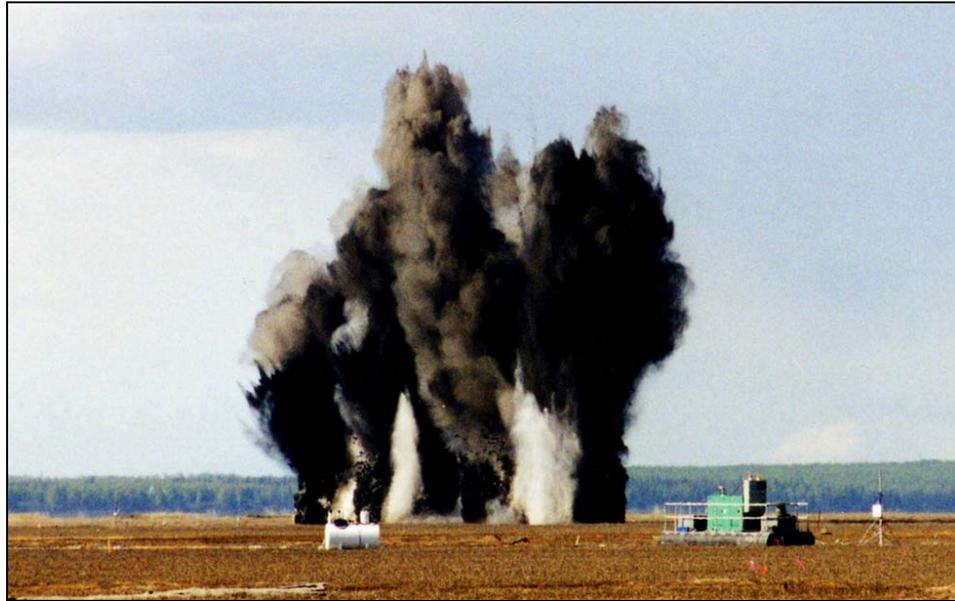
**Figure 10. Blasting a sump drainage ditch with Bangalore torpedoes and det cord.**

Ditching from isolated low points within a pond or adjacent ponded areas to the sump requires the formation of small (20- × 30-cm) ditches. Both Bangalores and detonation (det) cord (M456) have been used successfully to form these ditches: Bangalores where high points or hardpan needs to be breached and detonation cord elsewhere (Fig. 10). The detonation cord is preassembled into five-strand twisted bundles about 30 m long wrapped with ty-wraps every 3 m prior to field placement (Fig. 11). When using det cord, forcing it into the mud or precutting slots into vegetated areas and inserting the det cord into the slots greatly

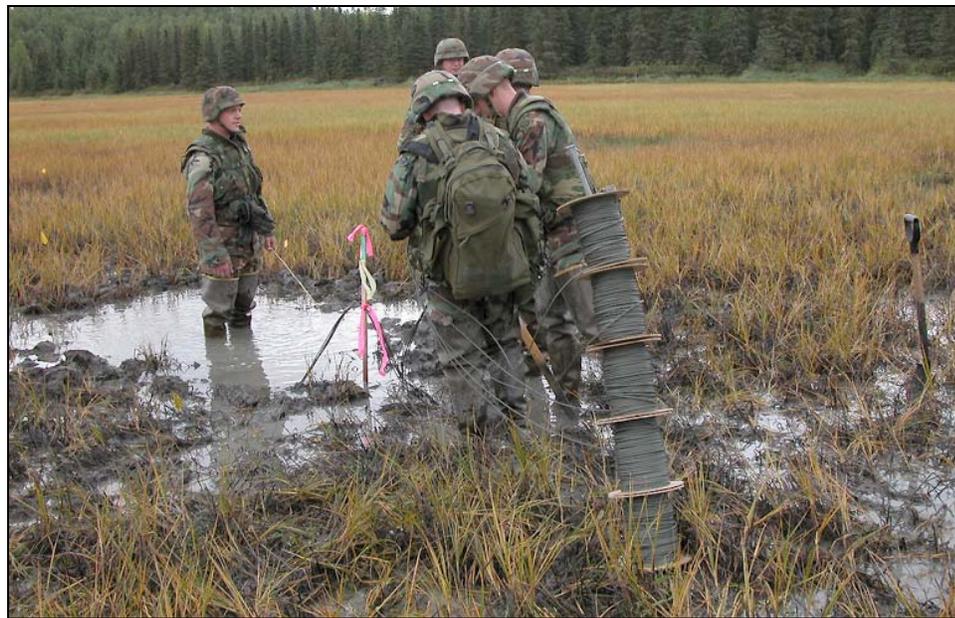
**Figure 11. Field assembly of a five-strand det cord run.**

enhances its effectiveness. Recently, we have found that doubling up the detonation cord (10-strand) and inserting it in precut slots in the areas where previously only Bangalores would work, such as heavily vegetated areas will form a sufficient drainage ditch. This allows ditching through difficult materials to be conducted closer to sensitive equipment without the concussion caused by the much larger Bangalores. Ditching to sumps is now done almost exclusively with det cord.

It is important that the det cord be pre-bundled. Bundling in the field has resulted in inconsistencies in the number of strands used (one to six) as well as long set-up times. Twisting of the det cord is also crucial to ensure that the bundle stays intact when pressed into the ground. Separation of the strands results in ineffectual excavation of the ditch. Ty-wraps alone are not sufficient, as the strands will separate when tamped. Although tamping by foot is not recommended in FM 5-250, we have not had problems with misfires due to internal cracking of the cord. This may be due to the multistrand make-up of the line.
