## **Impact of the Ballville Dam on Ice Jams in Fremont, Ohio**

**Report Prepared by**

**Carrie M. Vuyovich, PE  
Cold Regions Research and Engineering Laboratory  
U.S. Army Engineer Research and Development Center  
72 Lyme Road, Hanover, NH 03755-1290**

**January 2008**

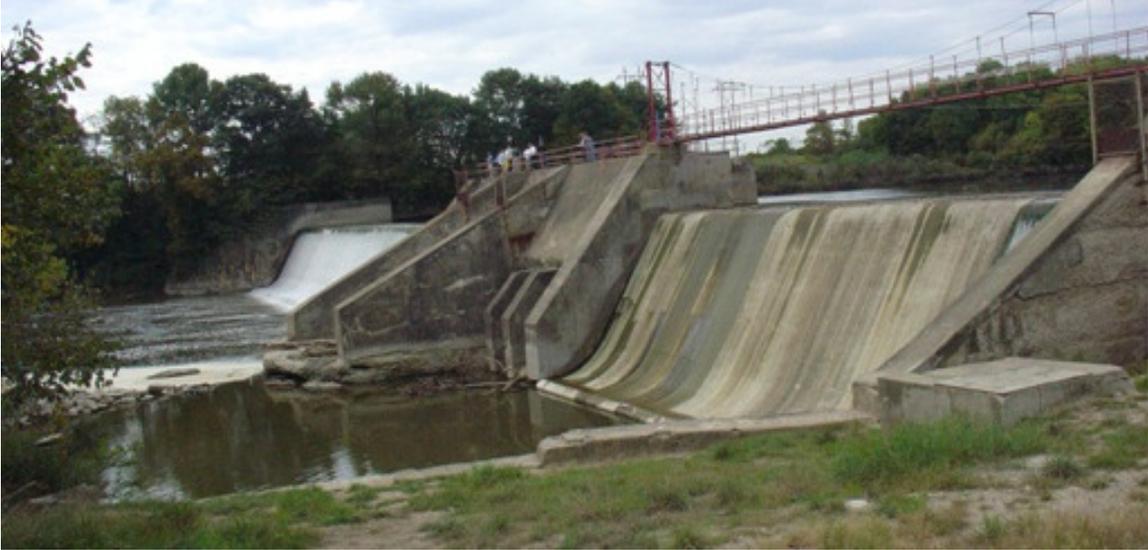
**Figure 1. Ballville Dam**

The Ballville Dam is a 34.4 foot high concrete overflow structure. There are two overflow sections separated by a 92.5 foot long water intake structure with 6 sluiceway passages (Figure 1). The right overflow section is 228 feet long and the left overflow section is 86.5 feet long. The crest elevation of the right overflow section is 624.68 feet; of the left overflow section is 625.1; and of the top of the intake structure is 634.68 feet. There is a 702 foot long retaining wall extending upstream on the left bank that has an elevation of 636.74 feet (USACE 1981).

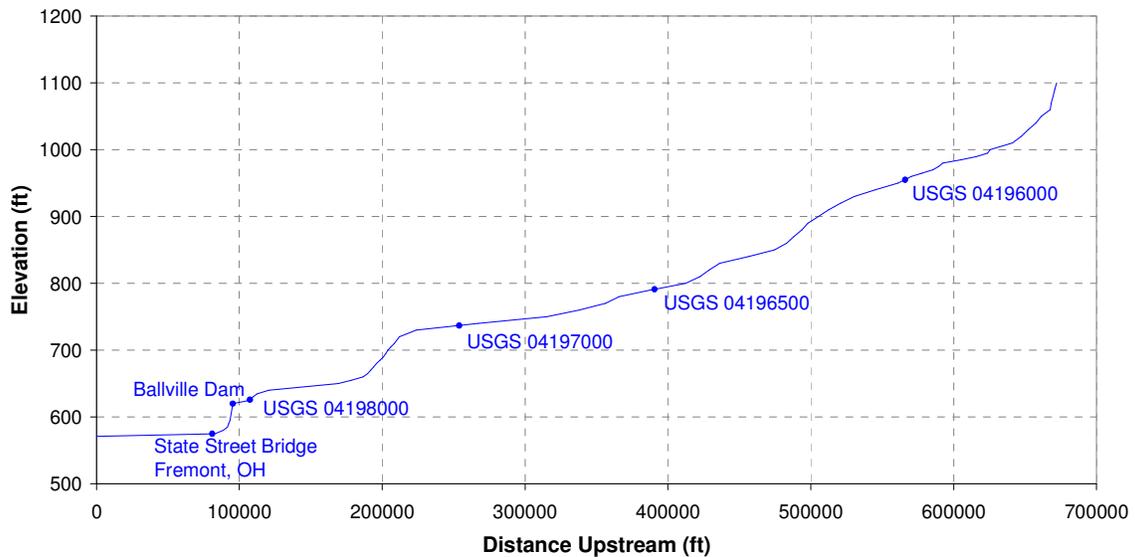
Figure 2. Profile of Sandusky River

Ice formation on the Sandusky River is heavily influenced by the river’s geomorphology, as shown in its profile (Figure 2) and its location in northern Ohio. The Sandusky River flows from south to north, traveling about 127 miles with a mean gradient of 0.00074 ft/ft (Evans et al 2002). The steepest portion of the river is a series of rapids with exposed bedrock between the Ballville Dam and downtown Fremont, with a mean gradient of 0.003 ft/ft. Fremont, OH is located near the downstream end of the Sandusky River, approximately 10 miles before the river empties into the Sandusky Bay of Lake Erie. The water surface between Fremont, OH and the Sandusky Bay is essentially flat, as the backwater from the bay reaches almost all the way to town. The channel bottom elevation at Fremont is below the mean lake level at Sandusky Bay (USACE 1963).

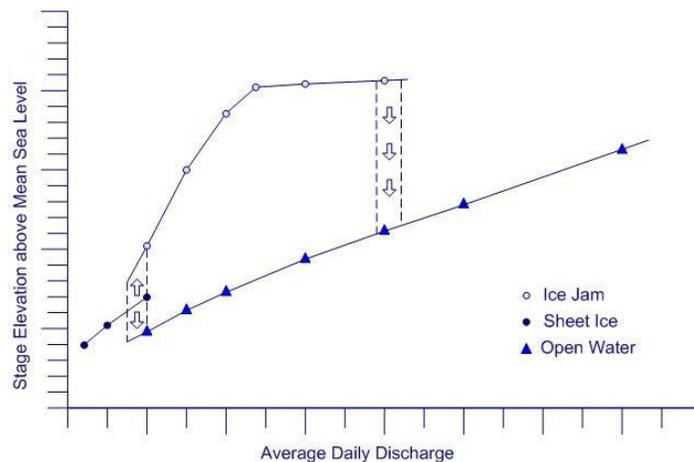
**Figure 3. Open water and ice-affected stage-discharge (after Tuthill et al 1996)**

Ice cover breakup results from thermal or mechanical processes (USACE 2002). Thermal breakup, caused when the cover melts and thins as a result of warming air and water temperatures, is largely benign, although it can result in the movement of ice pieces that later jam. A gradual rise in flow over many days or weeks will often weaken and melt the ice cover in place avoiding a dynamic breakup. Dynamic breakup occurs when the mechanical forces on the ice cover exceed the resisting forces of the ice. This usually occurs during rapid increases in discharge caused by heavy rain often accompanied by snowmelt. The rising stage lifts the ice. Once the ice cover has lifted, it fractures along the riverbanks and then rapidly breaks into smaller pieces, which begin to move downstream. If the concentration of the moving ice rubble exceeds the transport capacity of the river, an ice jam forms. Ice jams can occur when the breakup ice run impacts an intact ice cover or other obstacles such as bridges or dams. Jams can form as a result of hydraulic or morphological factors (e.g., decrease in energy slope, increase in channel depth or width). The ice thickness and ice strength at the time of break-up influences the severity of the ice jam. At some greater discharge the ice jam may release when it can no longer withstand the downstream forces acting on it. Figure 3 illustrates the stage-discharge relationship for an ice cover, including breakup, jamming, and finally ice jam failure.

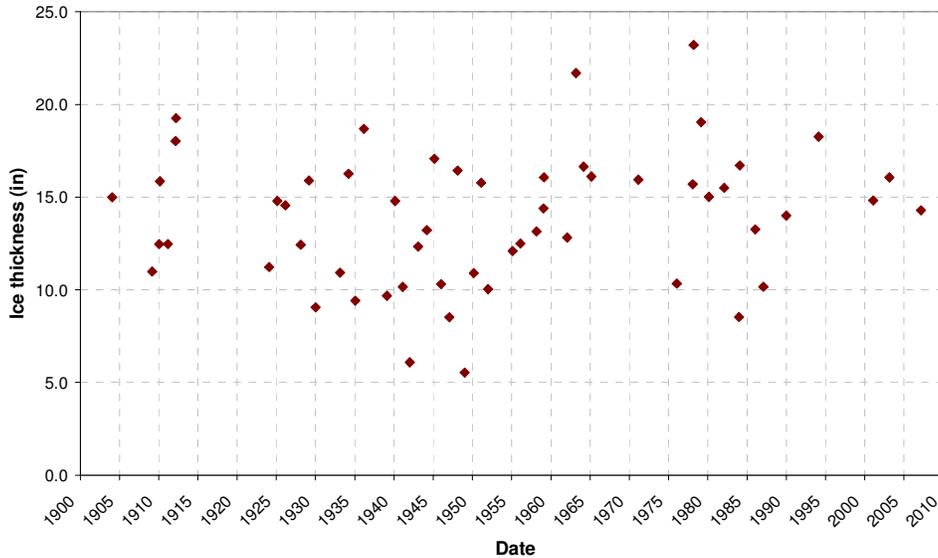
Figure 4. Calculated ice thickness for each ice event in Fremont, OH.

While this method provides a reasonable estimate of ice growth due to heat transfer to the atmosphere, other factors, such as the presence of a snow cover on top of the ice or frazil ice deposition underneath the ice, may also affect the ice thickness. The estimated thermally grown ice thickness at the time of each ice event is shown in Figure 4. Based on the AFDD analysis, the average ice thickness during an ice event on the Sandusky River is 13.8 inches.

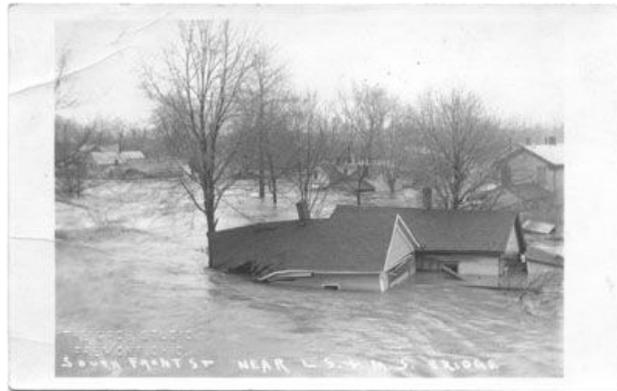
Figure 5. 1883 Ice Jam Event, Fremont, OH (Sandusky County Scrapbook)

No reliable measurement of stage exists for the 1883 event, but anecdotal evidence describes the water level as approximately 3 feet lower than the 1913 open water event of record, or 17.5 feet at the State Street Bridge (Thomas 1913). This is approximately the same level as the 1959 event. A newspaper clipping in 1959 described the 18 February 1883 ice jam event, “Ice was piled 6 or 8 feet high on State Street both east and west of the river...Traces of the flood remained for many months, even the huge cakes of ice did not melt and disappear entirely until the following May...Pressure of the enormous ice cakes caused the New York Central railroad to collapse...While the ice jam flood of 1883 was the worst of any ever to affect the city, water damage was not as great as that of the 1913 flood. (News-Messenger 1959)”

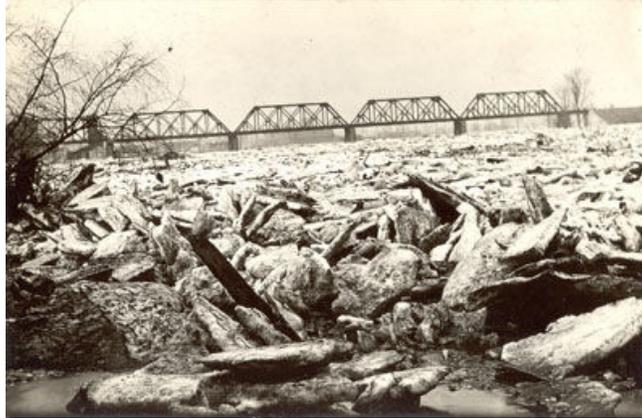
Figure 6. 1904 Ice jam event, Fremont, OH (Sandusky County Scrapbook)

On 23 January 1904, heavy rain caused increased discharge in the Sandusky River which led to an early ice breakup. The stage at the State Street Bridge was recorded at 16.5 ft. An article in the New York Times describes the event: “The ice in the Sandusky River is gorged from ten to twenty-five feet high in the very heart of the city, and the only channel the water has is through the main business street, where it rushes with great velocity. The water receded somewhat during the forenoon, but not enough to relieve the situation to any extent. “One-half the city is underwater, and no estimate of damage can be made at present. All day the ice has been coming down the Sandusky River and gorging until the gorges now extend to a point above the city, throwing all the back water over the low portions of the city. The entire east side, in the Third Ward, is under water.” (New York Times 1904)

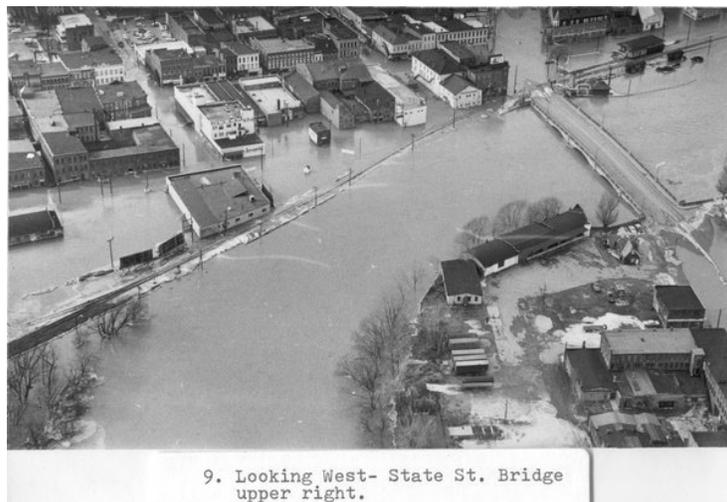
Figure 7. 1959 Ice Jam event, Fremont, OH (Sandusky County Scrapbook)

On 19 January, 1959 four inches of snow fell in the Sandusky River Watershed. The following day, temperatures rose, the falling snow turned to rain and in a twenty-four hour period over 20-21 January 1.76 inches of rain fell in Fremont, OH. A mile-long ice jam formed approximately 1 mile downstream of Fremont. By 1:00 pm on the 21 January the stage began to rise in the Sandusky River in downtown Fremont. Early in the morning on 22 January the water levels reached flood stage of 12 feet at the State Street Bridge and downtown Fremont was flooded. For four days the water level remained above flood stage until finally receding on 26 January. The peak occurred on 24 January when water levels reached 17.2 feet in downtown Fremont (Figure 7).

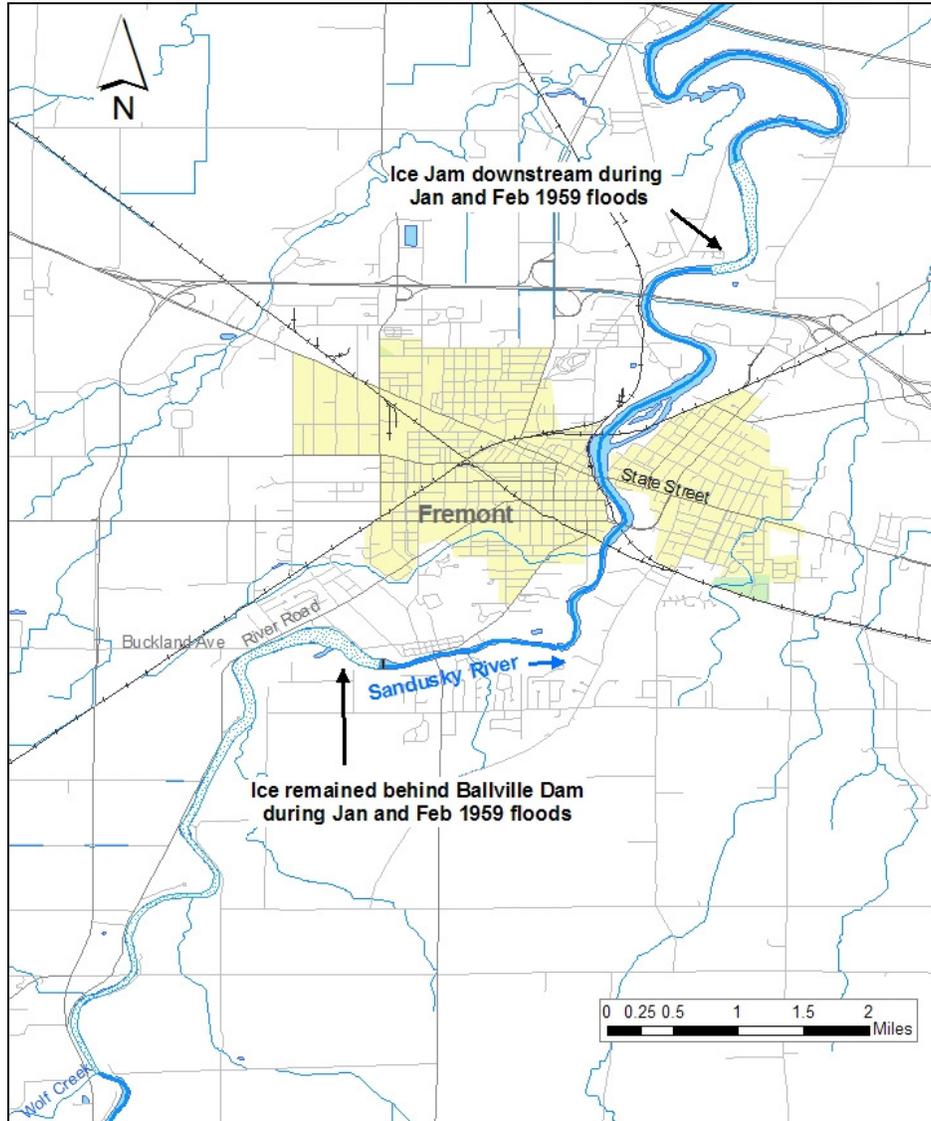
**Figure 8. Map depicting ice events of 1959**

An ice jam was also reported upstream of the Ballville Dam, which remained in place throughout the January flooding event and afterwards was described as “more solid than ever...no sign of breaking up”. The jam behind the sheet ice on the Ballville Dam was described as extending from Buckland Avenue to where Wolfe Creek emptied into the

Sandusky River. The locations of ice jams during the 1959 floods were estimated based on the published reports (Figure 8).

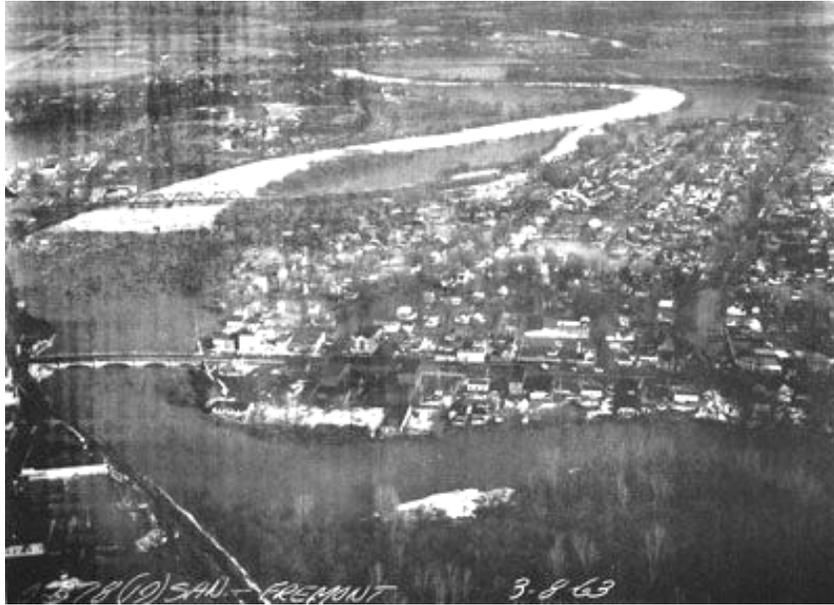
Figure 9. Ice jam flood in Fremont, OH, 8 March 1963 (looking downstream)

Immediately following, the stage dropped rapidly while the discharge continued to climb. This is typical of an ice jam release. When the discharge reached a peak of 21,500 cfs on 8 March, the stage upstream of the dam was approximately 10.8 ft, which is still higher than the open water stage for that discharge, indicating the effects of ice were still present. In an aerial image taken on 8 March 1963 (Figure 10), an intact ice cover is visible upstream of the dam. Ice rubble visible in the upper portion of the river is likely the start of the ice jam upstream of the dam extending further upstream. An open lead through the center of the ice cover is where some ice possibly released causing the drop in stage two days earlier.

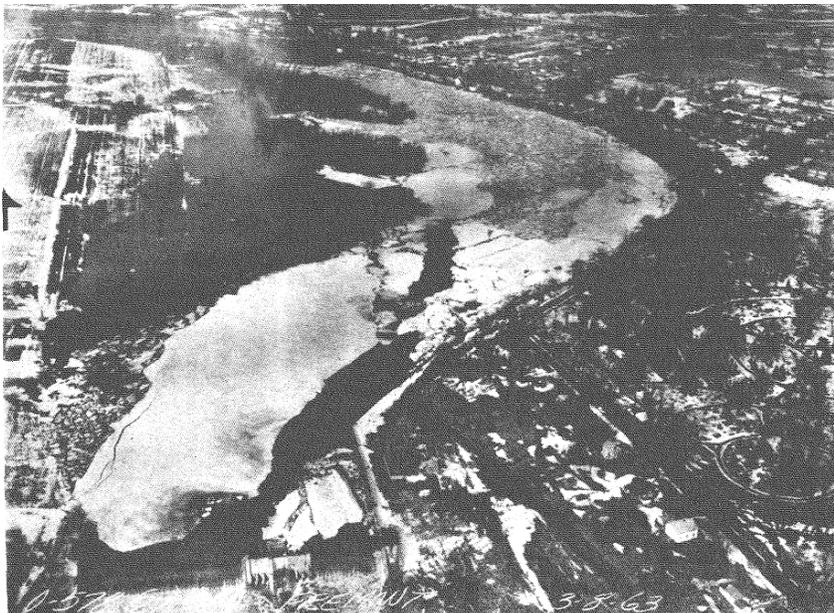
Figure 10. Ice Jam upstream of Ballville Dam, 8 March 1963 (looking upstream)

“It is interesting to note that although the March 1913 flood is the flood of record (63,500 cfs), the water surface profile of the March 1963 flood is approximately the same at Ballville Dam and for a short distance upstream. This condition reflects the severe ice conditions in the river during the 1963 event and the fact that the Ballville Dam failed during the 1913 flood. The high ice jam stages inundated farm land and surrounded buildings on several agricultural properties upstream of the dam, although total damages were relatively minor (USACE, 1963).”

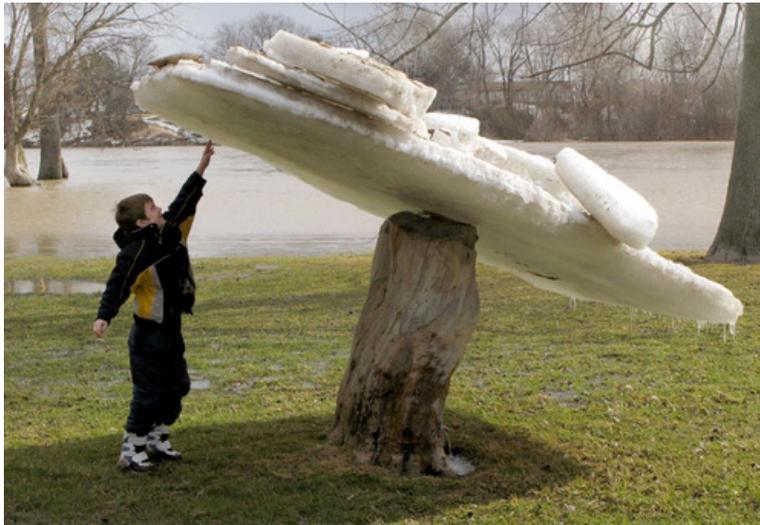
**Figure 11. Ice floe stranded on a stump near River Road (Detrich 2007)**

The ice jam event that occurred upstream of the Ballville Dam in March 2007 caused minor flooding on River Road and left large pieces of ice stranded in the area around the dam (Figure 11). No ice jams or high water were reported in Fremont during the ice jam. This event is significant because it is a recorded instance of an ice jam releasing and ice flowing over the dam. The ice jam occurred early in the morning on 2 March and reached a peak stage of 11.15 ft at 7:30 am at the USGS gage (04198000). Between 7:30 and 8:00 am the ice jam released and the ice floes were witnessed going over the dam<sup>1</sup>. Only stage data is reported for the 2007 event because discharge data is based on open water rating curve and has not yet been corrected for the effects of ice<sup>2</sup> (Figure 12).

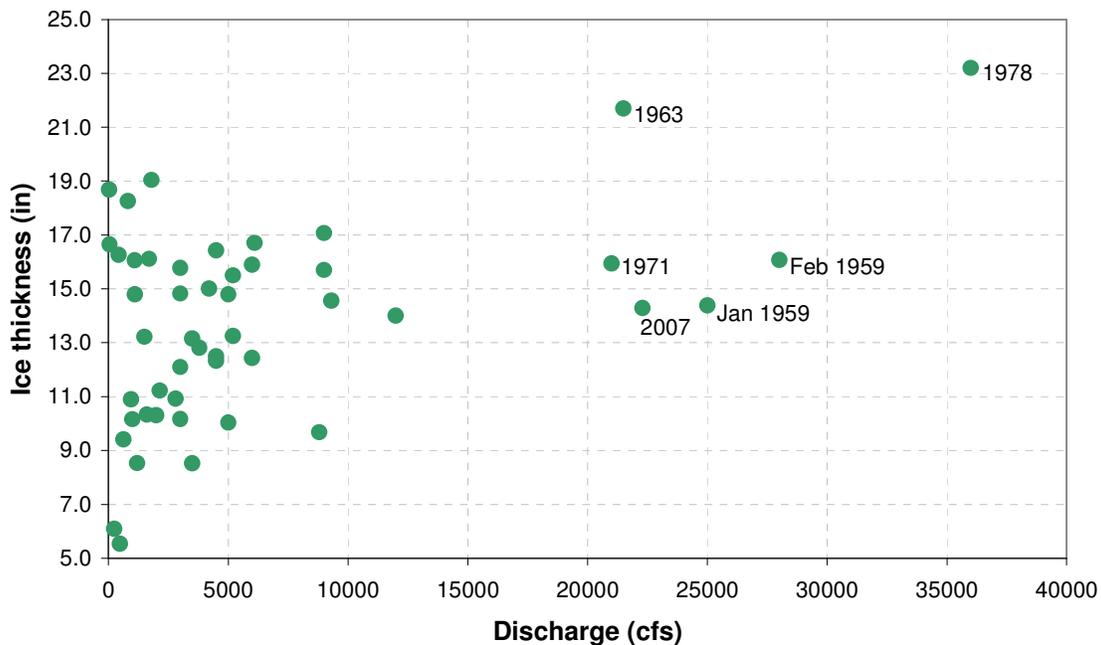
**Figure 13. Discharge and estimated ice thickness during ice jam events**

Historical ice jams were analyzed to understand to what degree the Ballville Dam influences the location and severity of ice jams in Fremont. Of the 58 recorded ice jams found, 47 occurred upstream of the Ballville Dam. In 18 of these ice events the stage exceeded the flood stage of 10 feet, but was only reported as maximum gage height due to ice at the USGS gage. A plot of calculated ice thickness and discharge, during events when data was available, indicates that most of the minor ice jams, with the exception of 1971 and 1978, had a discharge less than 15,000 cfs at the time of the event (Figure 13). The ice jams of 1971 and 1978 were both reported upstream of the Ballville Dam, and no record of an ice jam occurring in town during either of these years was found, though additional research might uncover more information. The major ice jams occurred when the ice thickness was greater than 13 inches and the discharge was greater than 20,000 cfs.

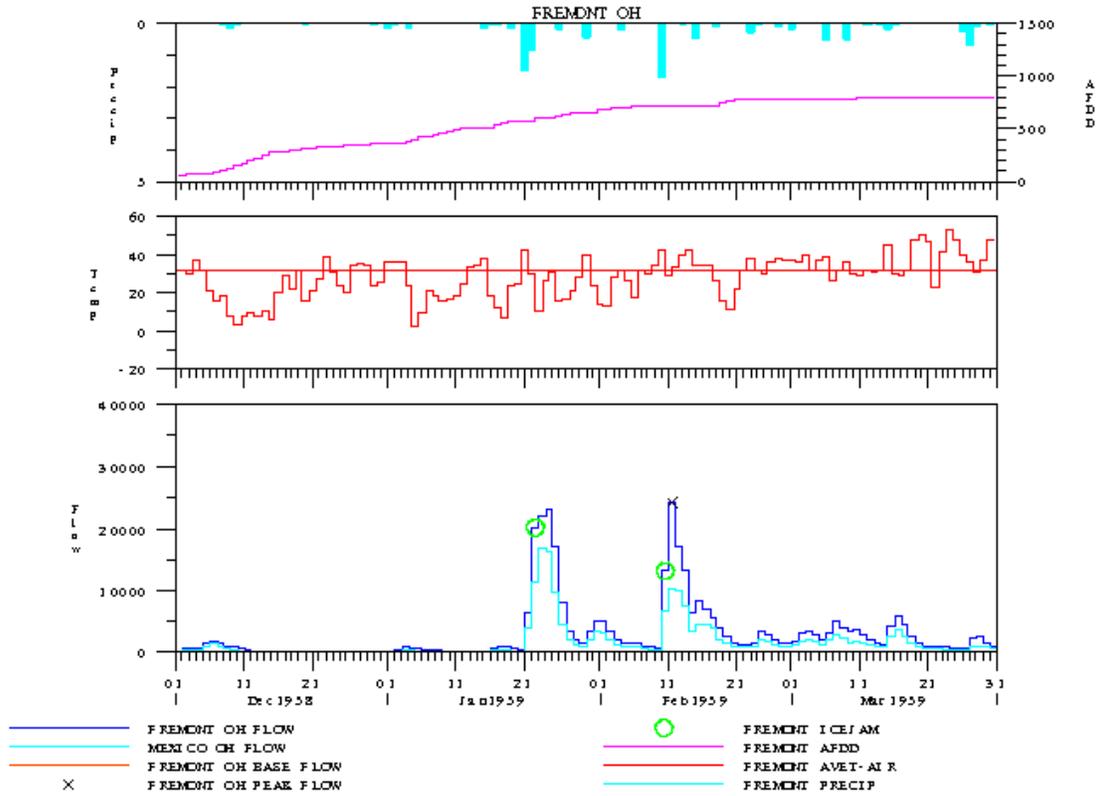
Figure 14. Plot of 1959 Precipitation, AFDD, Air Temperature and Discharge

discharge to rise sharply in January and again in February when the ice strength is typically highest due to cold temperatures. In 1963 the winter had been very cold with almost twice as many freezing degree-days accumulated as in 1959. Even though the 1963 ice jam occurred in March, the ice was still approximately 2 feet thick when the discharge again increased rapidly. In contrast, during the March 2007 ice jam air temperatures had been at or above freezing in the days leading up to the event. It is expected that the ice had already been weakened, facilitating break up and allowing the ice to flow over the dam.

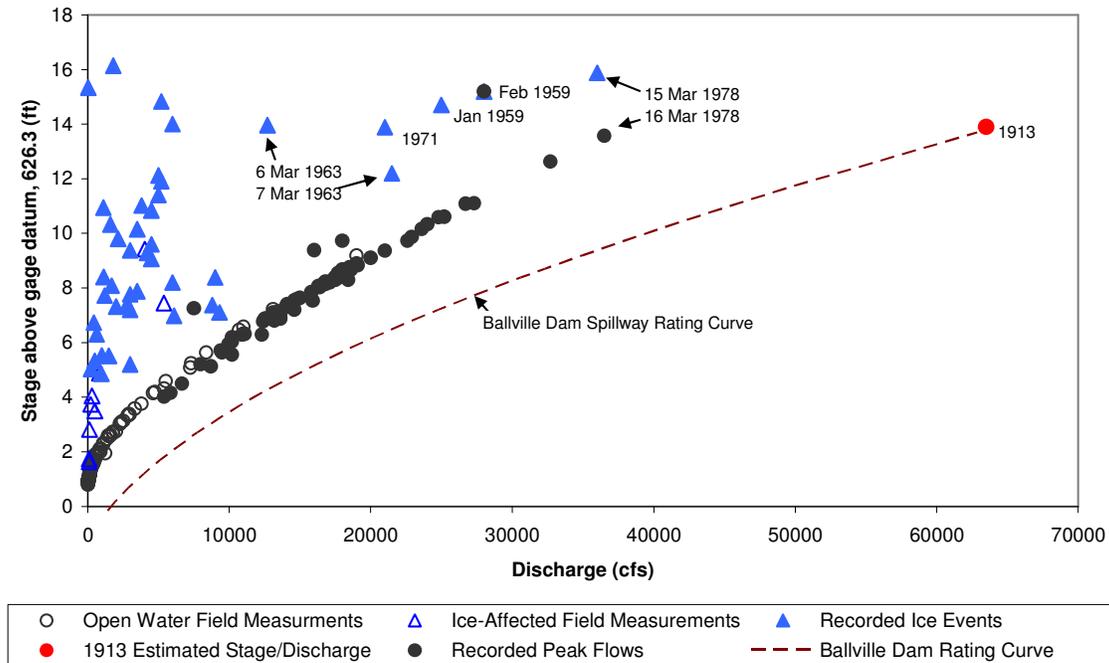
**Figure 17. Open-water and ice-affected stage readings upstream of the Ballville Dam**

The presence of ice behind the Ballville Dam causes water levels to rise higher than during open water conditions. The open water and ice-affected stage readings at the USGS gage upstream of the Ballville Dam are shown in Figure 17. Since the USGS gage was not installed until 1923, the 1913 stage and discharge were estimated using high water marks (USACE 1962). The stage during the 1913 flood of record is below the open water stage-discharge relationship because the dam failed during the event. Also shown on the graph is the stage-discharge rating curve for the Ballville Dam spillway (USACE 1981). The 2007 ice jam event is not shown on this graph because discharge measurements have not been corrected for the effects of ice at this time.

The 1978 event recorded the highest average daily discharge for an ice jam, 36,000 cfs on 15 March. At 7:30 pm on 15 March an ice jam was recorded upstream of the Ballville Dam which caused the maximum annual stage for that year of 15.88 feet. On 16 March 1978 a peak discharge of 36,500 cfs was reported, but the stage had dropped to 13.57 feet, which corresponds to the open water stage. It is possible that the ice overtopped the dam on 15 March after reaching a maximum discharge that the ice could withstand. If the ice overtopped the dam and traveled downstream either the discharge was sufficient to push the ice past Fremont so no jam occurred, or a jam occurred but because of the newly constructed flood walls no flooding was reported.

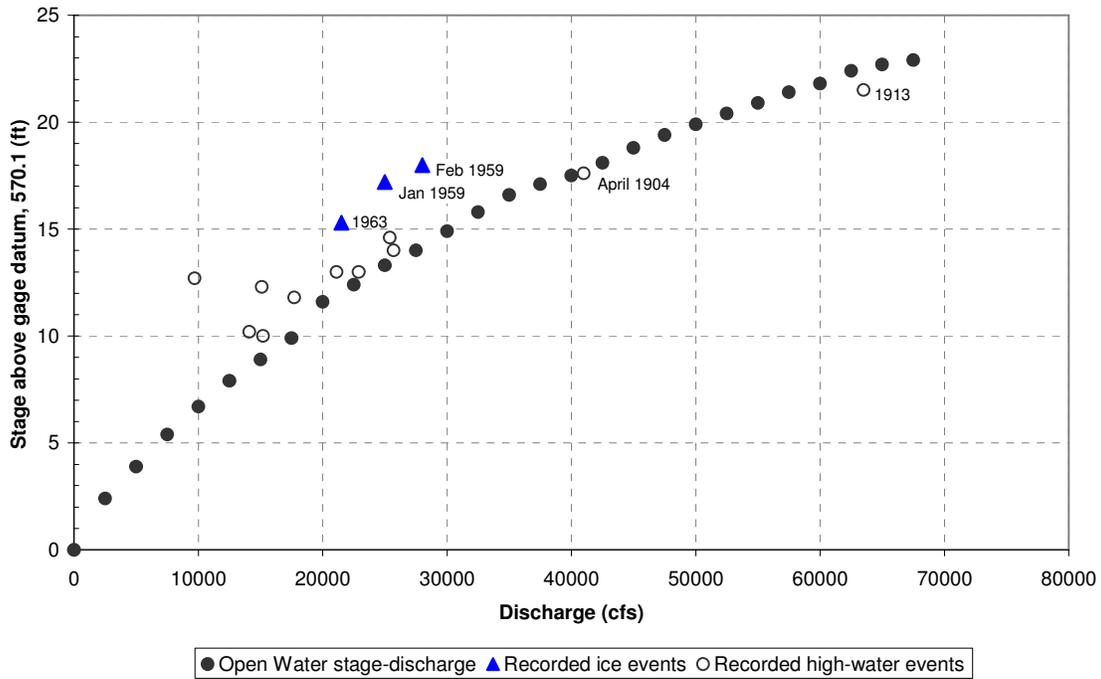
Figure 18. Open water and ice-affected stage readings at the State Street Bridge.

The recorded stage readings at the NWS gage on the State Street Bridge are shown in Figure 18. Stage readings were obtained from Fremont News-Messenger articles (1959), USACE reports (1962, 1963 and 1964) and NWS observation sheets (NCDC 2007b). The indicated discharge is the average daily discharge from the USGS gage upstream of Ballville Dam, except for the three recorded ice events for which the peak discharge

recorded was used (Jan and Feb 1959 and 1963). The stage-discharge relationship for this location was estimated by the US Army Corps of Engineers in a report on the proposed flood control of the Sandusky River in Fremont, OH (USACE 1962). The stage-discharge relationship for the improved conditions after the flood walls were built and the existing conditions are not significantly different at the State Street Bridge location. Unfortunately stage and discharge information is not available for the significant ice events which occurred during the 1800s for comparison. The 1913 event is below the rating curve because according the USACE 1962 report, the datum of the staff gage was lowered by 1.1 feet in 1925 and the stage of the 1913 event should be increased to 22.6 feet.

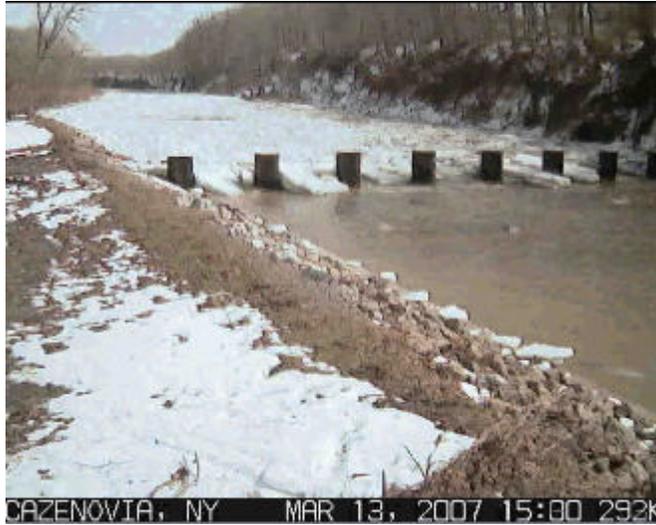
**Figure 19. Ice jam at Cazenovia Creek ice control structure**

*Permanent Ice Control Structure.* Install a permanent ice control structure such as ice piers at the location of the dam (Tuthill and Lever 2006). The Ballville Dam is ideally located to protect the City of Fremont from damaging ice jams. Ice piers constructed at the same location would prevent upstream ice from contributing to an ice jam in downtown Fremont yet allow the floodwave to pass through. A structure of this type was constructed on Cazenovia Creek in Western New York State (Lever et al 2000). An image of the Cazenovia Creek ice control structure during an ice run in March 2007 was taken by a remote web camera installed at the site (Figure 19). Ice piers do not block upstream passage of fish, downstream passage of sediment, or passage of small recreational boats such as kayaks and canoes. The expected level of protection of permanent ice control structures, such as ice piers, can be quantitatively estimated with a high level of confidence based on laboratory tests, field performance of existing structures, and ice modeling. Generally, permanent structures can be expected to provide a high level of protection.
