# **Survey of River Ice Influences on Channel Bathymetry Along the Fort Peck Reach of the Missouri River, Winter 1998–1999**

Leonard J. Zabilansky, Robert Ettema, James Wuebben, and  
Norbert Yankielun

September 2002

Technical Report  
ERDC/CRREL TR-02-14

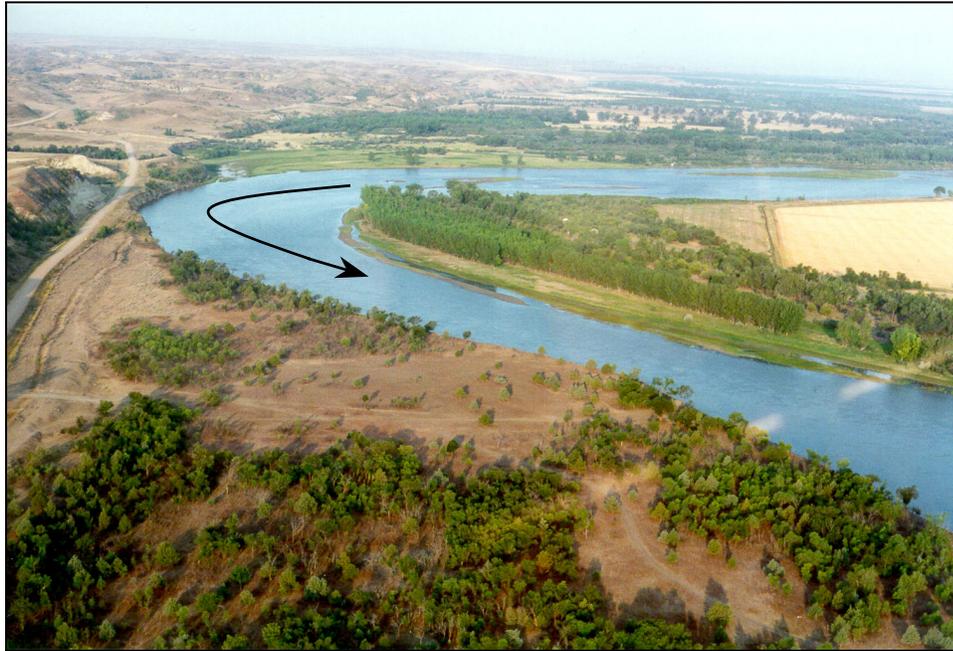
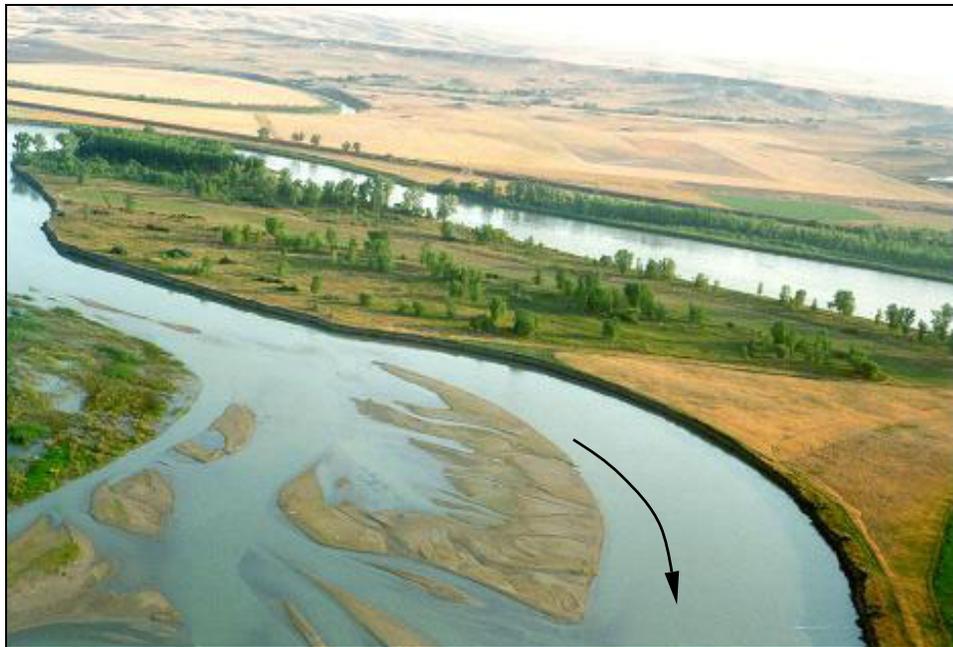
**Figure 2. Typical subreaches in the Fort Peck reach.**

**a. A typical subreach in which the river narrows to a single channel bend. (From CRM 1996.)**

**b. A typical subreach in which the river widens and flows in two or more sub-channels. (From CRM 1996.)**

This site is representative of river reaches with upstream and downstream ends that are constrained and narrowed to a single channel by a bluff located along one side of the river. Figure 3 shows the site in the summer of 1996 and Figure 2a shows the reach immediately upstream of the Culbertson site.

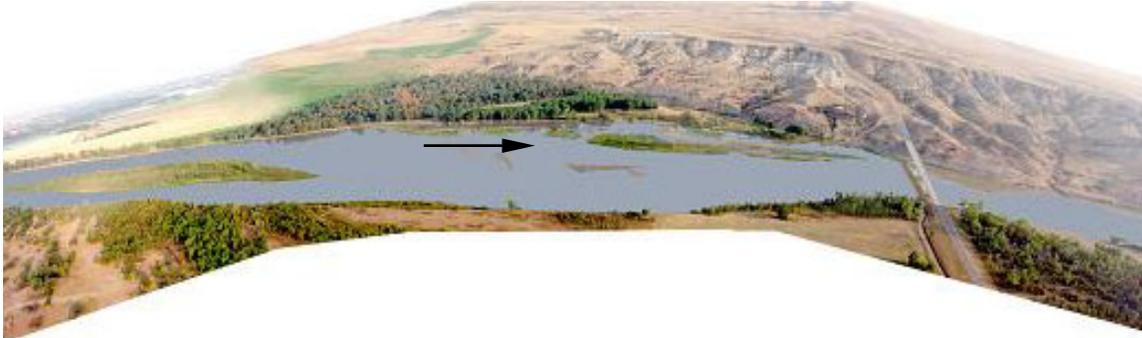
**Figure 3. Missouri River between RM 1621 and 1620, near Culbertson, Montana. (From CRM 1996.)**

annual sediment load is estimated to be about  $5 \times 10^6$  tons, based on a continuous record of suspended sediment load recorded from 1958 to 1972 at a sediment-measuring station located just downstream of the Highway 16 bridge at Culbertson (RM 1620) and shown on the right side of Figure 3 (USACE-Omaha 1986). About 35% of the suspended load consists of silt and clay originating from

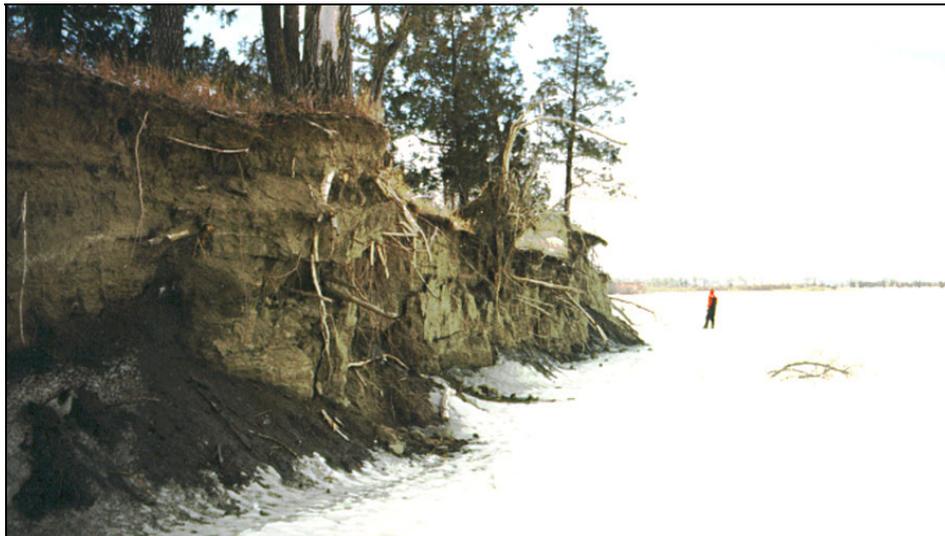
**Figure 5. Riverbank along the reach.**

At some locations along the Fort Peck reach, especially in channel bends, the river has cut quite steep riverbanks (Fig. 5). The riverbanks typically are formed of soils having relatively low shear strength, especially low cohesive strength (Simon et al. 1999), and typically consisting of silty and sandy layers interspersed with clay or silty clay layers. The occurrence of a layer of sandy or silty soil at the base of a riverbank makes it prone to erosion. This feature is common at the sites selected for this survey.

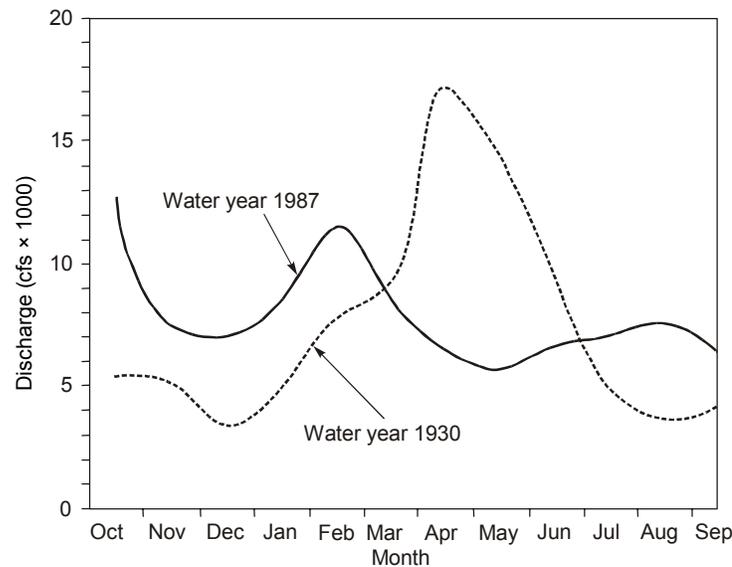
**Figure 6. Hydrographs for water years 1930 and 1987, before and after construction of the Fort Peck Dam.**

occurred during the winter months. The average peak winter flows increased from about 5,000 cfs to about 14,000 cfs. Figure 6 compares the pre-dam and post-dam mean daily flows at the Wolf Point gage (RM 1700) for the water years 1930 and 1987. However, in the past two years, flow releases have varied substantially from the discharge for water year 1987 shown in Figure 6. Figure 7

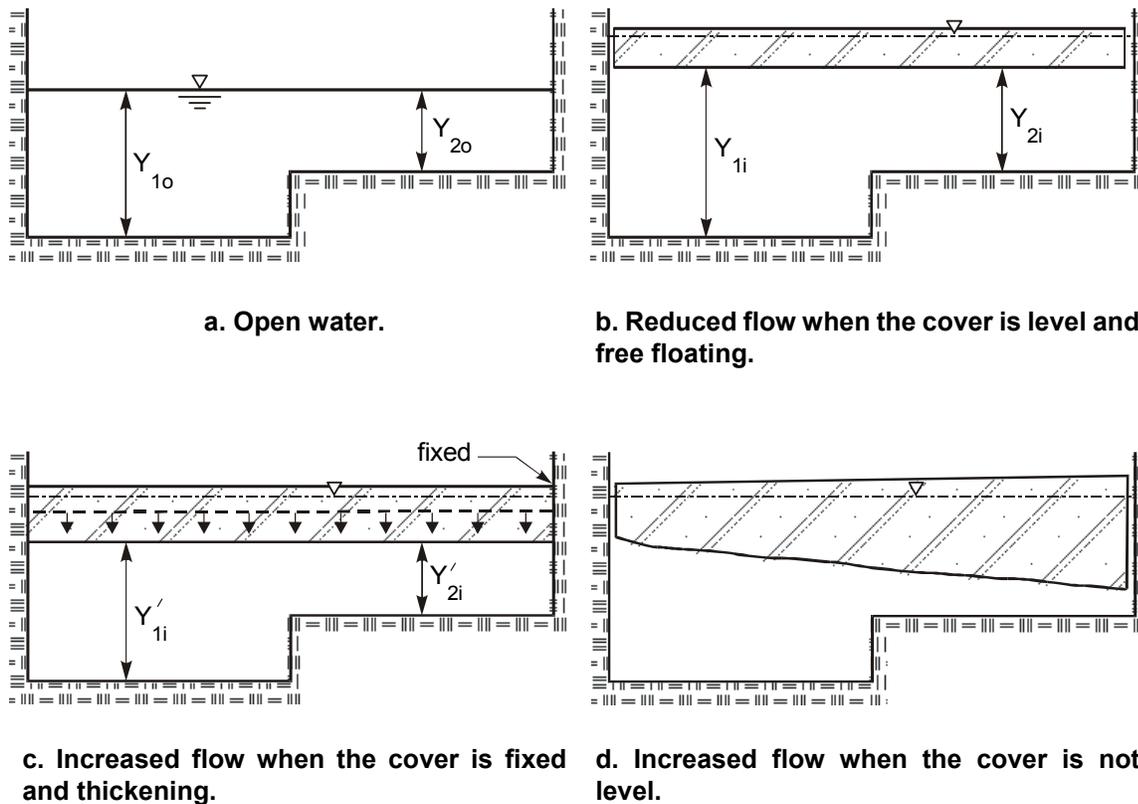
**Figure 9. Effect of ice cover on flow conveyance in lateral segments of a two-part, compound channel.**

For constant flow, a free-floating, uniformly thick ice cover reduces the magnitudes of the two conveyance components. It smears flow over the full channel width, as  $K_{1i}/K_{2i} < K_{1o}/K_{2o}$  (Fig. 9b), where the subscript "i" denotes ice-

covered. However, if the ice cover were fixed to the channel banks and thickened, the reverse occurs:  $K_{1i}/K_{2i} > K_{1o}/K_{2o}$  (Fig. 9c), because the reduction in flow depth represents a higher percentage of the overall depth for the shallower portion. Under this condition, the cover squeezes or concentrates flow along a thalweg, where the flow is deeper. If the thalweg lies close to one side of a channel (e.g., near the outer bank of a bend), such a concentration of flow may cause the thalweg to shift position and then deepen. On the other hand, if the thalweg were located more centrally in a channel, a fixed cover may deepen the thalweg in the same position. Also, the cover, by reducing flow through the shallower portion, may trigger further reductions in conveyance through the shallower portion by promoting ice accumulation (frazil slush or pans) and/or bed sediment deposition there. Additional flow concentration is possible if the cover is not uniformly thick (Fig. 9d), if ice grounds on the channel bed, or if shorefast or accumulated ice develops from one or both banks.

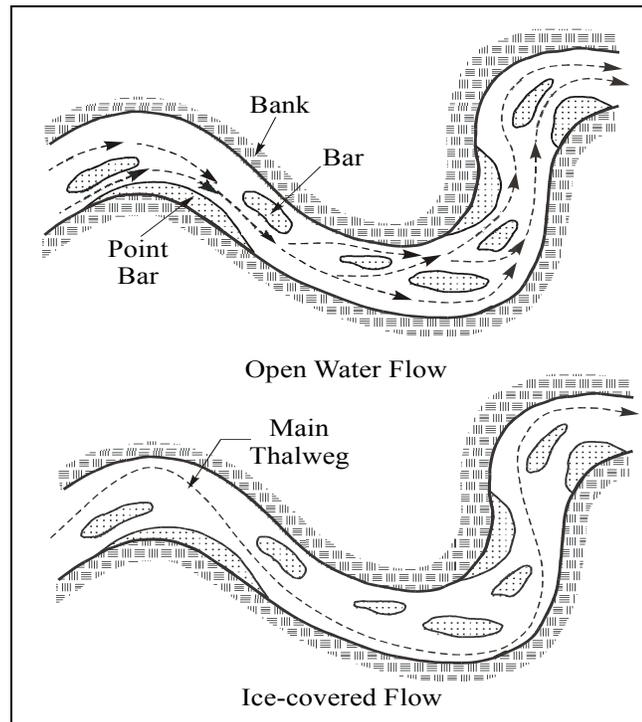
For sinuous-braided channels, as in Figure 13, ice cover formation and the associated decrease in the energy gradient may cause flow to concentrate in a single thalweg of greater sinuosity than the open water thalweg. For braided channels an ice cover may concentrate the flow into the larger subchannels.

**Figure 13. River ice impact on the thalweg of a sinuous-braided channel. An ice cover causes the main thalweg to become more sinuous.**

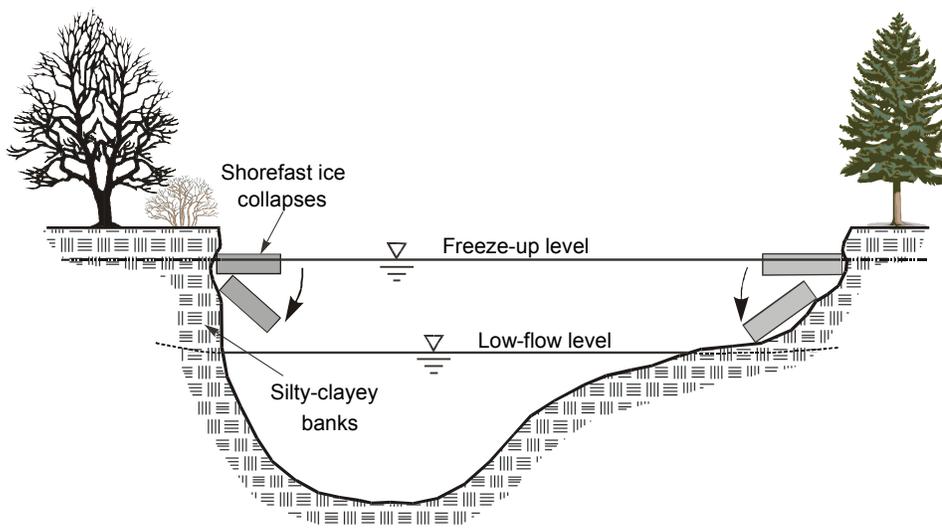
Figure 14 illustrates ways in which bankfast ice might weaken a riverbank. The ice cover freezes into the riverbank. The size of the ice root is limited by the groundwater elevation and temperature and by the nature of the riverbank material. When the water level in the channel drops and the ice cover breaks up, ice that remains attached to the riverbank rotates and tears a portion of the riverbank as it drops. It is difficult to get direct field observations of this mechanism for bankfast ice attached to vertical riverbanks. There is evidence for a related mechanism commonly termed plucking, which is used with regard to the loss of riprap stones frozen to an ice sheet. Wuebben (1995), for instance, discussed plucking concerns in the design of riprap for riverbank protection.

**Figure 14. Collapse of shorefast ice, and possibly bank material, following lowering of the flow stage. At present, shorefast ice effects on bank erosion are not well known.**

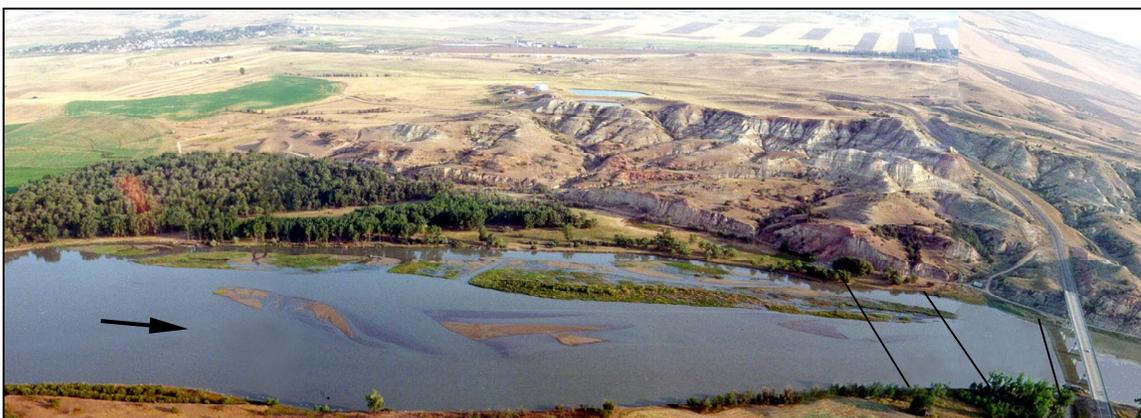
**Figure 16. Aerial view of RM 1620–1621, Culbertson site. The arrow shows the direction of flow, and the lines show the approximate locations of the surveys. (From CRM 1996.)**

Between these two constrictions, the channel widens along the greater portion of the reach and initially divides into two subchannels around a vegetated bar as illustrated by Figure 16. Then, it further subdivides into as many as three subchannels. The channel subsequently narrows as the river becomes constrained

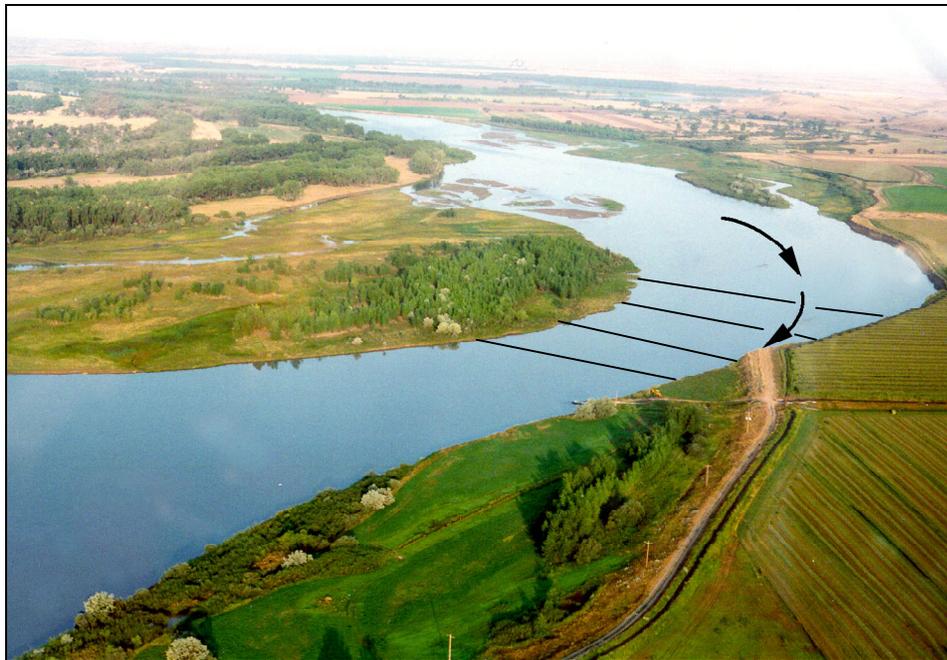
At RM 1623.5 the channel's thalweg impinges along the base of the channel's north bank and actively erodes a 3000-ft-long portion of the bank. The exact rates of bank recession have not been determined, but the erosion is causing significant loss of prime irrigated cropland. As the bank has receded, the thalweg has shifted accordingly. In addition, the shifting thalweg has caused a sediment deposition problem at a downstream location where a small irrigation pump draws water for the croplands.

**Figure 18. Aerial view of RM 1623–1624, Tveit-Johnson site. The arrows show the direction of flow, and the lines show the approximate locations of the surveys. (From CRM 1996.)**

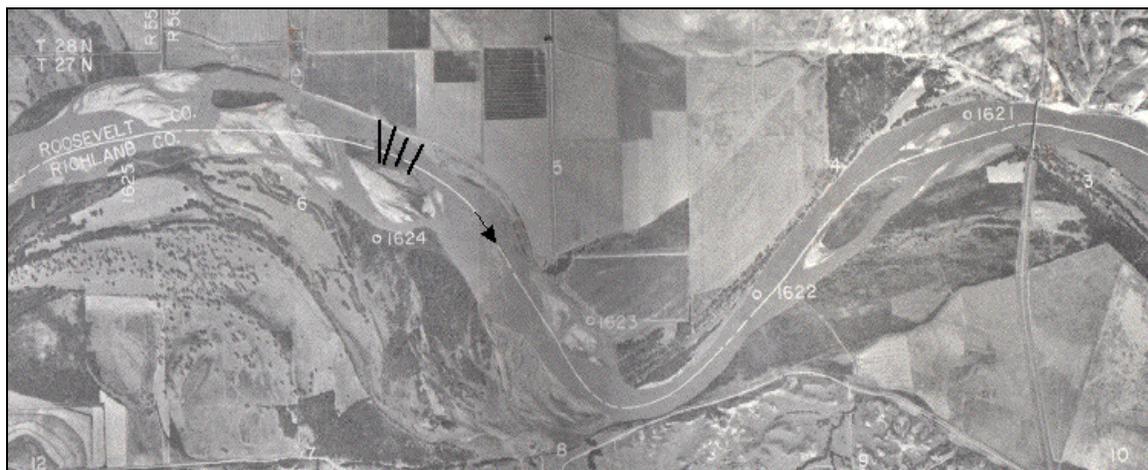
**Figure 19. Survey cross sections near RM 1623–1624, Tveit-Johnson site. (From USACE-Omaha 1983.)**

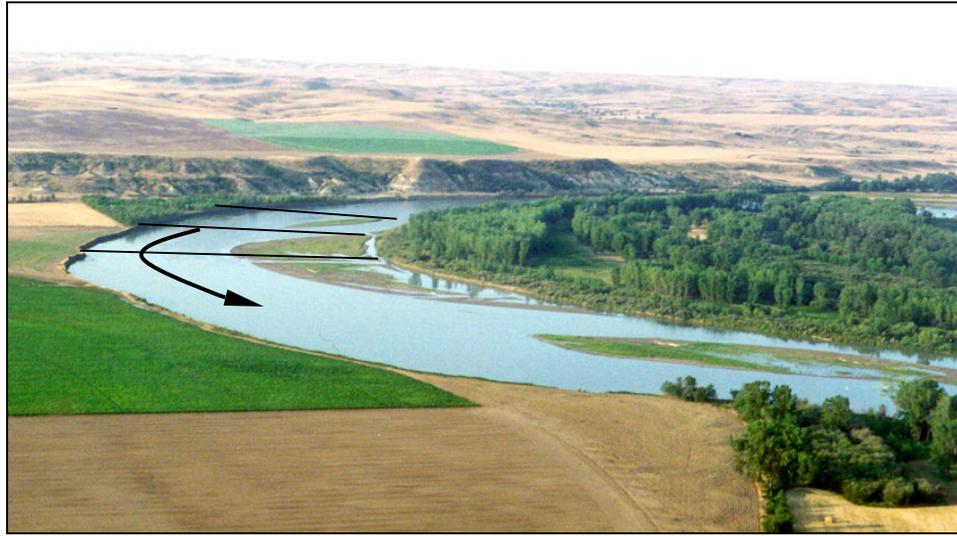
Figure 20. Aerial view of RM 1631–1632, Vournas site. The arrow shows the direction of flow, and the lines show the approximate locations of the surveys. (From CRM 1996.)

This site was selected for monitoring because it likely would be useful for determining how an ice cover influences flow distribution and loose-bed bathymetry in a channel bend. In particular, survey information from the site would be of use in assessing whether and how an ice cover may shift the channel thalweg. A further ice process of interest at the Vournas site is the occasional formation of an ice jam. The frequency of jamming is not known precisely, because jam occurrence has not been recorded routinely. However, anecdotal accounts indicate that the ice jams here approximately every ten years. When a jam develops, it backs up flow and causes it to spill overland until it enters the river at the downstream side of the meander loop. As the neck of the meander loop is relatively wide and overland flow velocities small, jam-induced flooding apparently deposits sediment on the flooded land.\*

The findings from this site are representative of ice formation impacts on a curved alluvial channel comprising a dominant single thalweg aligned along a steep outer bank, such as illustrated in Figure 20. The river has a much smaller subchannel along its inner bank. It was evident that river ice exerted pronounced hydraulic and geomechanical influences on the river channel at this site.

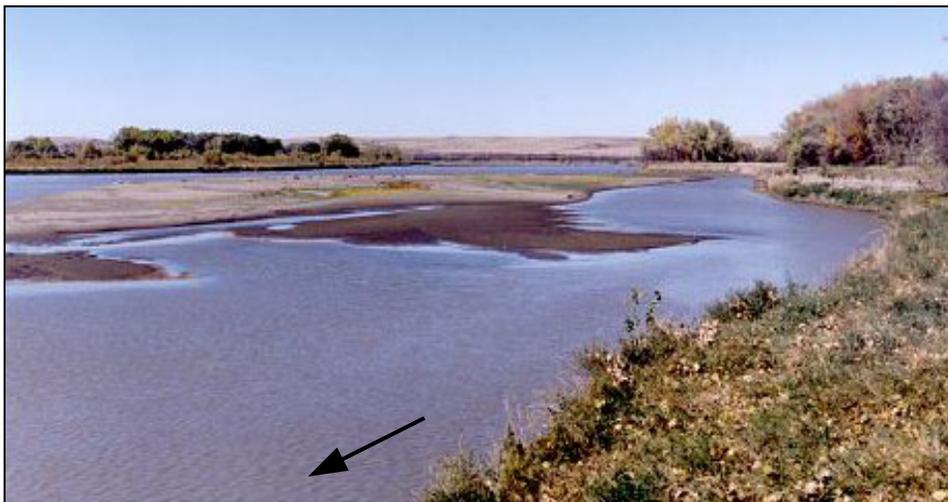
**Figure 22. RM 1646, Mattelin site.**

This site comprises a comparatively straight segment of river with two subchannels around several medial bars (Fig. 22). The subchannels converge at the downstream end of a large medial bar, then divide into two subchannels a short distance downstream. The north bank of the river is about 10–15 ft high and has been subject to extensive erosion. Four cross sections were selected for monitoring. The general locations and orientations of the cross sections are indicated in Figure 23, an aerial photograph taken in 1983 (USACE-Omaha 1983).

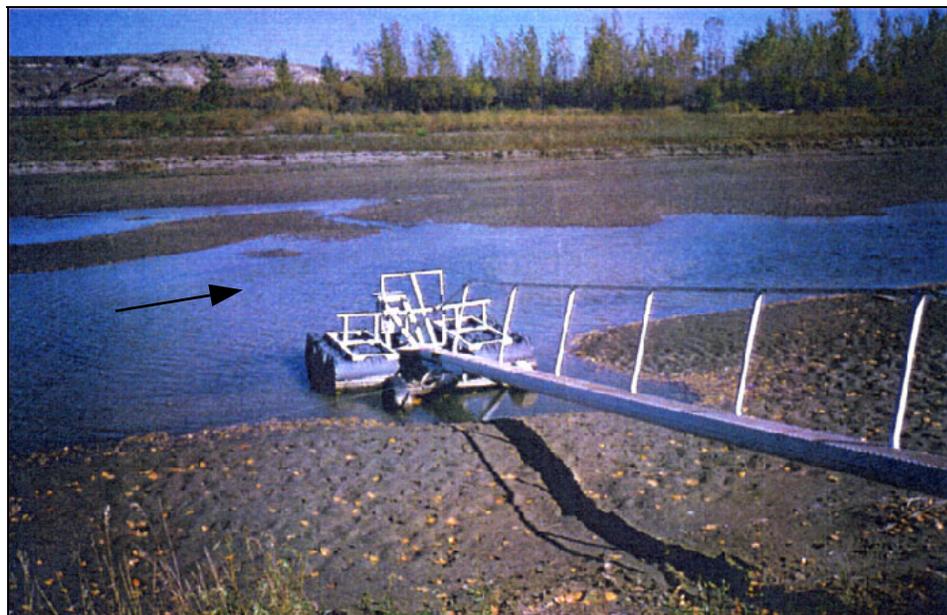
Figure 24. Sediment accumulation at an irrigation pump site near RM 1687, Whitmer site.

This site was observed, but no bathymetry measurements were made. The morphology of the site is similar to the Mattelin and Culbertson sites. As with those sites, an irrigation pump location is being affected by sedimentation (Fig. 24).

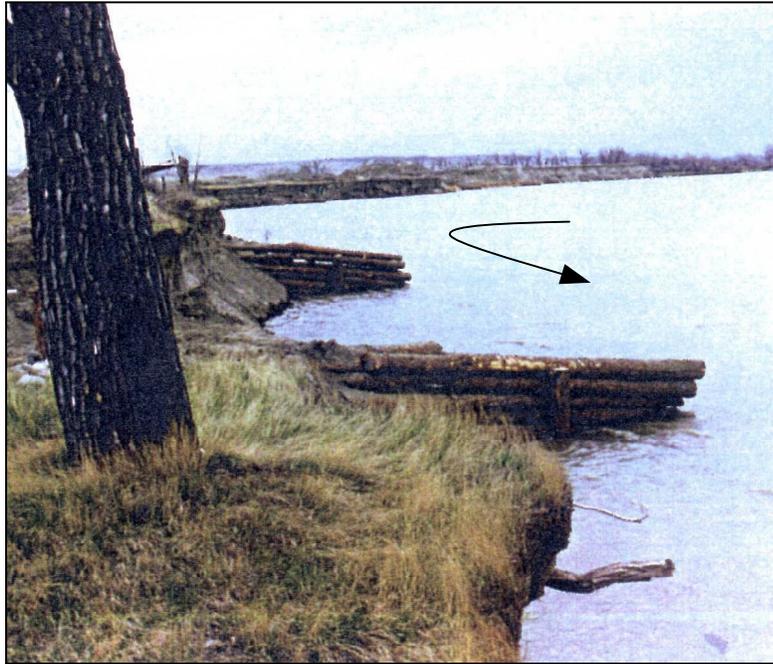
**Figure 25. RM 1716, Pipal site.**

Flow entering this site passes around a large medial bar at the upstream end of the site. The flow then moves in a single channel that curves to form the upstream bend of a meander loop (Fig. 25). The outer bank of the channel bend is about 15–20 ft high and is subject to extensive erosion, with the consequent loss of cropland. The bend's inner bank is lower and, typical of bends in the river, slopes gradually into the river. Four cross sections were selected for monitoring (Fig. 26).

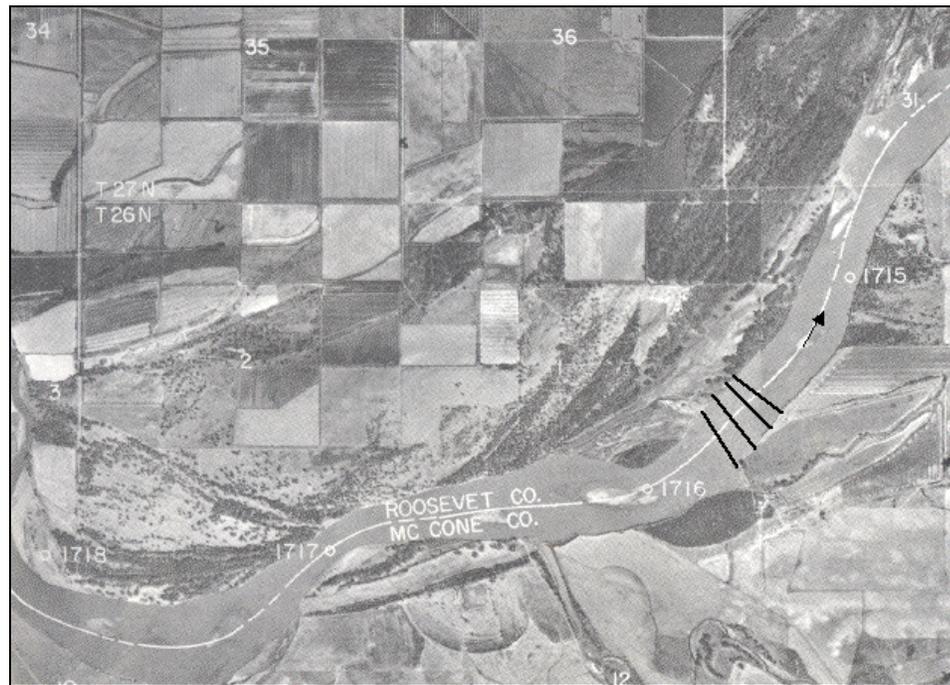
**Figure 26. Survey cross sections near RM 1715–1716, Pipal site. (From USACE-Omaha 1983.)**

This site was selected for monitoring because it would yield insights into ice cover influences on flow distribution and loose-bed bathymetry in a channel bend. As with the Tveit-Johnson and Vournas sites, the Pipal site would be of use in assessing whether and how an ice cover may shift the channel thalweg. Two additional purposes motivated monitoring of this site: the site was well suited for examining how river ice affects bank erosion, and it provided an opportunity to observe how several forms of bank stabilization structures perform in ice-covered flow.

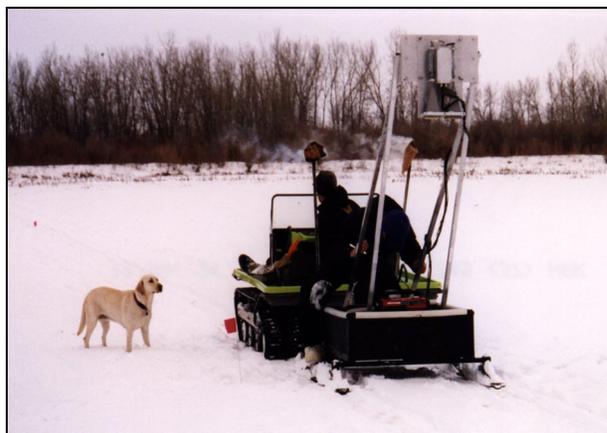
**Figure 27. Sled with microwave radar towed by an all-terrain vehicle.**

At the survey cross sections, a Ku-band radar (18–26.5 GHz) was towed across the ice by an all-terrain vehicle. The radar antenna was mounted on a sled, with the antenna approximately 6 ft above the ice cover (Fig. 27). Radar profiles were made of the ice cover, and the cross-section stations were marked on the

trace for latter verification using ground-truth measurements. The ice cover generally ranged from 8 to 25 in. thick. Adjacent to the bridge piers at the Culbertson site the ice was up to 40 in. thick.

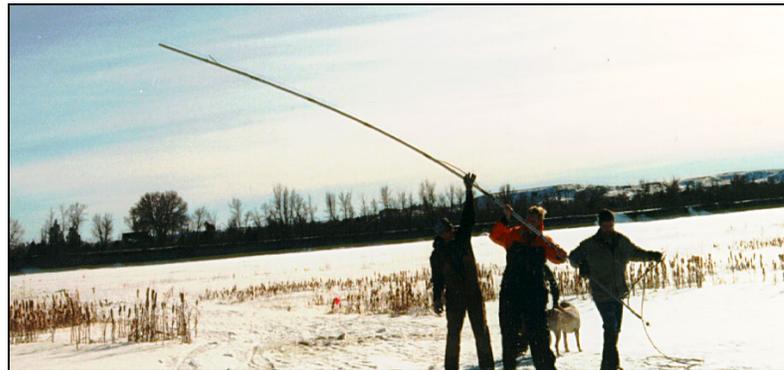
**Figure 31. Velocity profiling.**

Flow velocity was measured using the two-component electromagnetic (Marsh-McBirney Model 511) velocity meter attached to an extendable pole (Fig. 30). Velocity measurements were taken at 19.5-in. incremental flow depths, with the sensor probe oriented such that its X-velocity component was aligned with the survey line. The velocity probe was attached to a series of 3.3-ft-long extension rods that combined to a maximum length of 18.05 ft. For the January survey, 1-in.-diameter fiberglass rods were used, but the assembled rod was too flexible and bent excessively in high-velocity zones. For the February survey, a 1.25-in.-diameter aluminum rod was used; it was considerably more rigid. The rod's maximum length was increased to 21.3 ft, requiring a team to launch the probe for each measurement (Fig. 31).

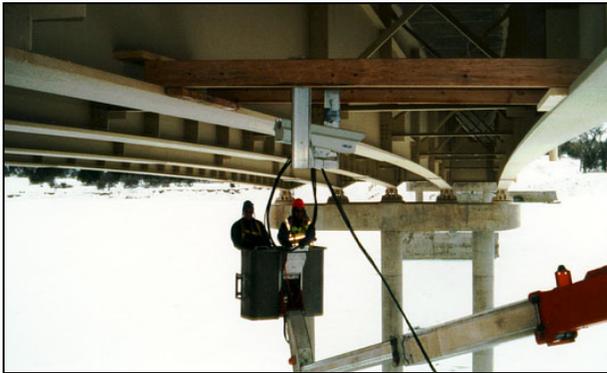
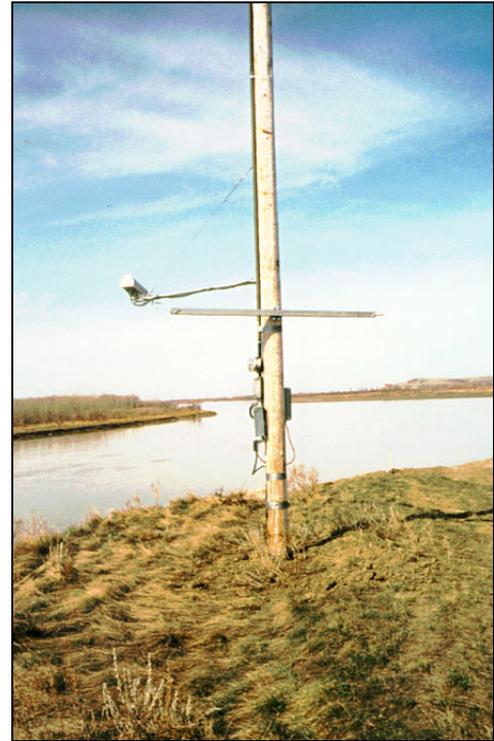
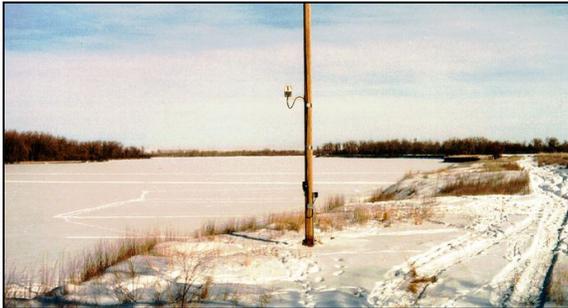
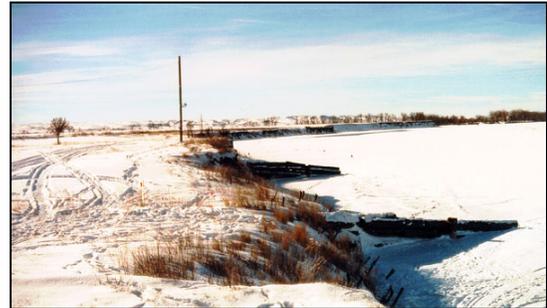
Figure 32. The four web cameras.

a. Culbertson.

b. Tveit-Johnson.

c. Pipal upstream.

d. Pipal downstream.

The digital cameras and environmental housings were installed under the bridge at the Culbertson site and attached to power poles at the Tveit-Johnson and upstream and downstream areas at the Pipal sites (Fig. 32). Digitized images were uploaded to CRREL via phone modems using a hardwired phone line at all the sites, except at the remote Tveit-Johnson site, where a cellular phone had to be used. The cameras and associated hardware were connected to 120-VAC power. Images were automatically displayed on the web site ([www.crrel.usace.army.mil/ierd/scour](http://www.crrel.usace.army.mil/ierd/scour)).

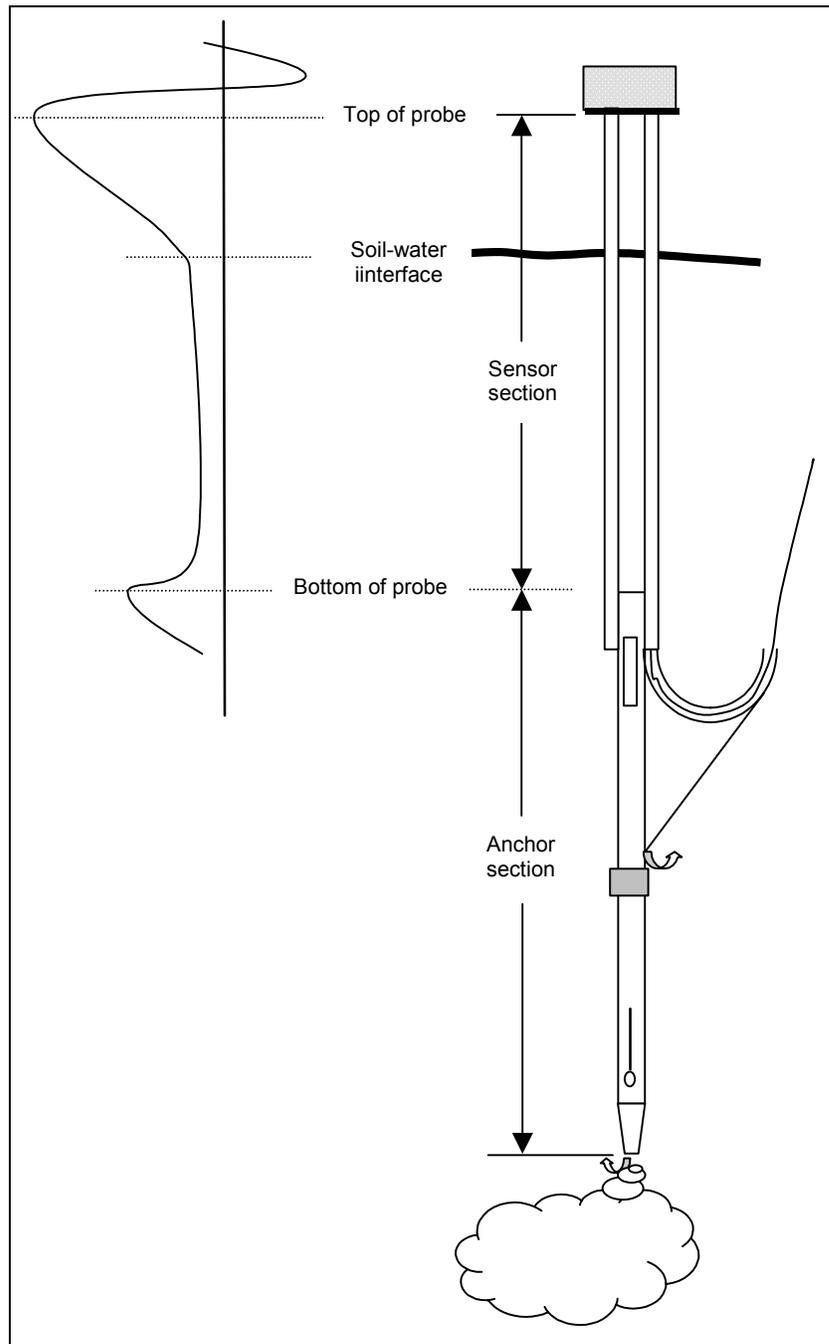
Figure 33. Simulated TDR signal and schematic of probe.

The lower anchoring section laterally stabilizes the probe when bed sediment is eroded, exposing the probe to impacts from bed load material and water pressure. The length of the anchoring section is a function of the requisite lateral resistance of the bed material; it is typically on the order of 7 ft. The coax cable

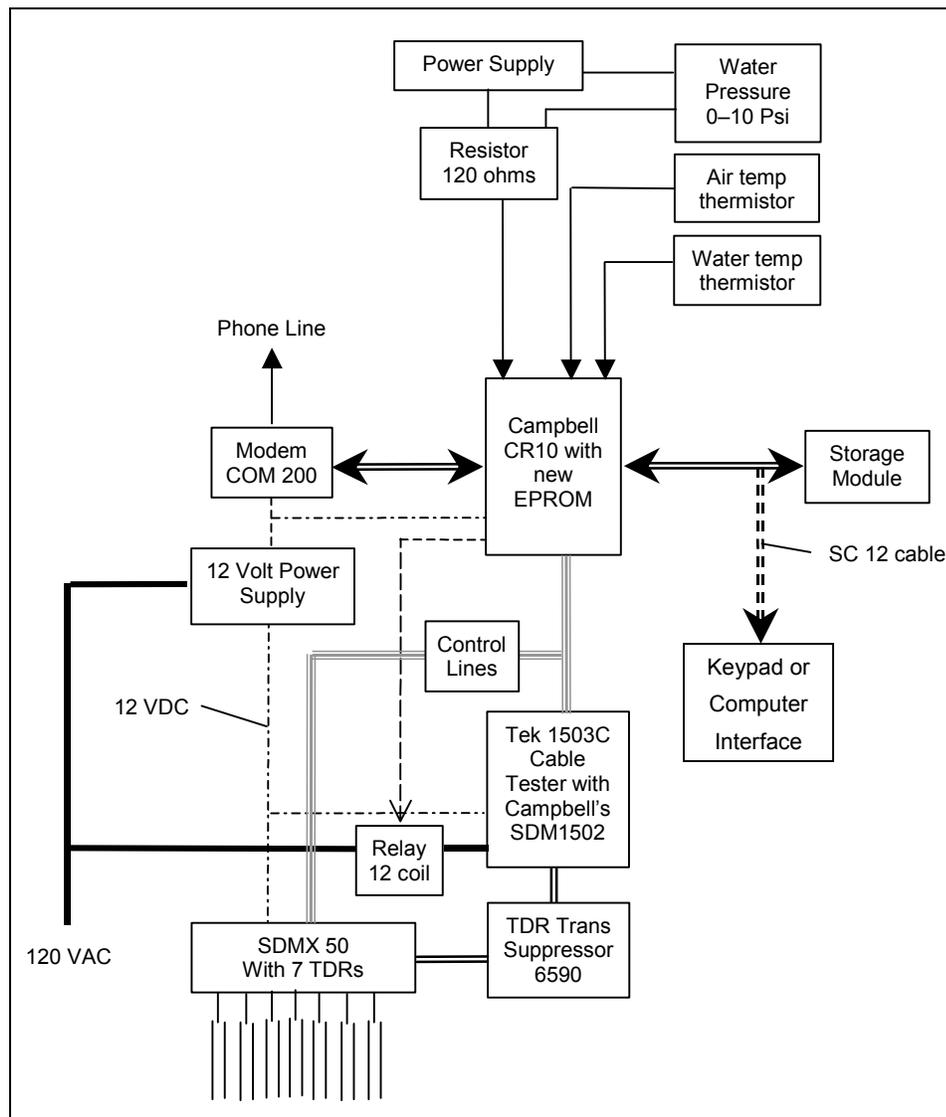
Figure 35. Schematic of the on-shore data acquisition system.

Bed elevations were recorded using the on-shore data collection system shown in Figure 35. The coax cable from each probe was connected to one of eight channels on a multiplexer board. A Campbell Scientific Inc. (CSI) CR10 data acquisition system configured the multiplexer to the desired channel. A Tektronics 1502 generated the electromagnetic pulse, captured the return signal, and used 251 points to digitized the reflected image. The digitized image was read and stored by the CR10 in a local storage module. A computer at CRREL recovered the data daily using a modem integrated into the DAC package.

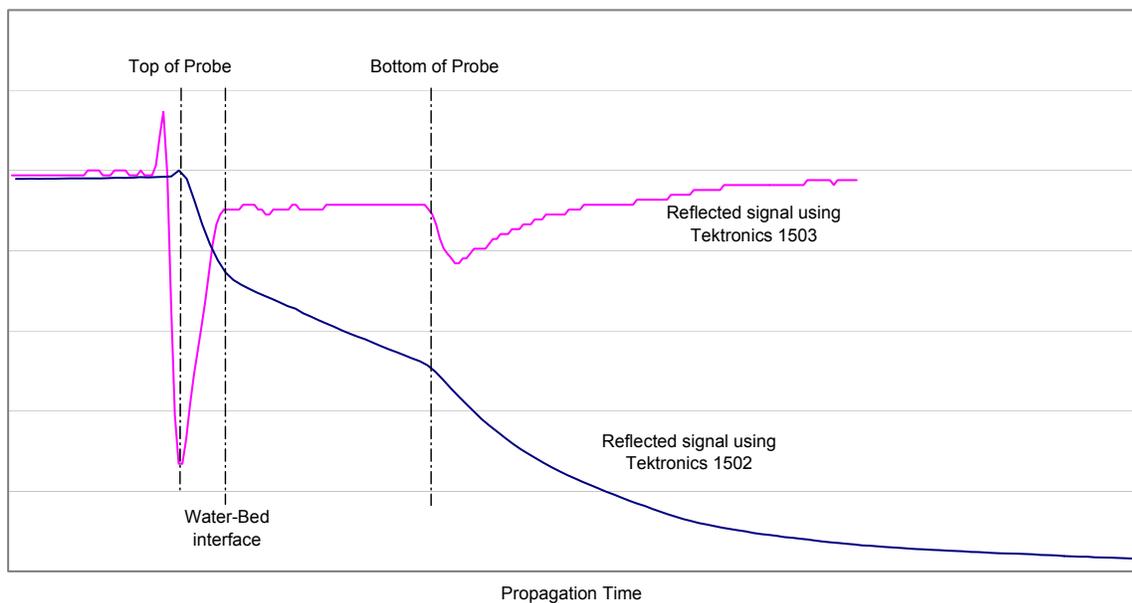
Determination of the distance between the probe top to the water-soil interface at the bed is based on the propagation velocity of the TDR pulse in water.

**Figure 36. Comparison between the reflected signals using a Tektronics 1502 step pulse and a Tektronics 1503 using the impulse signal.**

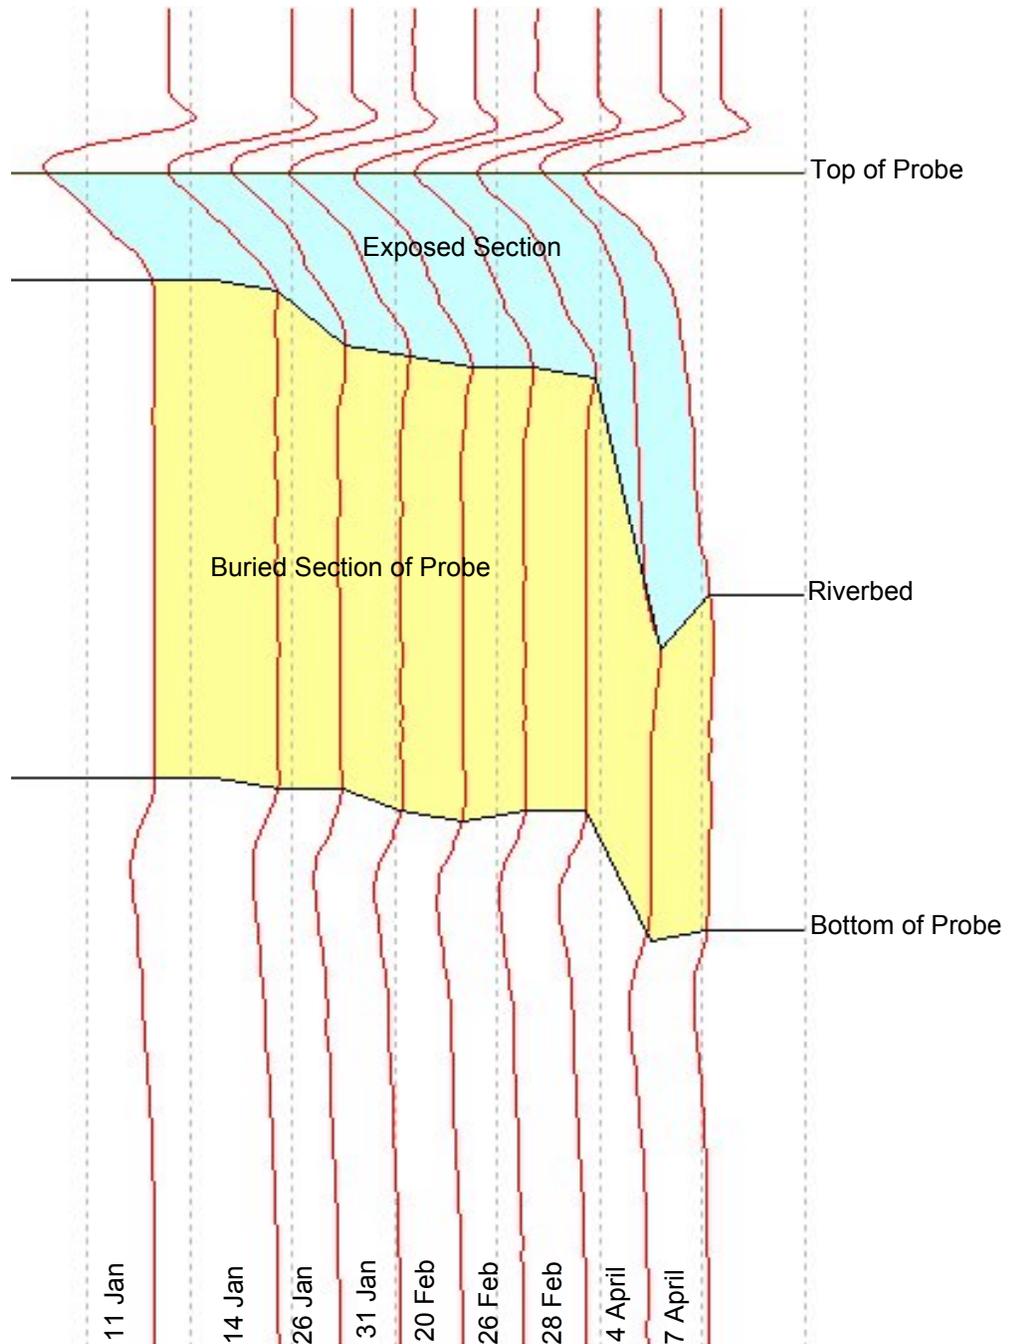
Images from TDR 1, on the north bank of the north channel, using the 1503 for the period 11 January and 7 April are shown in Figure 39. The top of the probe is indicated by the signal fluctuation at the top. The water–sediment interface appears as a change in slope, with the end of the probe appearing where the signal returns to its nominal value. The upper shaded area on Figure 39 represents the distance between the top of the probe and the water–sediment interface, or the riverbed. The depths of erosion and redeposition were computed using the propagation velocity in water, which is slower compared to that of the sediment. Consequently, as more of the probe becomes exposed to the water, the round-trip travel time of the signal also increases. This increase makes the probe “electrically longer,” causing the inflection representing the bottom of the probe to shift down. Because of the differences of the velocity of propagation, the implied scale in the exposed region of the probe cannot be used for determining the depth of sediment around the probe. The exposed/buried length of the probe has to be calculated using eq 6. The accuracy of the TDR in various media is described by Yankielun and Zabilansky (1999).

Figure 39. Waterfall plot of images from TDR 1 captured using the 1503.

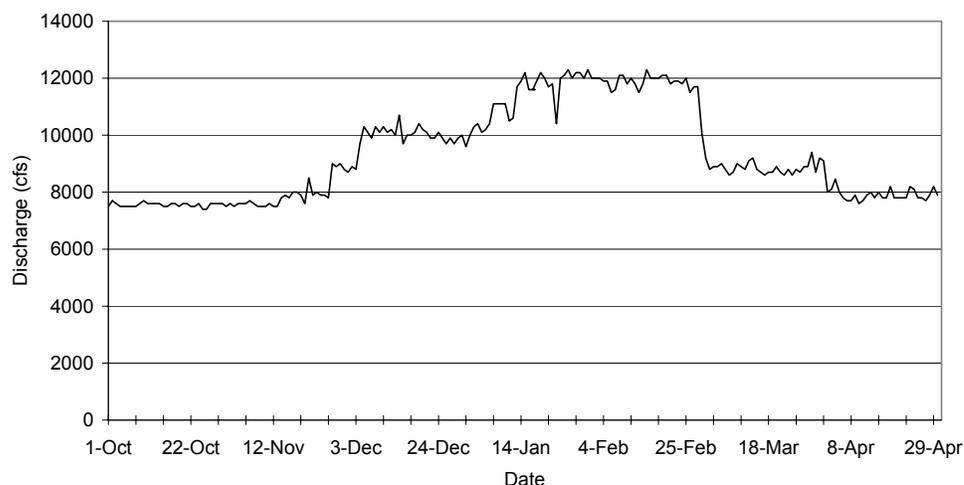
The weather and flow conditions were conducive for conducting the bathymetric surveys, which could be carried out on the scheduled dates. Flow conditions in the reach essentially were in accord with the CWCP schedule for flow release from the Fort Peck Dam and are typical of the winter flow regime for the river (Fig. 40).

**Figure 40. Discharge from the Fort Peck Dam, 1 October 1998 to 1 May 1999.**

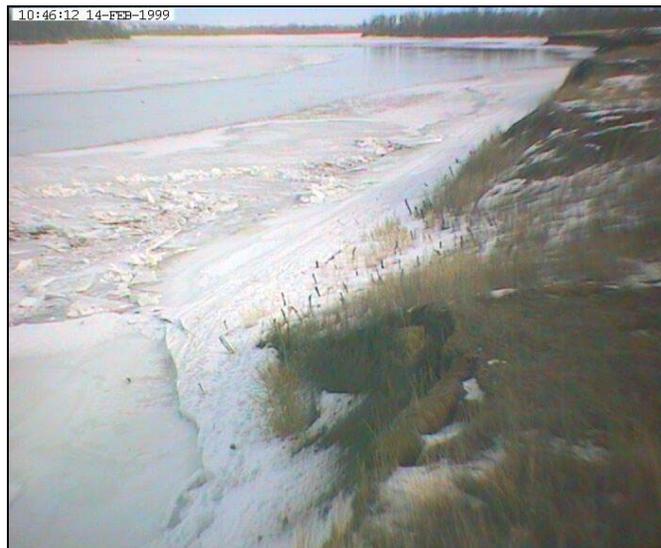
The ice cover broke up along the Fort Peck reach during late March. It had broken up about one month earlier at some upstream sites; for example, at the Pipal site the ice cover broke up in mid-February during a brief period when the air temperatures were close to 30°F and the warm water released from the dam progressed downstream, melting the ice cover. The ice conditions at 1400 on February 14 in the downstream reach of the Pipal site are shown in Figure 42. The warm water followed the thalweg, melting out the ice in the channel area. As channel area opened up, ice would break off the shoreline and migrate downstream. Similar breakup occurred at the other sites. Figure 43 is from the Culbertson camera at 0900 on March 17.

**Figure 42. Early stage of breakup in the downstream reach of the Pipal site on 14 February 1999.**

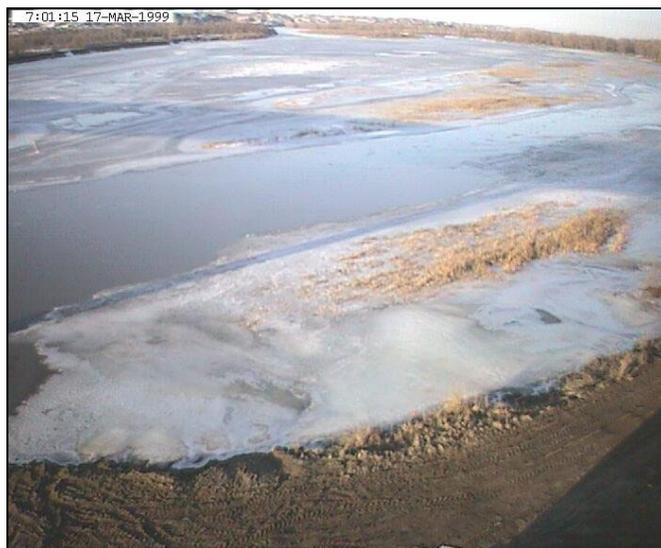
**Figure 43. Ice conditions at the Culbertson site on 17 March 1999 in the early stages of breakup.**

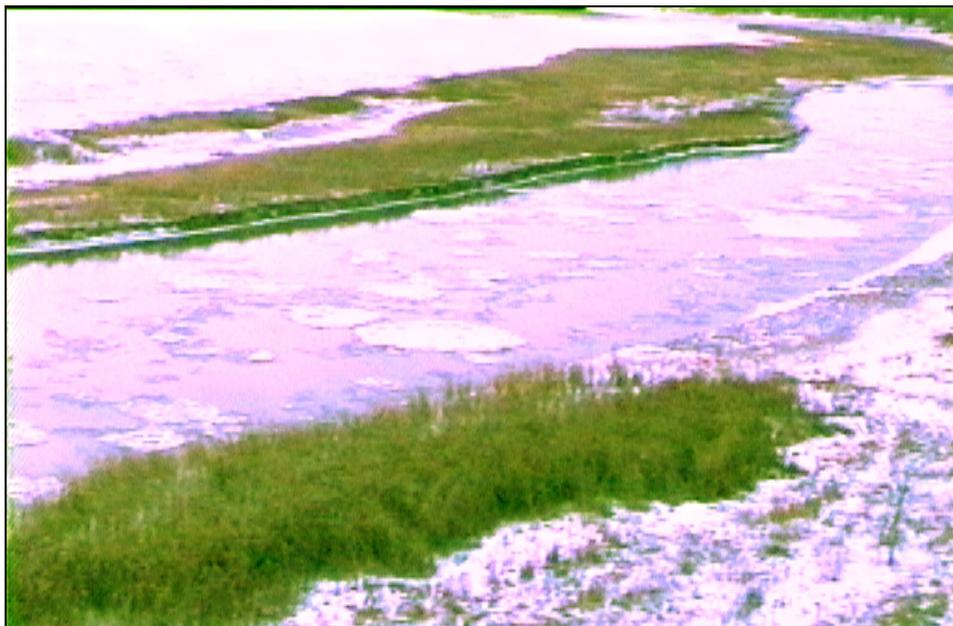
Figure 45. Culbertson site during freeze-up prior to the ice arching across the north channel (view from north bank with flow right to left).

The most evident influence of ice cover formation was a shift in the alignment of the river’s main thalweg from the south subchannel to the north subchannel. Drifting ice accumulated first at, and then bridged across, the upstream end of the north subchannel. Over time a relatively smooth ice cover formed thermally on the remaining length of the north subchannel. The initial accumulation of ice at the upstream end of the north subchannel deflected a subsequent heavier drift of ice, which moved into and packed thicker in the south subchannel. Figure 45 was taken as the ice was thickening in the south channel and the ice was starting to arch across the entrance to the north channel. The sequence of photos in Figure 46 shows the site before ice cover formation, once the ice cover had formed, in mid-winter, during breakup, and after the ice cover had broken up and departed the site. The photographs show that, once the ice cover had departed, the north subchannel had enlarged at the expense of the south subchannel. A small, vegetated medial bar in the north subchannel was completely eroded, and a new medial bar had formed in the south subchannel.
