# **Survey of River Ice Influences on Channel Bathymetry Along the Fort Peck Reach of the Missouri River, Winter 1998–1999**

Leonard J. Zabilansky, Robert Ettema, James Wuebben, and  
Norbert Yankielun

September 2002

Technical Report  
ERDC/CRREL TR-02-14

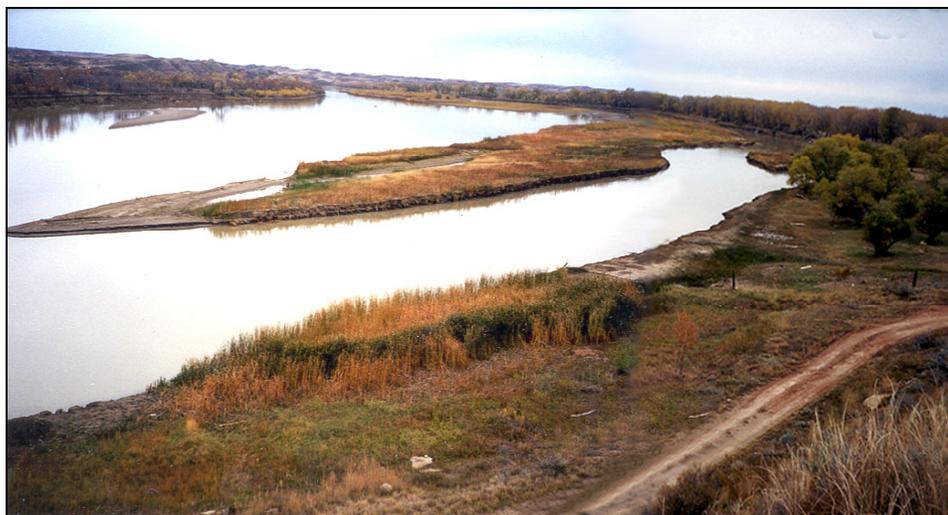
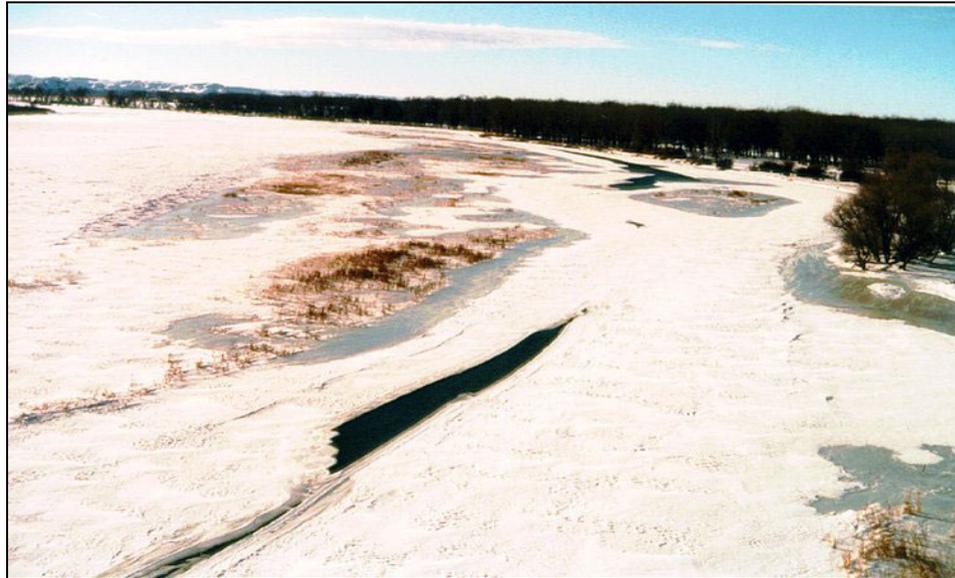
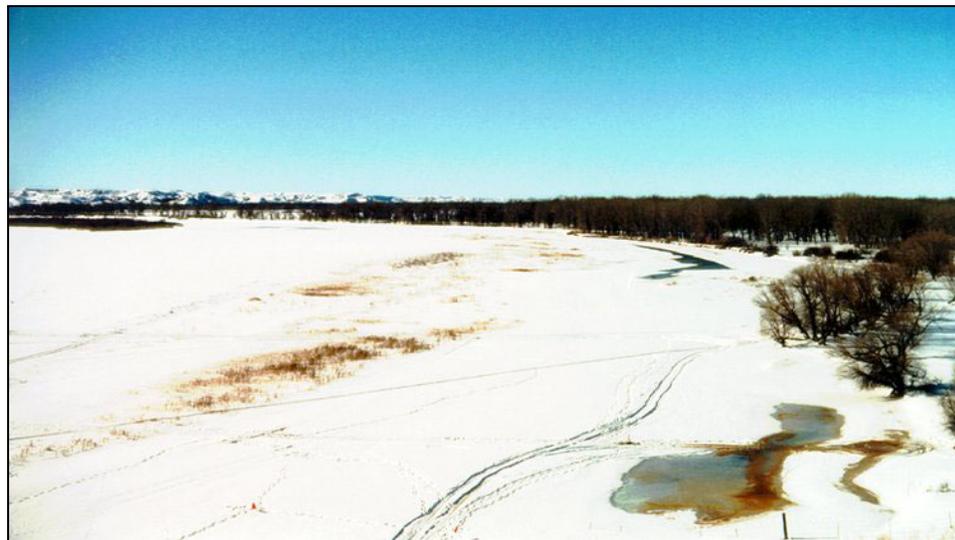
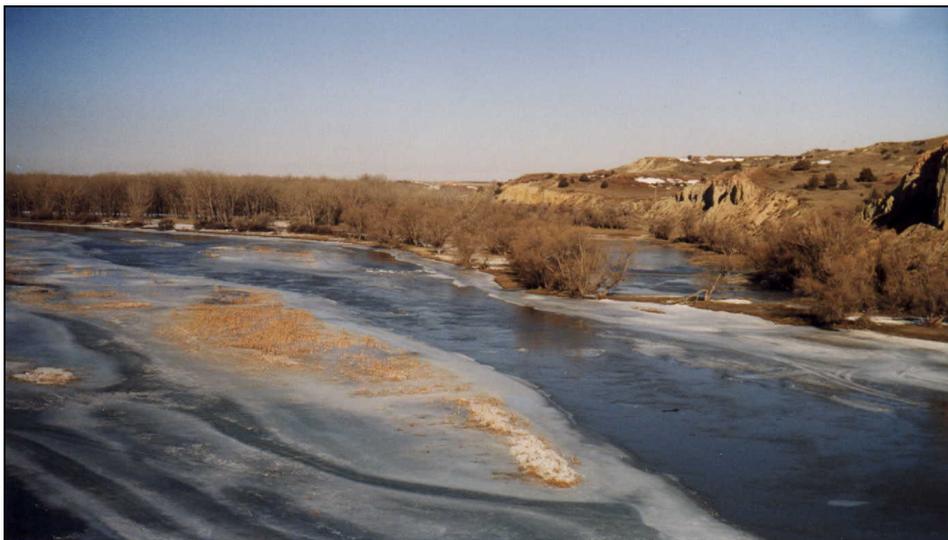
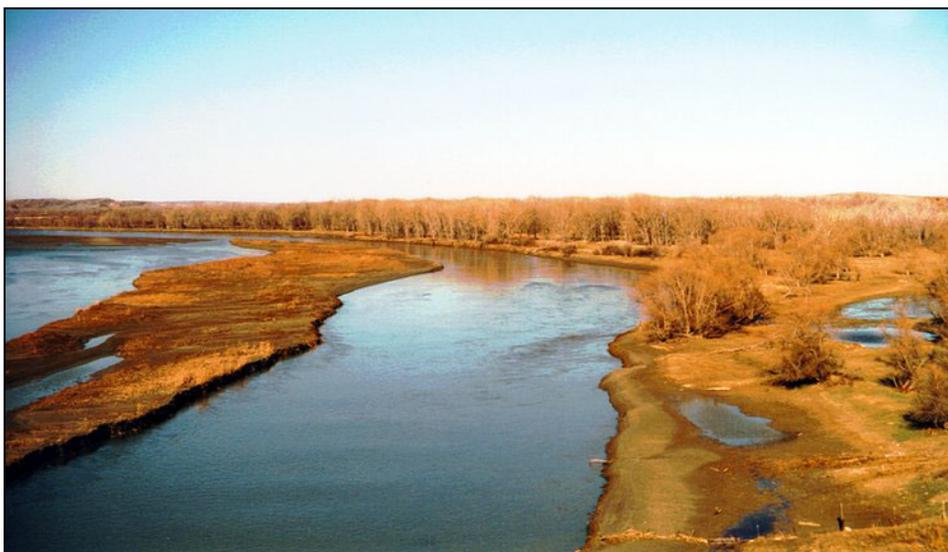
Figure 46. Culbertson site during the survey.

a. 14 October 1998 (view from the north bank with the flow from top to left side).

**b. 26 January 1999 (view from the north end of the bridge with the flow from top to lower left).**

**c. 23 February 1999 (view from the north end of the bridge with the flow from top to bottom).**

**d. 17 March 1999 (view from the south end of the bridge with the flow from left to right).**

**e. 4 April 1999 (view from the north end of the bridge with the flow top to bottom).**

The cover was thinnest (about 8 in.) where the flow was deepest and the flow velocities were greatest; these locations typically were the last to freeze over, primarily along the thalweg in the north channel (Fig. 46b, c and Fig. 47). The cover was thickest where it formed as bankfast ice over the bar (up to 35 in.) between the two subchannels and around the bridge piers (about 40 in.) as ice was incrementally thickened by a cyclic flooding–freezing process.

Reduced flow velocities in the south subchannel appear to have resulted in sediment deposition along much of that subchannel. Such sediment deposition would have further increased the flow resistance through the south subchannel. The amount of deposition was substantial—about 8 ft along the south subchannel at RM 1620.45 (Fig. 47). By the April survey the entire subchannel had silted up and a second medial bar had formed (Fig. 46e). At some locations along the

Most of the ice cover at the Culbertson site broke up and departed the site on 17 March (Fig. 46d), leaving no bankfast ice along the channel banks. Ice covers typically break up because of an increase in stage caused by snowmelt and/or rain runoff, but the ice cover at Culbertson warmed, weakened in place, and either melted in place or broke off as a floe and floated downstream. A reading taken 17 days after the ice cover broke up revealed that 2.8 ft of the probe remained exposed. We used eq 6 with the change of the inflection points on the 1503 images to determine the changes in elevation at all the TDR locations (Fig. 50).

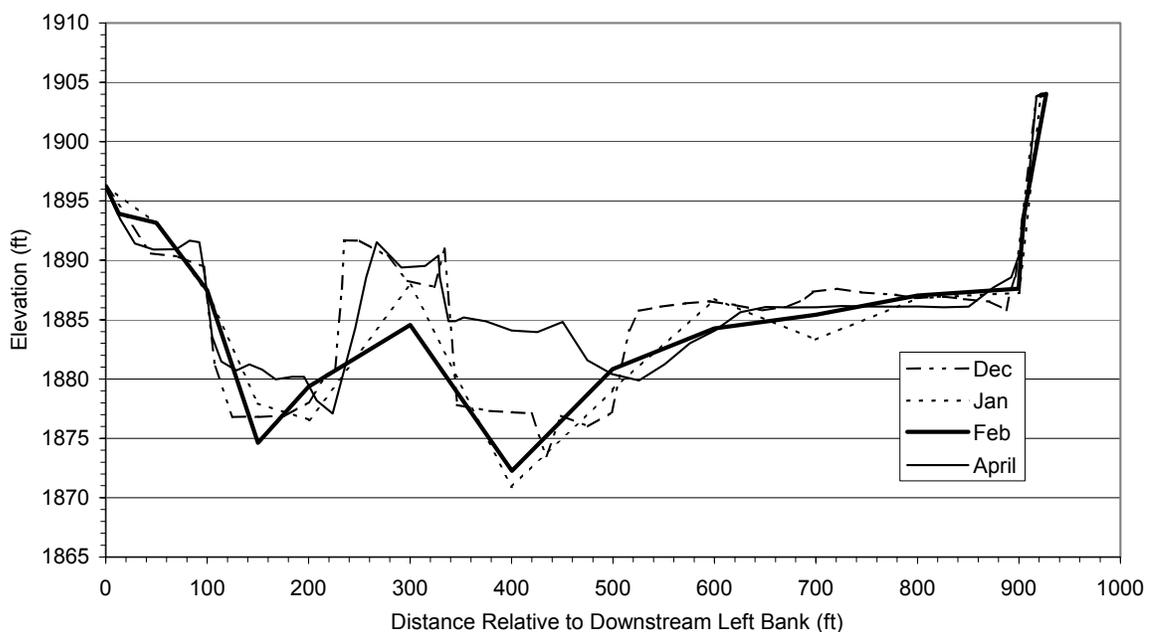
**Figure 47. Bed profiles of cross sections at RM 1620.4.**

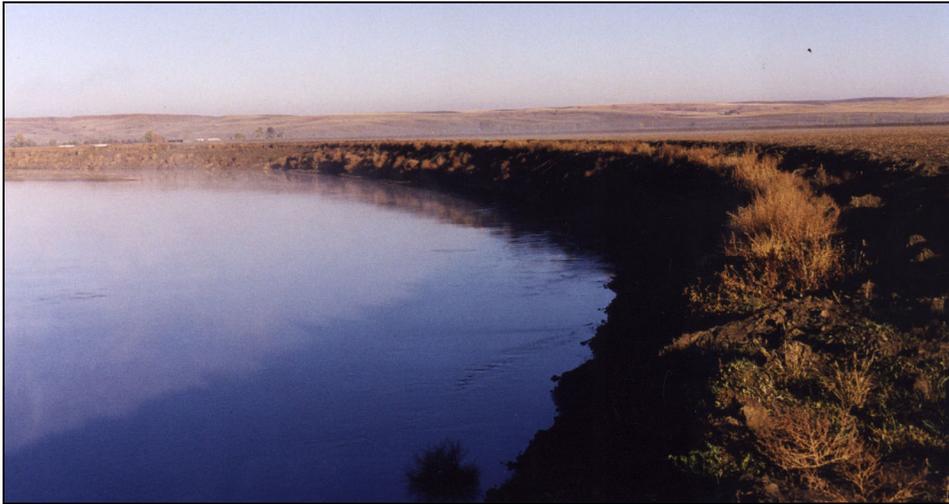
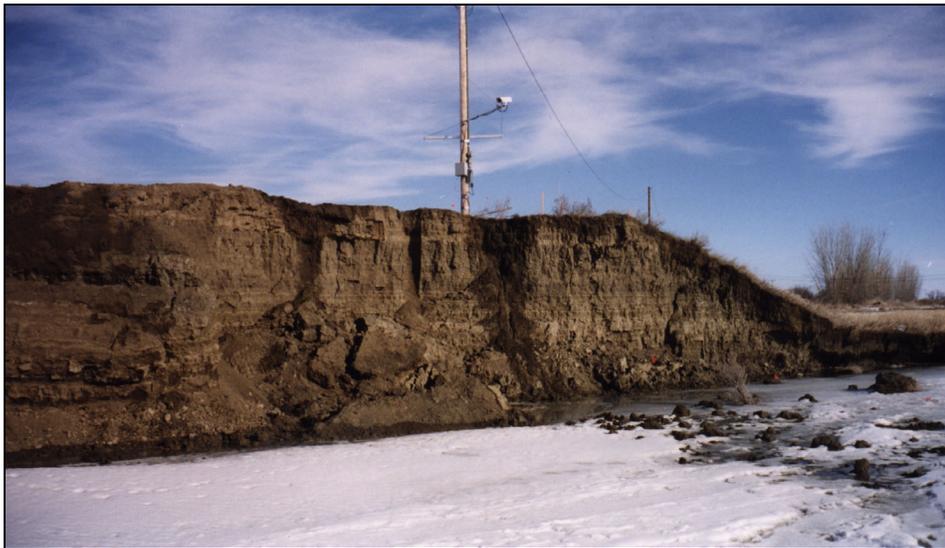
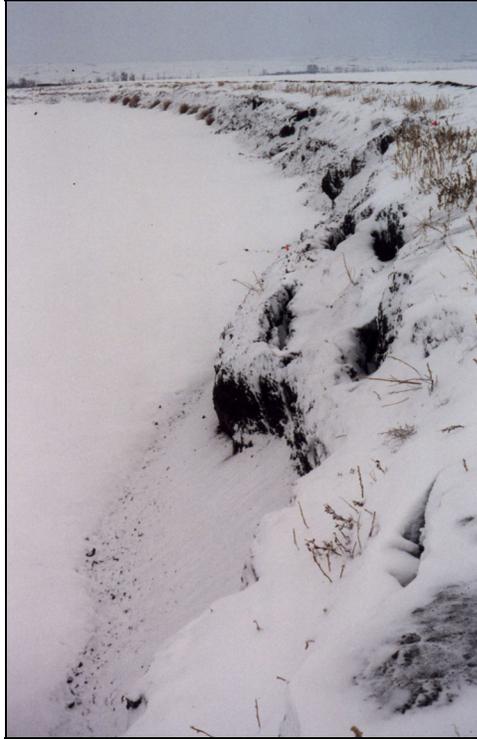
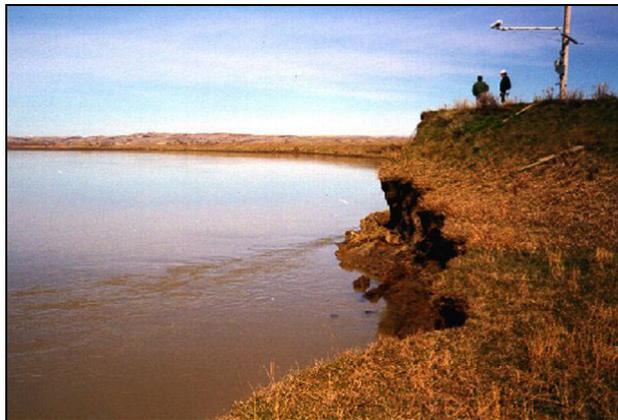
Figure 55. Tveit-Johnson site (RM 1623–1624) during the survey.

a. 14 October 1998 (view from the north bank with the flow from top to bottom).

b. 26 January 1999 (view from the ice looking at the north bank with the flow from left to right).

**c. 21 February 1999 (looking at the north bank with the flow from top to bottom).**

**d. 4 April 1999 (view from the north bank with the flow from top to bottom).**

The Missouri River at this site forms a sinuous loop that is migrating downstream. The principal hydraulic influence of ice cover formation through the site is to aggravate the already unstable alignment of the river's thalweg relative to the north bank. The bank's migration is hastened because the river's thalweg is not aligned with the bank but sweeps across the riverbed and impinges against the north bank, as is evident in Figure 18, which shows the site during open water conditions. Figure 55 shows the site prior to ice cover formation, following freeze-up, during ice cover formation, and after ice cover breakup.

Observations suggest that river ice formation accelerates the downstream migration of the meander loop, apparently by concentrating the flow toward the apex of the loop's eroding outer bank. Flow velocities along the bank's toe are increased, as is erosion of bank toe material.

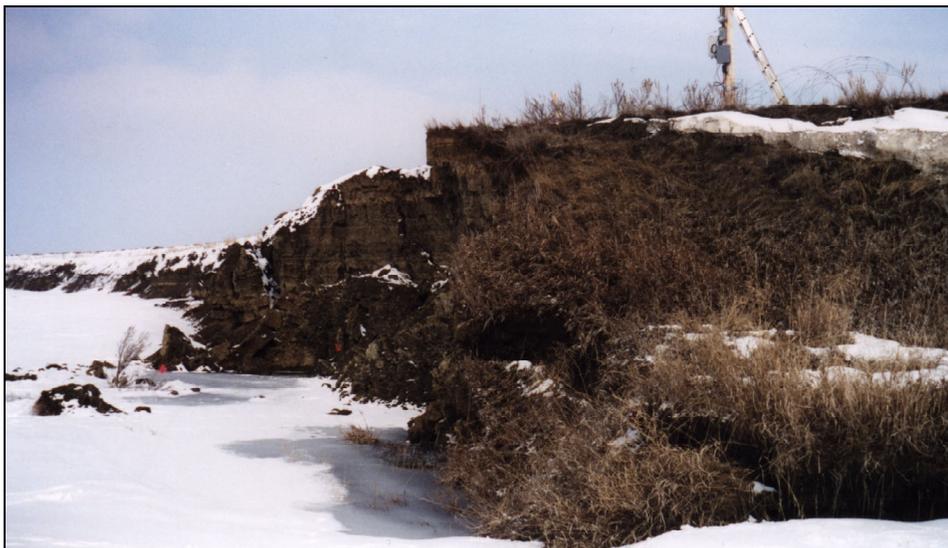
**Figure 56. Collapsing north bank at RM 1623.**

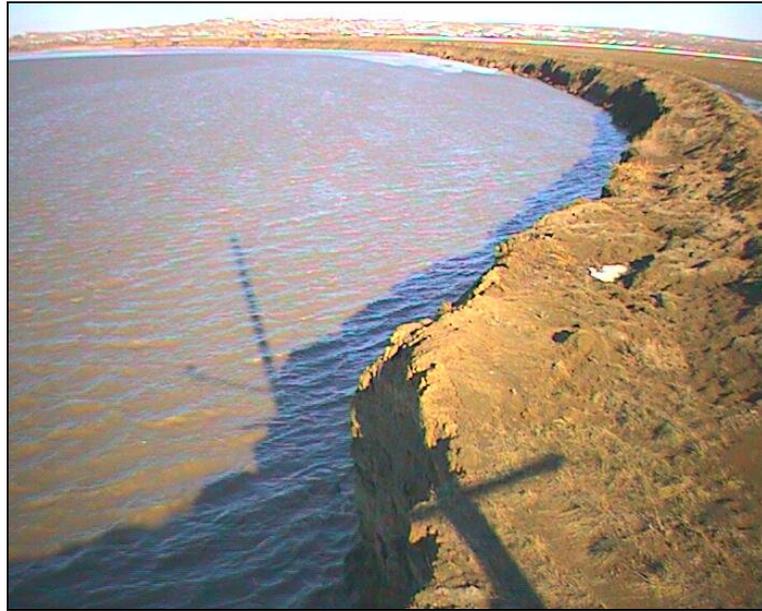
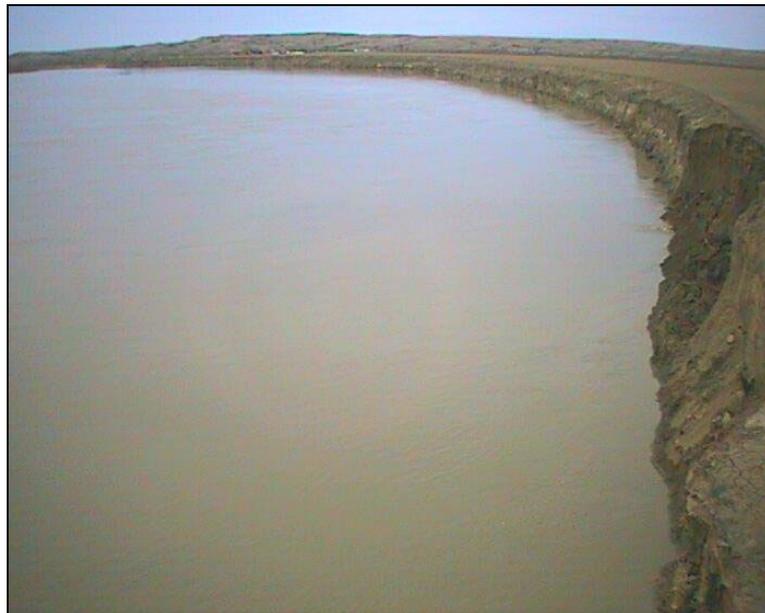
**a. March 17, immediately following ice out (March 16).**

**b. March 30, prior to relocating the camera pole.**

**Figure 57. Change in the north bank position following breakup.**

The last image from the web camera on March 16 shows that the ice cover was intact but that water was beginning to ooze over the ice cover. The following morning the ice was gone (Fig. 57a).

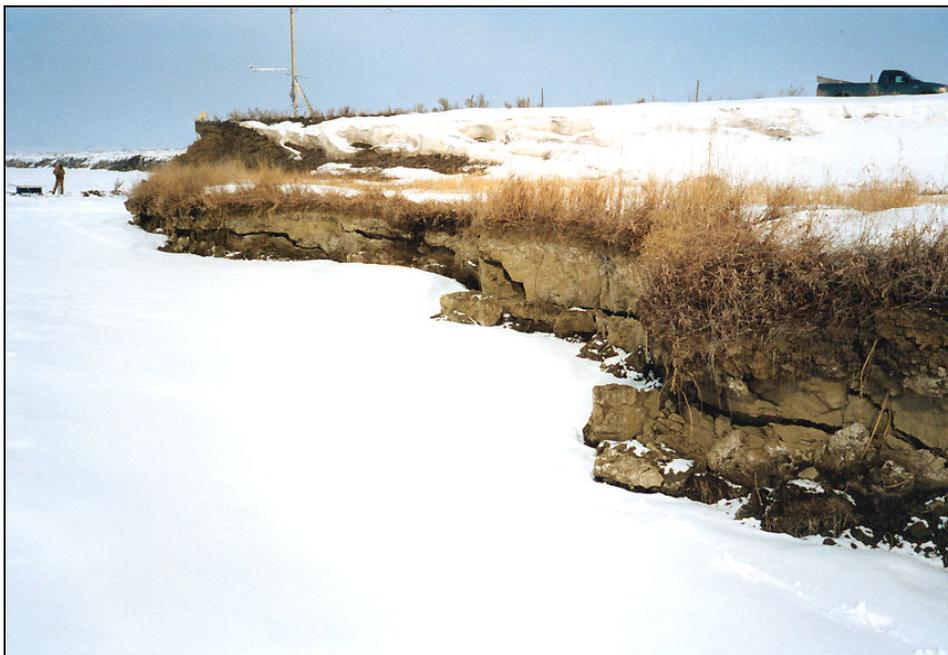
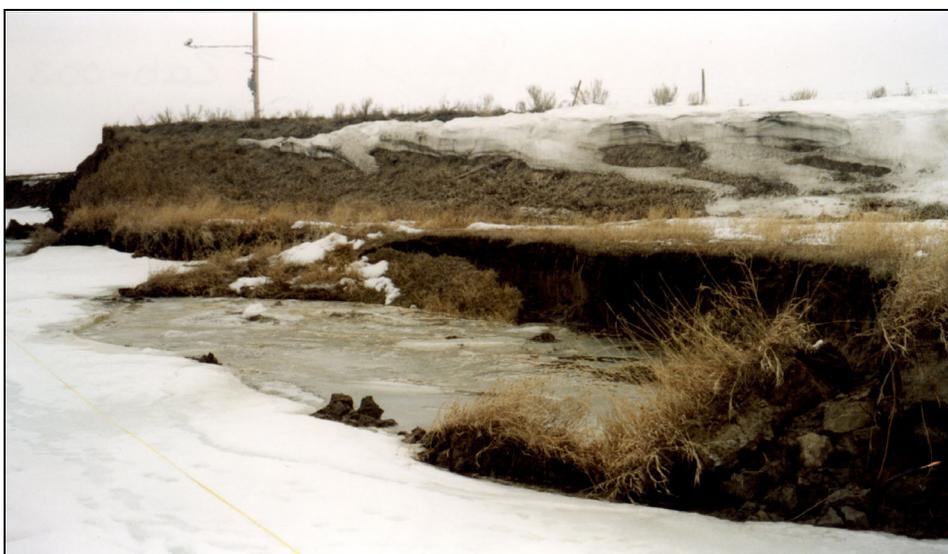
a. 26 January 1999.

b. 22 February 1999.

**Figure 58. Crack and ultimate riverbank failure above bankfast ice, RM 1623–1624, Tveit-Johnson site.**

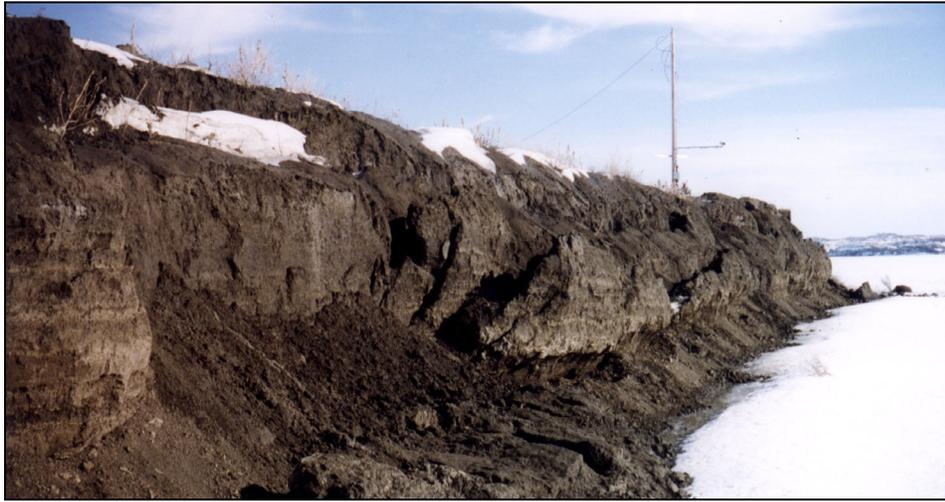
**Figure 61. North riverbank gradually tilting and failing, RM 1623, 21 February 1999.**

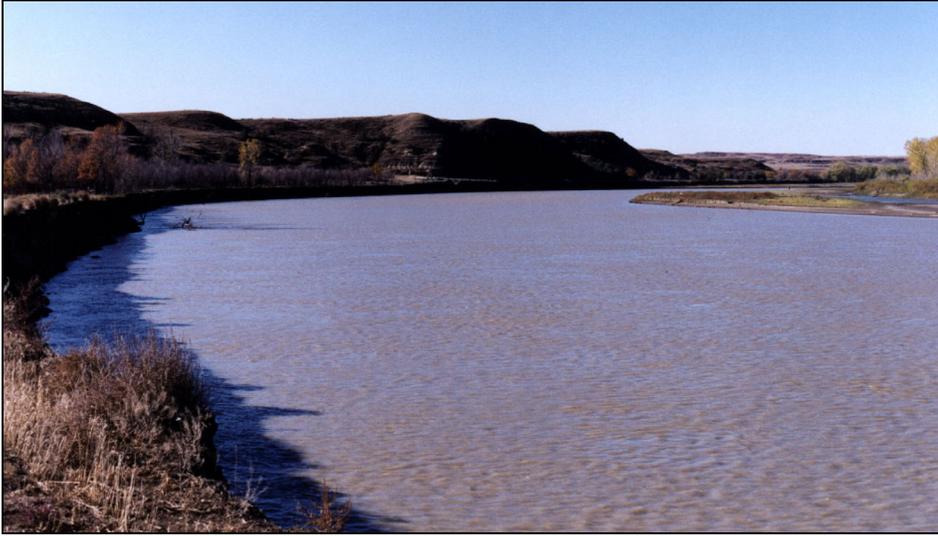
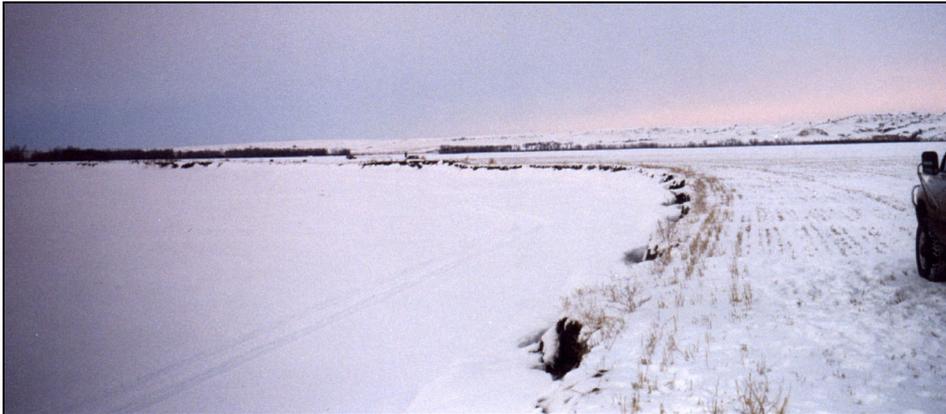
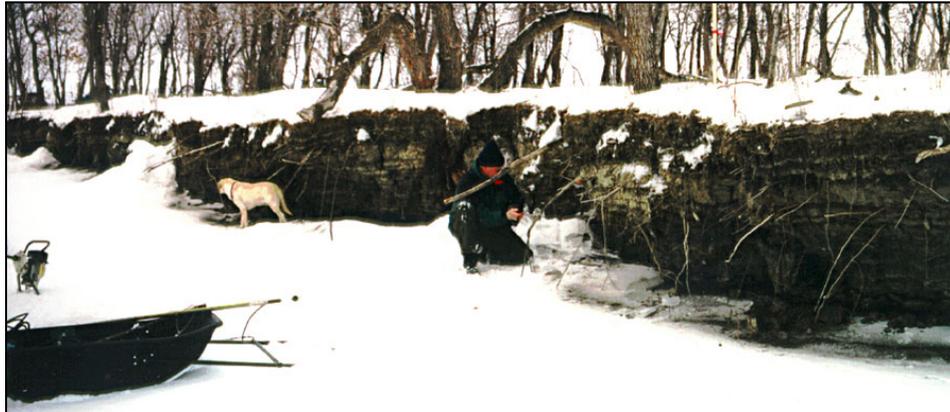
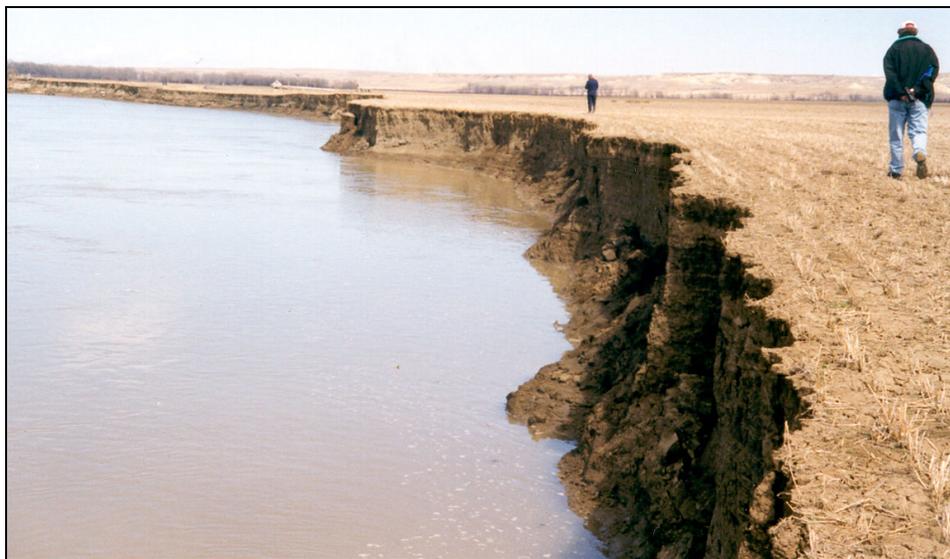
**Figure 62. Vournas site (RM 1631–1632) during the survey.**

**a. 14 October 1998 (view from the south bank with the flow from top to bottom).**

**b. 26 January 1999 (view from the south bank with the flow from bottom to top).**

c. 23 February 1999 (view of the south bank from the ice with the flow from bottom right to top left).

d. 4 April 1999 (view from the south bank with the flow from bottom to top).

Figure 62 shows the Vournas site before ice cover formation, following freeze-up, during ice cover formation, and shortly after breakup. Note how ice cover formation raised the flow stage through the site. The outer bank did not collapse while the ice cover was in place, at least not extensively. However, the bed profiles suggest that a localized bank failure may have occurred under the ice cover at the cross section at RM 1632.68.

The major instance of bank failure at the site occurred immediately after the ice cover broke up and was flushed from the site. As the flow elevation dropped, the combined effects of bed scour at the bank toe and weakening of the bank material caused the bank to recede about 3 ft on average. As can be seen in Figure 62d, once the ice cover had departed, the riverbend had migrated farther downstream, so the flow impinged at an awkward angle against the bank.

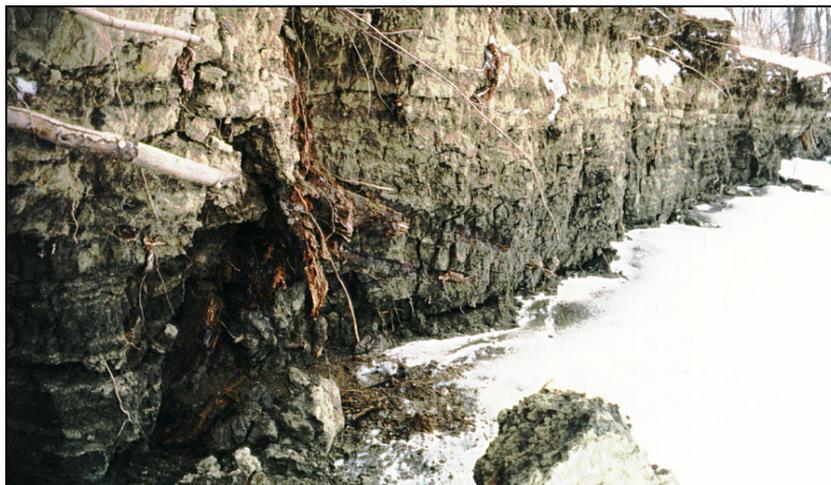
**Figure 63. Crack development in the south riverbank at RM 1632.55.**

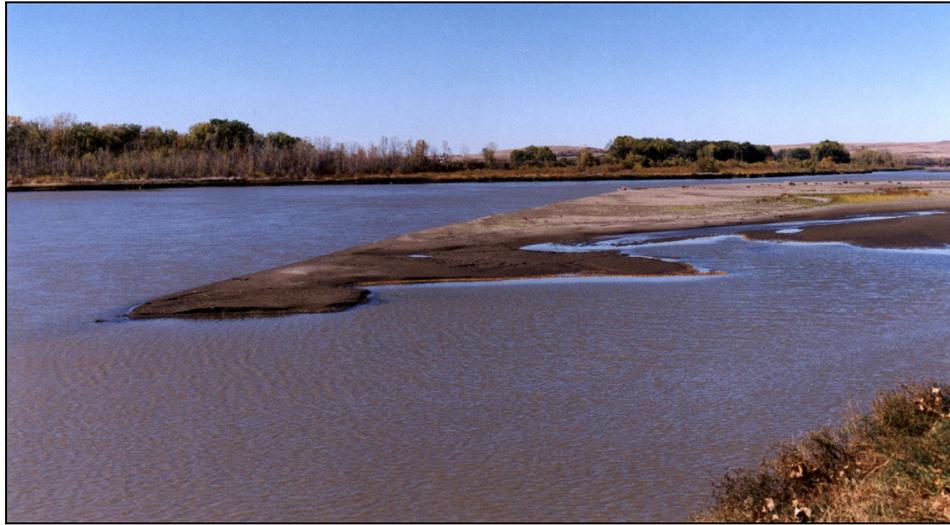
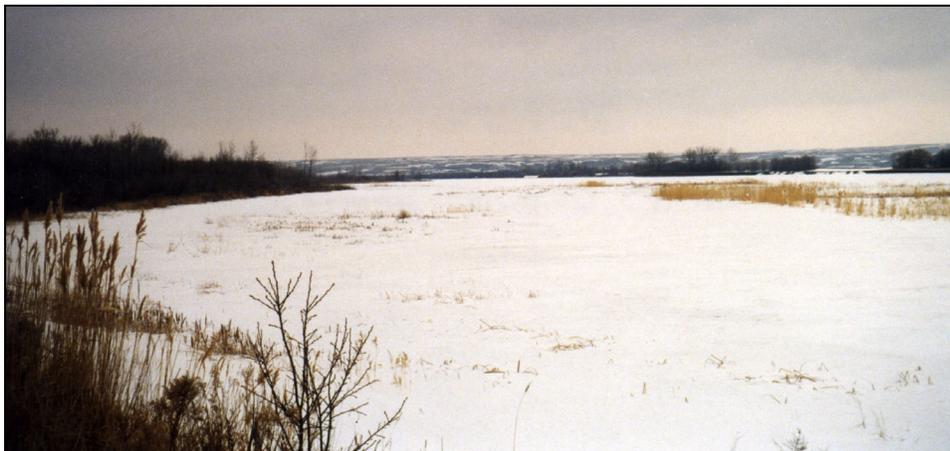
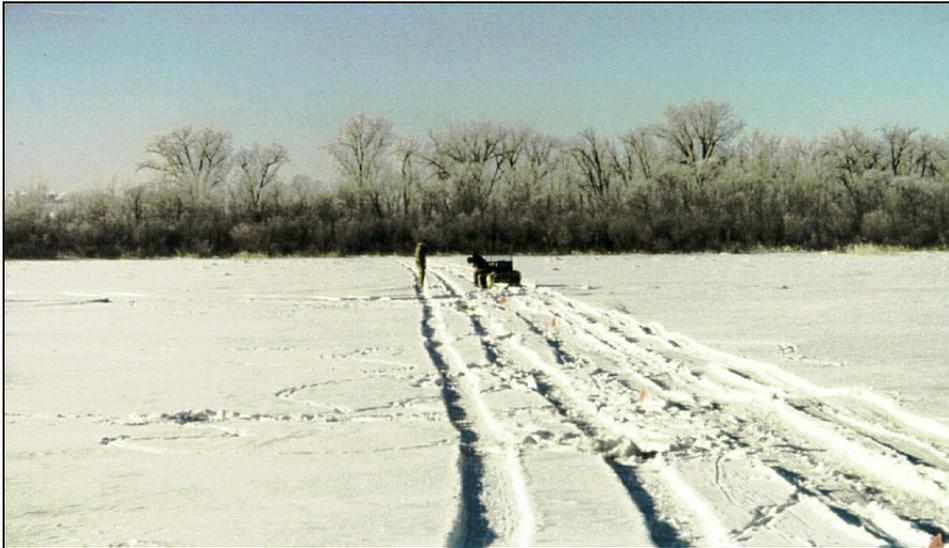
**Figure 66. Mattelin site (RM 1645–1647) during the survey.**

a. 14 October 1998 (view from the north bank with the flow from right to left).

b. 26 January 1999 (view of the south bank with the flow from top to bottom).

**c. 23 February 1999 (view across the upstream survey alignment with the flow from right to left).**

Figure 66 shows the Mattelin site before ice cover formation, following freeze-up, during ice cover formation, and shortly after breakup. It also shows how ice cover formation raised the flow stage through the site. Although cover progression through the site was not viewed directly (there was no video camera at this site), views of the site before, during, and after it became ice covered help

illustrate the changes that occurred in subchannel size and alignment. The size of the extended and expanded south subchannel is especially evident from Figures 66b and c from approximately the same location.

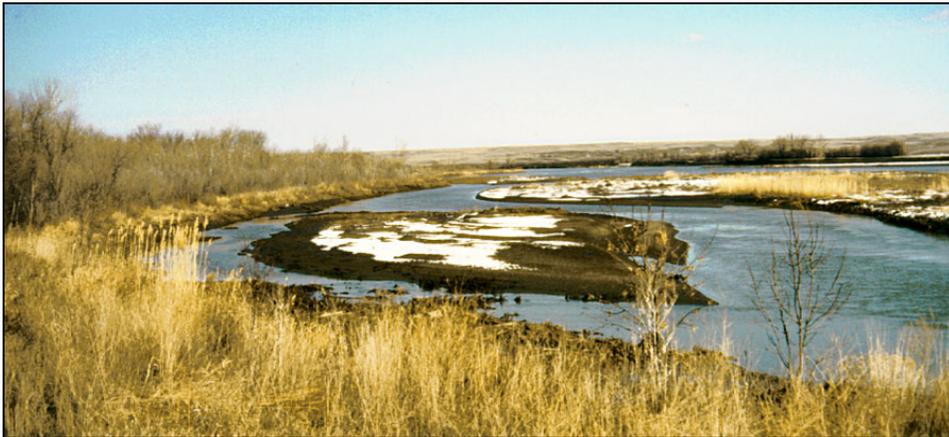
**d. 4 April 1999 (view of the south bank with the flow from top to bottom).**

**Figure 66 (cont.). Mattelin site (RM 1645–1647) during the survey.**

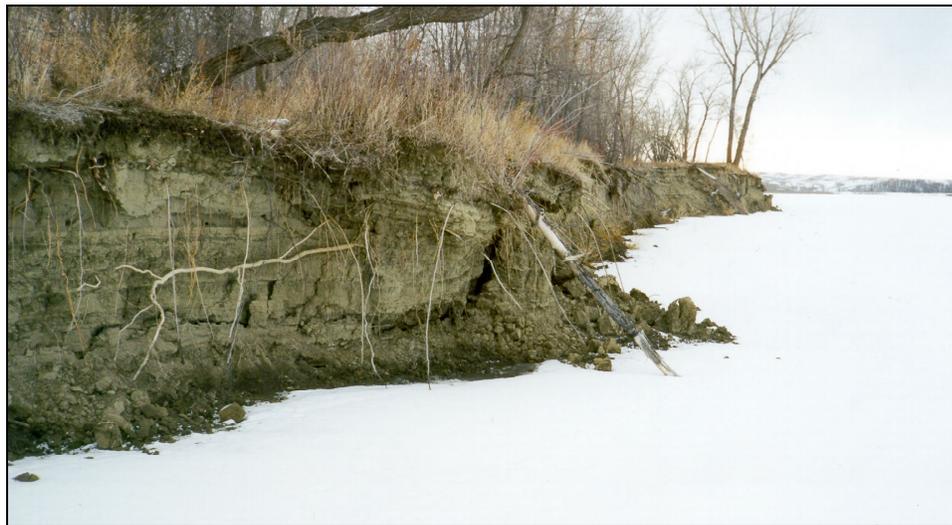
**Figure 69. Soil spalling from the face of the north riverbank at RM 1646.**

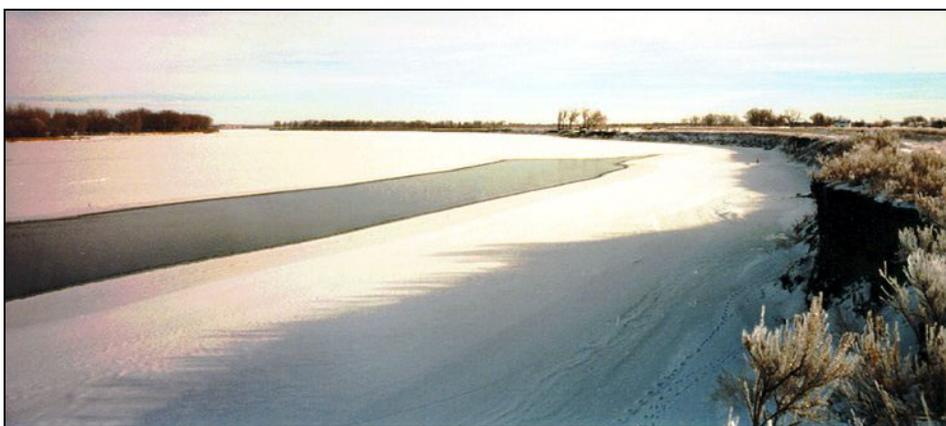
**Figure 70.** Open water area in the lee of a bar at RM 1716 (view of the south bank with the flow from left to right).

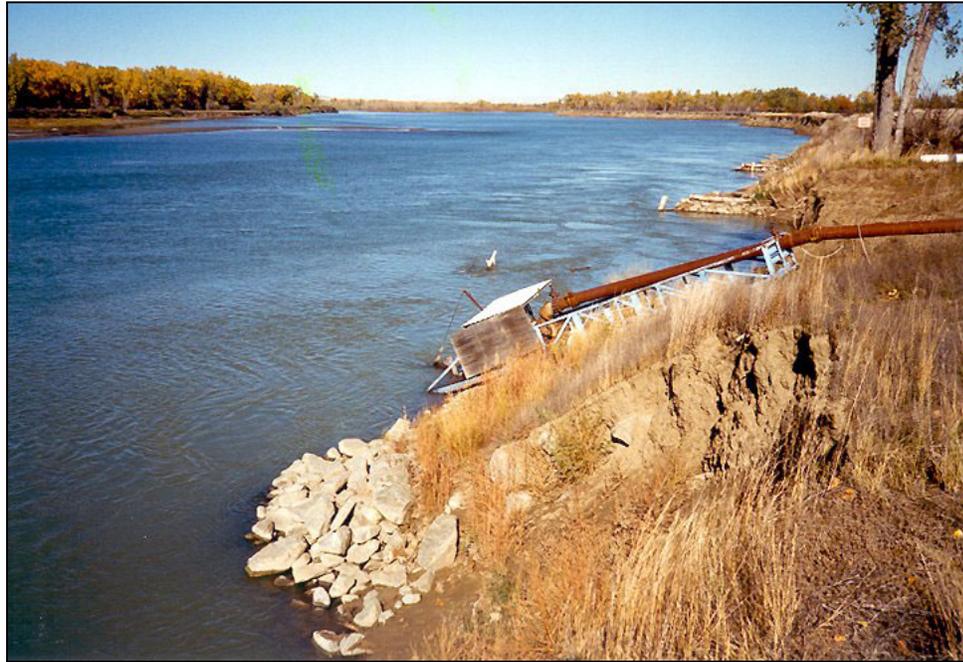
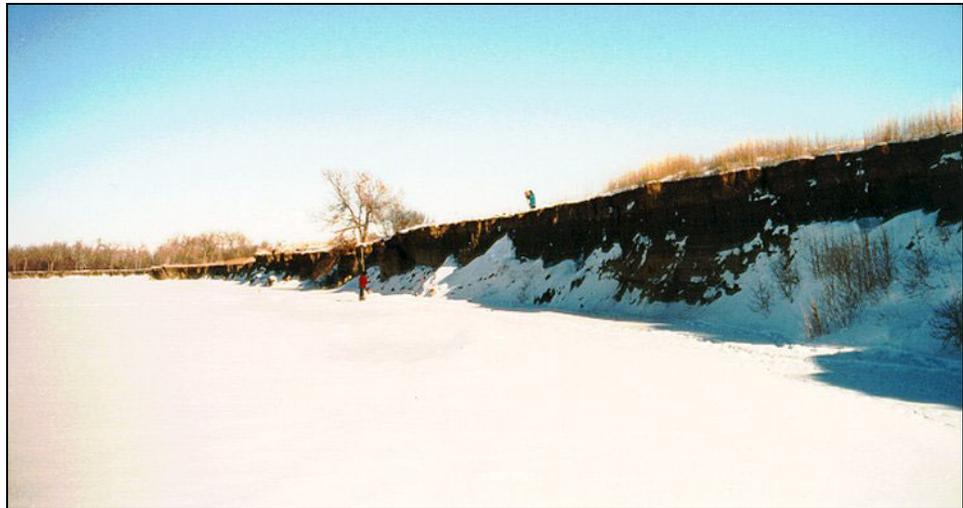
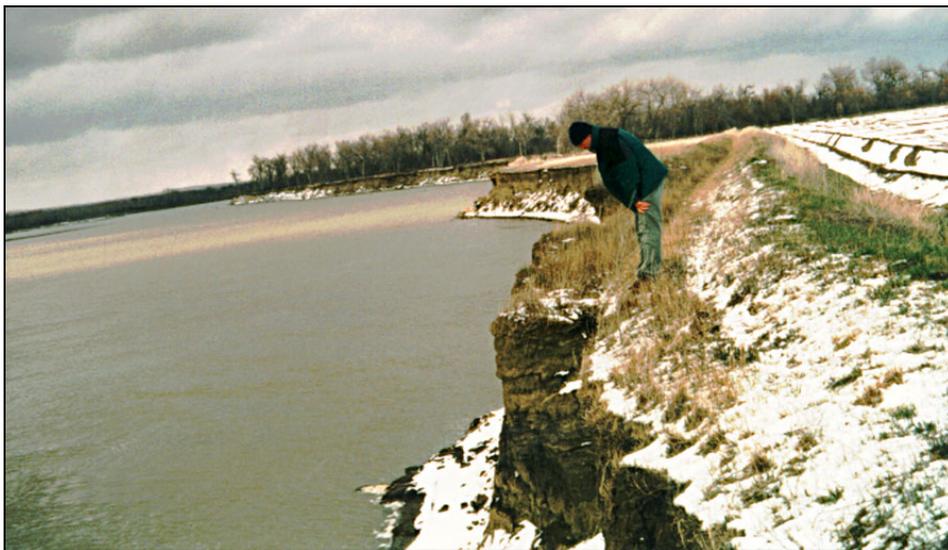
Figure 71. Pipal site (RM 1715–1716) during the survey.

Figure 71 shows the site before ice cover formation, while the site was ice covered, and after the ice cover broke up. The photos show how the additional flow resistance generated by the ice cover raised the flow stage. They also show the resultant shift in the outer bank and the channel thalweg alignment.

a. 14 October 1998 (view from the south bank with the flow from left to right).

b. 26 January 1999 (view of the south bank from the ice with the flow from lower right to left).

c. 4 April 1999 (view of the south bank with the flow from bottom to top).

The ice cover melted in place on the afternoon and evening of 14 February (Fig. 42), earlier than at the four downstream sites surveyed. Cover breakup, however, was accompanied by a major bank failure at the site. With the departure of the ice cover and lowering of the flow elevation, the combined effects of bed scour at the bank toe and bank material weakening caused the bank to recede about 3 ft on average. As can be seen from the view shown in Figure 71c, once the ice cover had departed, the riverbend had migrated far enough downstream so that the flow impinged at an awkward angle against the bank.

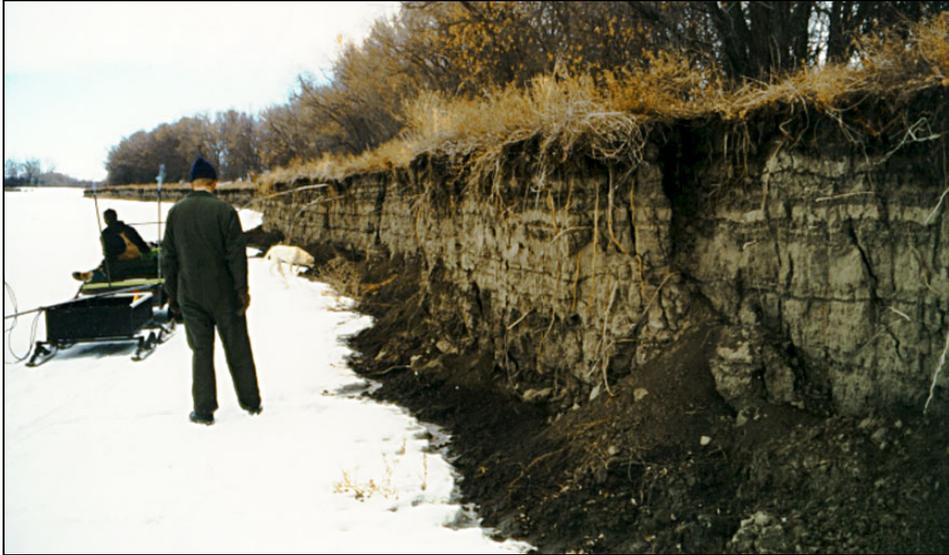
**Figure 75. Failing soil along the bank.**

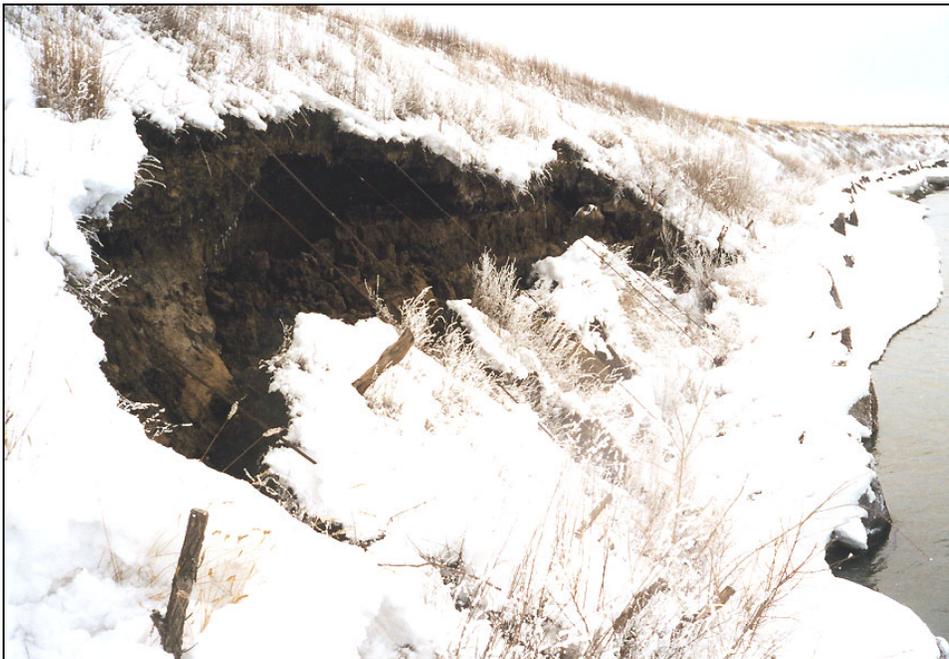
**Figure 76. Riverbank slip at RM 1716.**

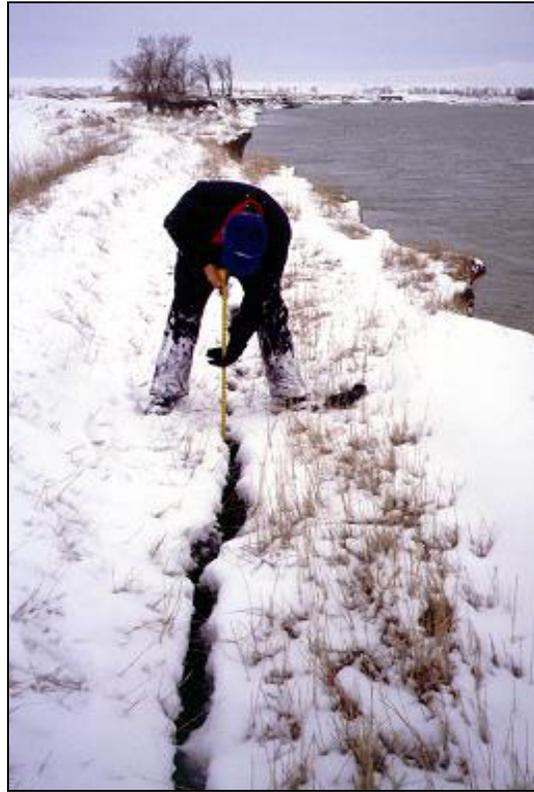
**Figure 77. Crack in the riverbank soil at RM 1715.**

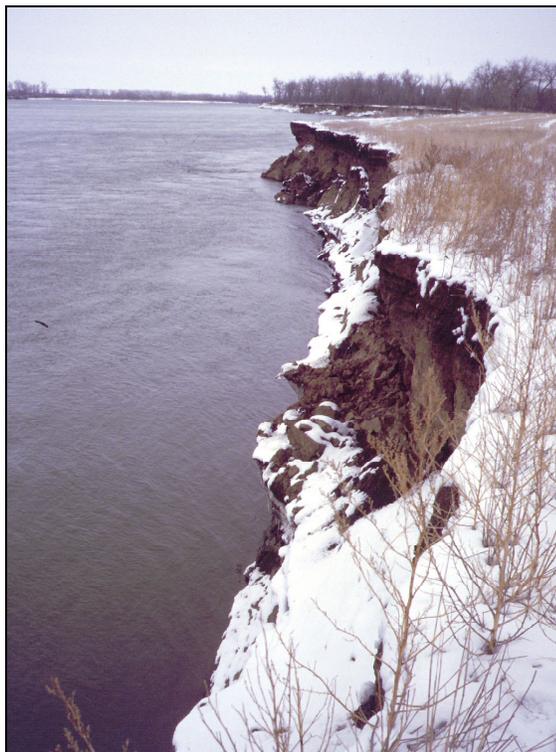
**Figure 78. Eroded riverbank along RM 1715.**

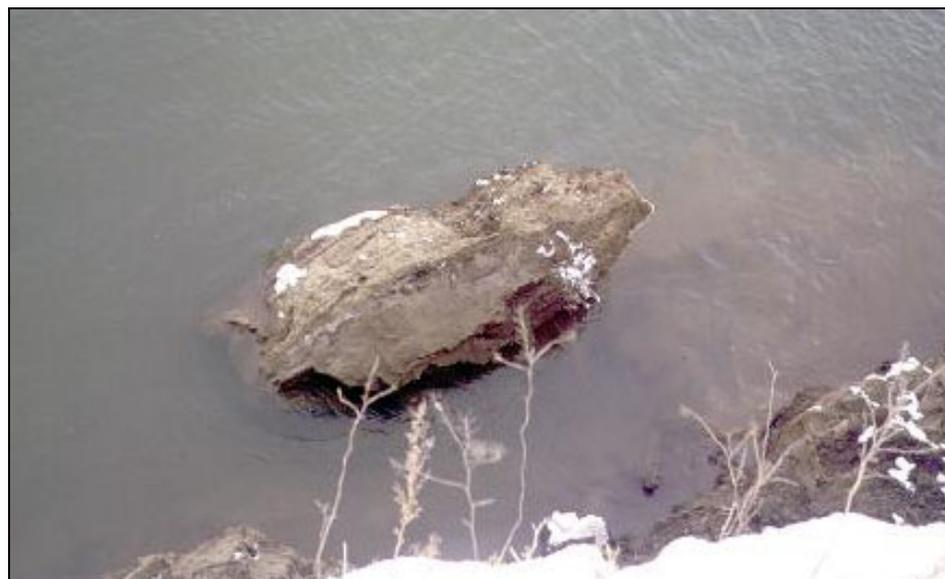
**Figure 79. Fallen block of bank material at the riverbank toe.**

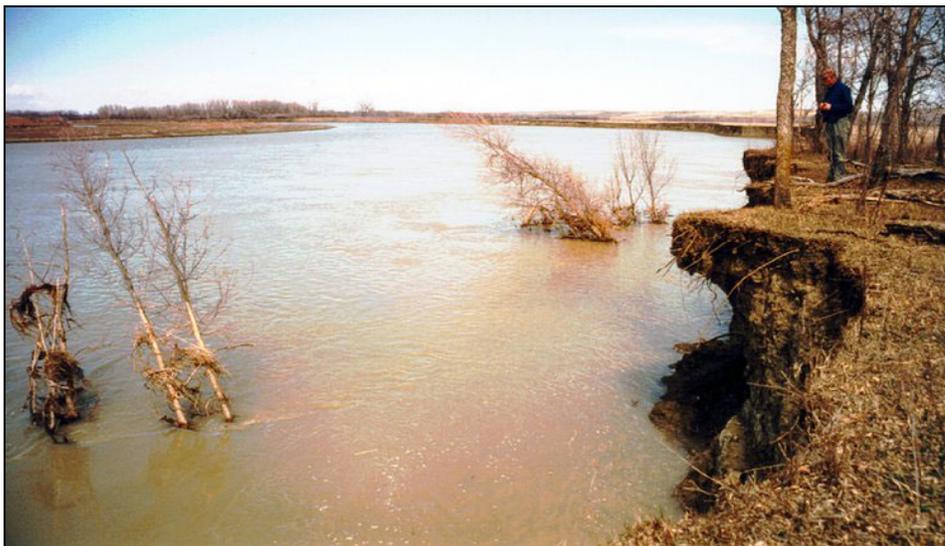
**Figure 80. Extensive undercutting of the riverbank at RM 1632.**

Erosion of the sandy silt layer at the base of the riverbank reduces riverbank stability. Although the upper level of the riverbank may overhang its lower level, the riverbank did not show evidence of extensive undercutting. However, because the riverbank soil is weak and there is little vegetation at the riverbank top, extensive undercutting was not needed to destabilize the riverbank. The combined effects of flow erosion and freeze–thaw processes eventually caused blocks or strips of riverbank soil to calve from the riverbank, as is evident in Figure 78. The blocks fell to the riverbank toe, where they provided temporary toe protection until gradually being eroded by the flow (Fig. 79). In comparison the root systems of trees along the top of the riverbank at the Vournas site resulted in much more extensive undercutting of that riverbank (Fig. 80).

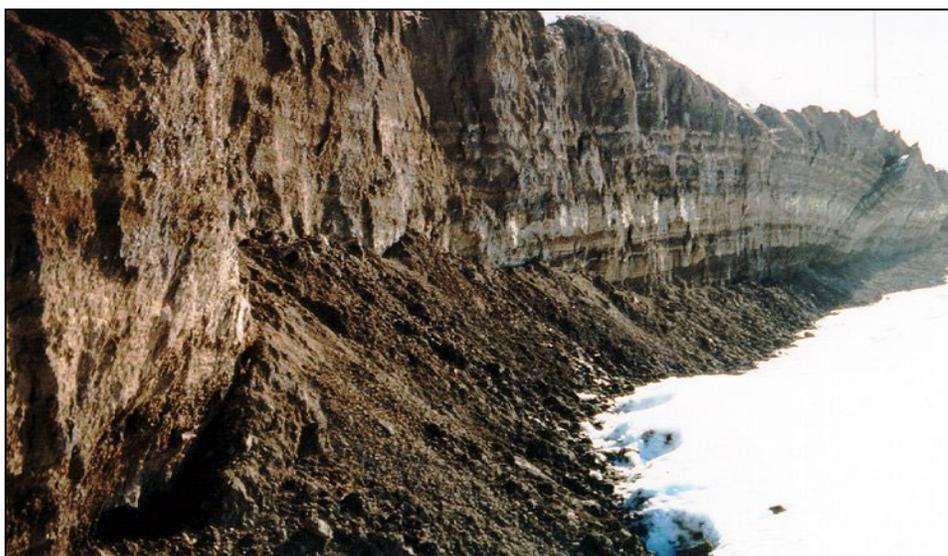
**Figure 81. Toppling at the Tveit-Johnson site.**

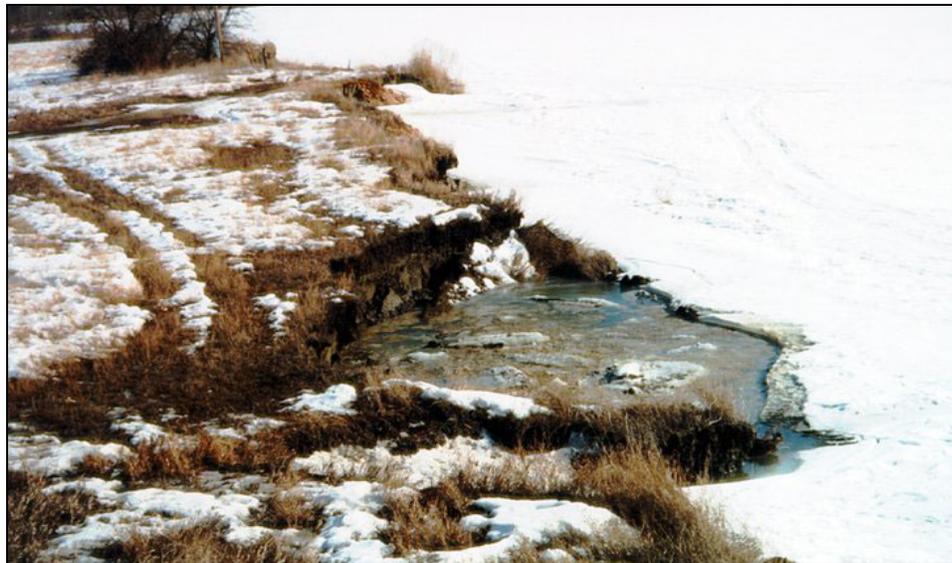
**Figure 82. Bank collapse following the formation of horizontal cracks.**

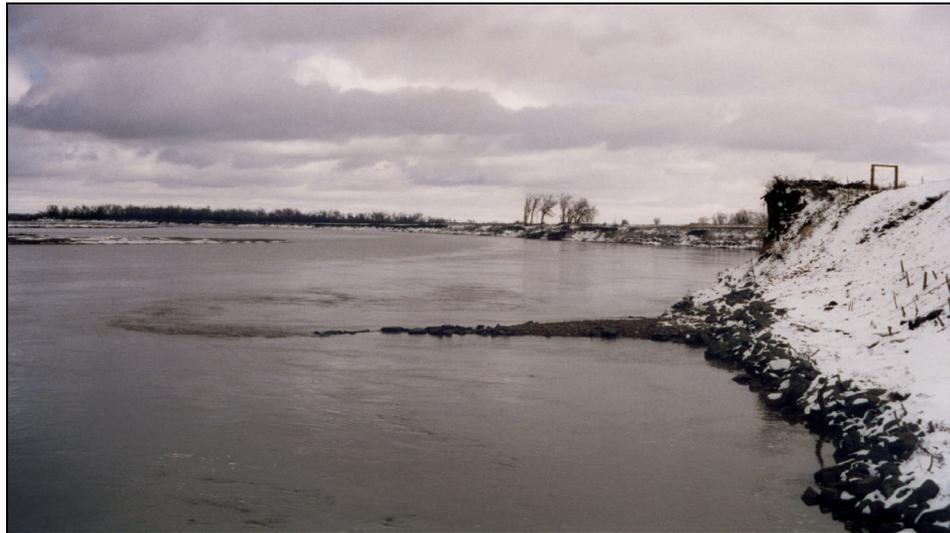
**a. Bendway weir.**

**Figure 84. Bank stabilization methods.**

A segment of the bank protected by the hay bale revetment and its riprap toe failed. The segment is located immediately upstream of bendway weir 2 (Fig. 84a), which may have played a role in the bank's collapse.
