# **Survey of River Ice Influences on Channel Bathymetry Along the Fort Peck Reach of the Missouri River, Winter 1998–1999**

Leonard J. Zabilansky, Robert Ettema, James Wuebben, and  
Norbert Yankielun

September 2002

Technical Report  
ERDC/CRREL TR-02-14

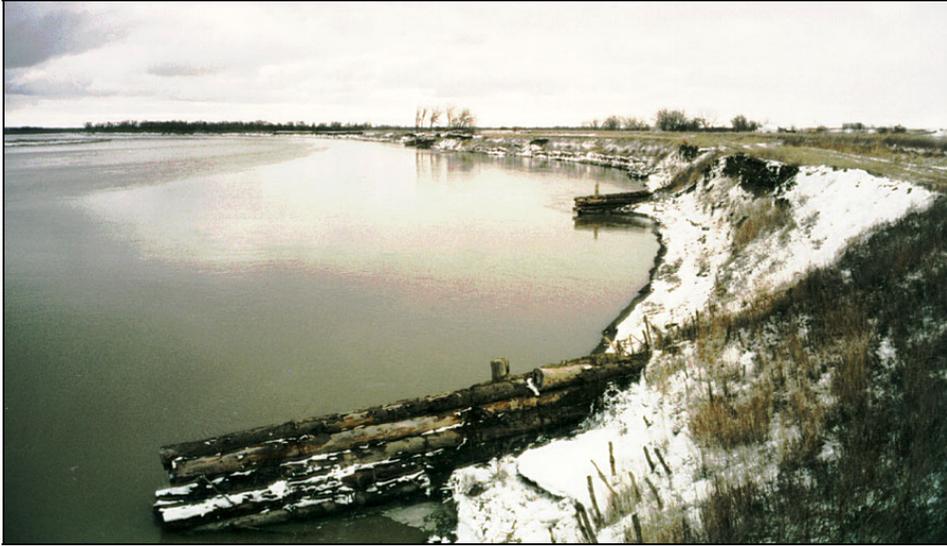
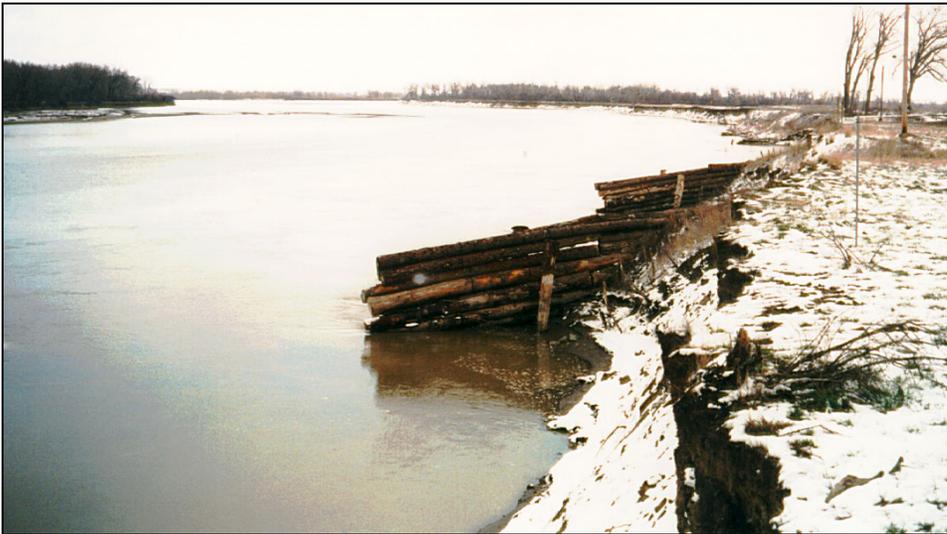
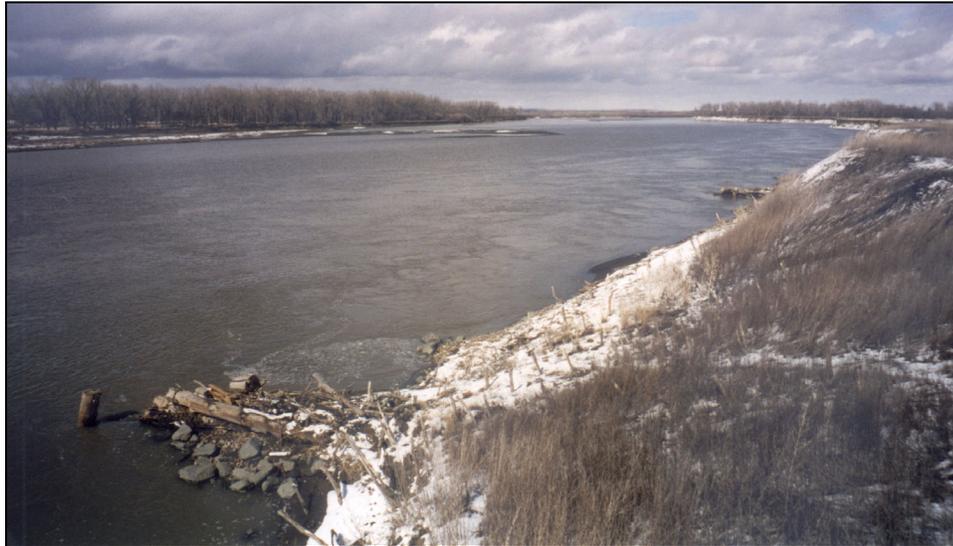
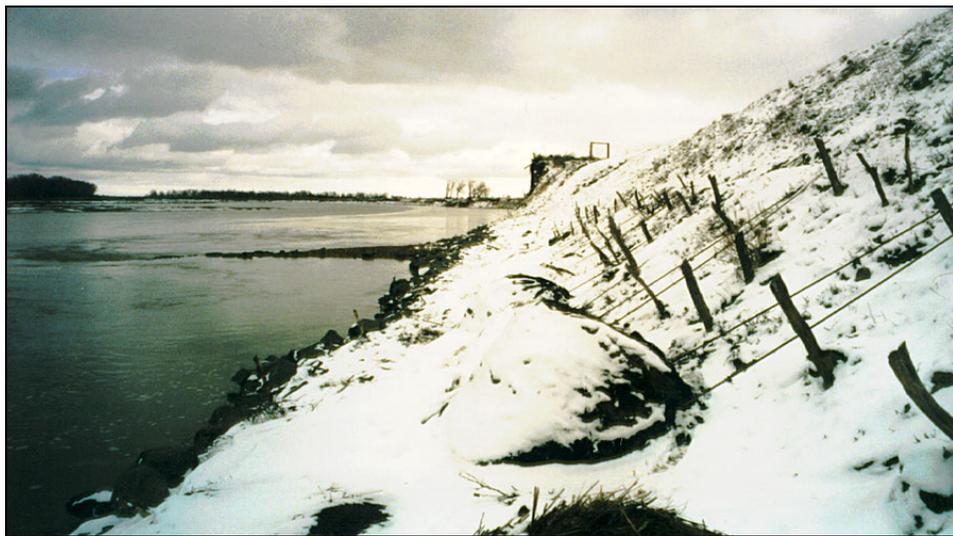
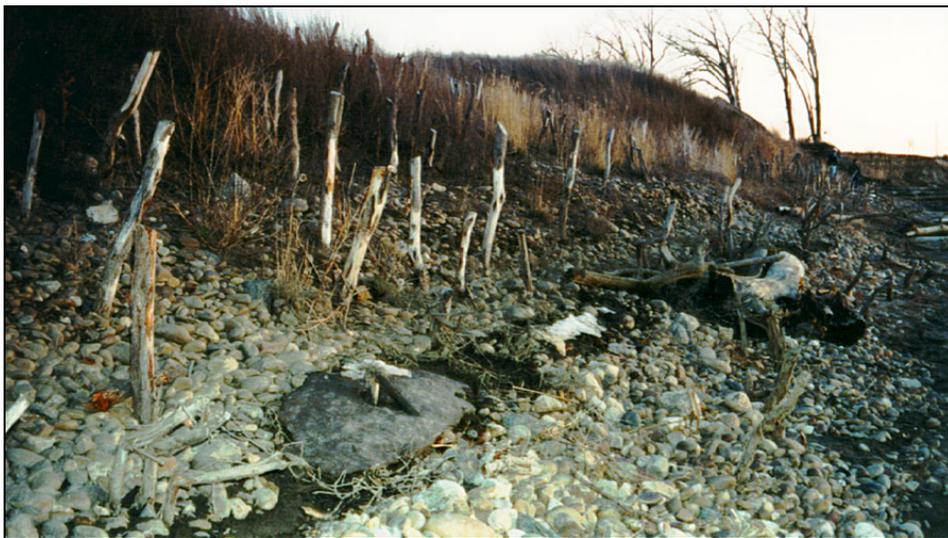
**b. Short log groin.**

**c. Tall log groin.**

**d. Rock-filled log cribs.**

**e. Hay bale revetment on riprap toe.**

**f. Willow stakes for shore stabilization**

The methods have worked reasonably well, given their trial nature. All but one method withstood ice cover formation during the winter of 1998-99, and there were a few deficiencies in a couple of the methods.

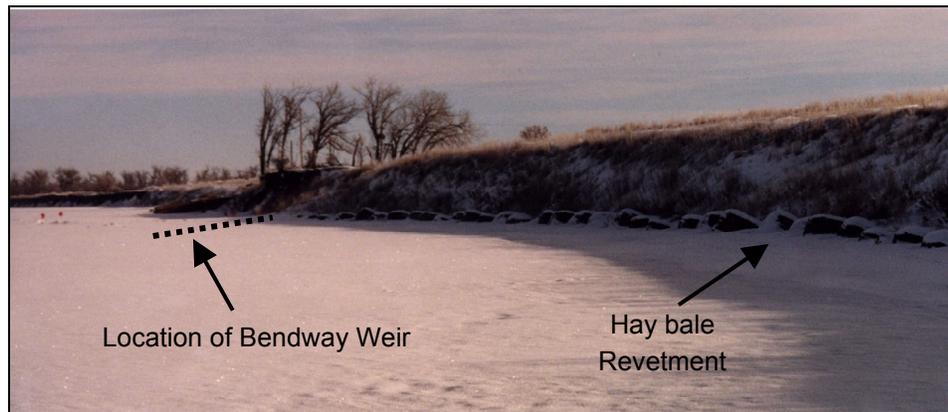
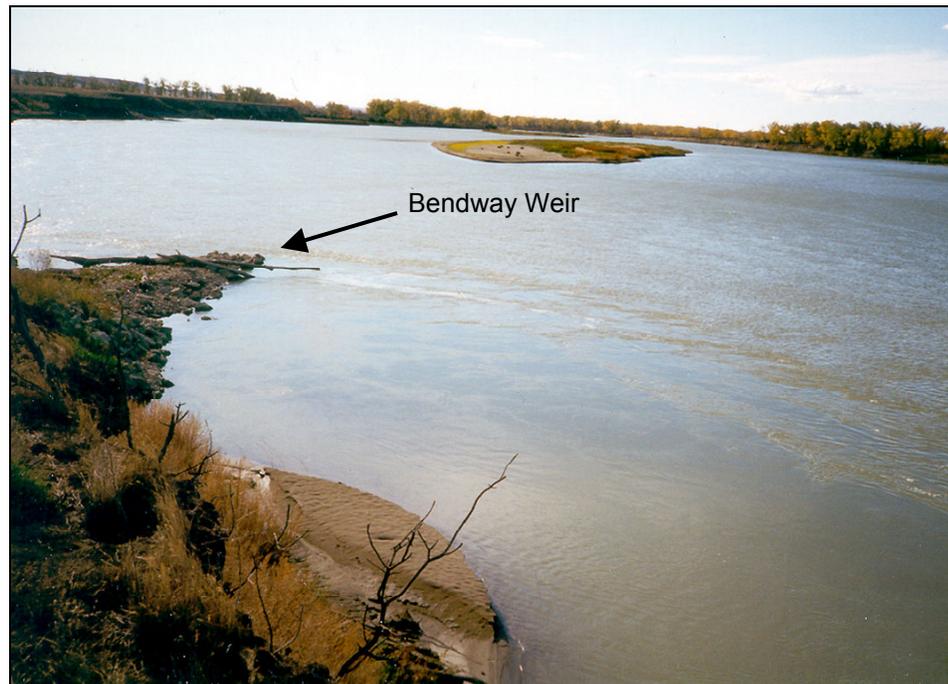
**Figure 85. Bendway weir.**

The two bendway weirs weathered the winter survey period apparently unscathed. Flows were of sufficiently large magnitude, and therefore flow stages were sufficiently high, that the weirs were submerged beneath the ice cover, though only by a maximum of a couple of feet (Fig. 85a). The bendway weirs appear not to have been significantly damaged when the ice cover broke up (Fig. 85b). River flows at the time of the photos in Figures 85a and 85b were 12,300 and 11,800 cfs, respectively.

Though the bendway weirs remained intact, the bank immediately upstream of bendway weir 2 suffered a local failure. A cusped segment of the bank collapsed as a rotational slide, most likely doing so immediately after the ice cover broke up.

a. Ice cover on 26 January 1999 when the river flow was 12,300 cfs.

b. Site after the ice had departed, 21 February 1999. The river flow was 11,800 cfs.

Although no flow velocity measurements were taken to document the flow patterns under the ice in the vicinity of the bendway weirs, it appears from observation of open water flow currents at the weirs that the weirs may have partially blocked flow along the bank. The bendway weirs would have caused the flow to make a sharp turn at the weir, locally increasing the flow velocities and turbulence along the bank. This may have led to localized scouring of the bed at the bank toe and thus contributed to the collapse of a portion of bank immediately upstream of bendway weir 2. This is a prime concern associated with the use of

Ice cover formation may adversely alter the flow field around structures placed to locally modify flow near a riverbank. The ice cover that formed over the bendway weirs and long groins appears to have negated their intended action by concentrating the flow locally toward the bank rather than away from the bank. This may have contributed to the collapse of a section of bank protected by riprap and hay bales.

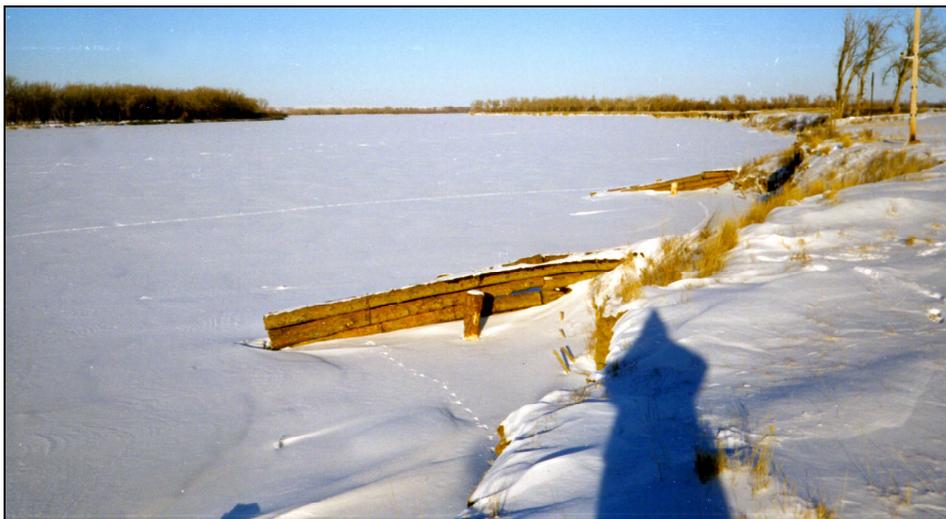
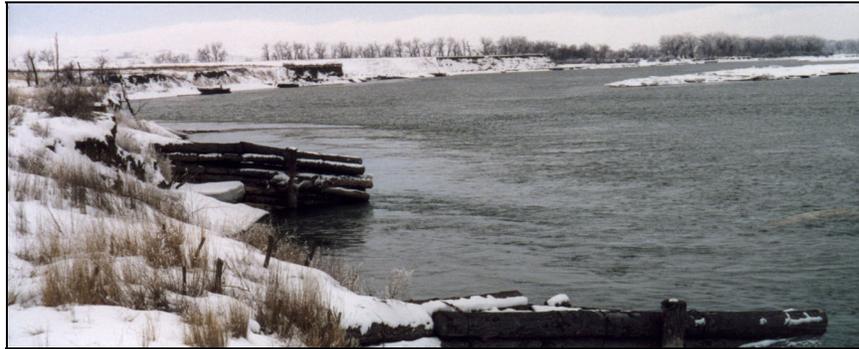
Figure 86. Log groins.

The log groins froze into the bankfast ice that formed along the site's south bank. The groins, which are built from long logs, withstood the ice loads associated with the ice cover and appeared to have been undamaged when the cover broke up and departed the site. Figure 86 shows a tall log groin frozen into the cover and the same groin after breakup. Figure 87 shows a short log groin encased in ice on January, shortly after the ice cover had broken up. A hinge crack that generally parallels the shoreline allowed rotation between the stationary bankfast ice and the flexing channel without vertical displacement across the crack. The groins locally supported the ice cover, causing the shoreline crack to

a. Frozen in ice, 26 January 1999.

**b. Following breakup.**  
**Figure 86 (cont.). Log groins.**

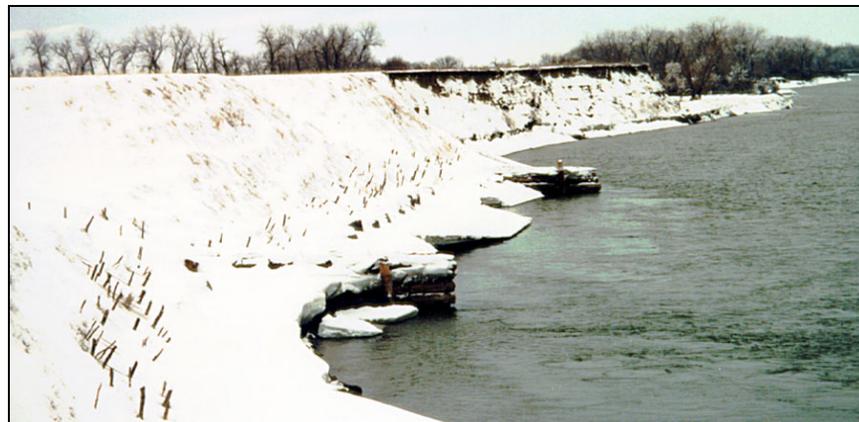
**b. Following breakup, 21 February 1999.**  
**Figure 87. Short groins.**

be relocated towards the channel and widening the margin of the bankfast ice. The dashed line in Figure 88 shows the relocated shoreline crack due to the short groins. The beneficial consequence of relocating is seen in Figure 87b, as the bankfast ice may have helped to protect the banks from damage during breakup. The taller log groins, which project farther out into the flow, relocated the shoreline crack farther away from shore, resulting in a wider band of bankfast ice. Following breakup, the water level dropped, and the wider bankfast ice was cantilevered from the shore. When the bank is steep, as at the Pipal site, a wider band of bankfast ice cantilevered from the bank exerts a larger load on the bank face as the supporting water level drops following break up. In approximate terms the load increases proportionally with the square of the width of the bankfast ice. As can be seen in Figure 89, the collapse of bankfast ice strips soil and vegetation from the face of the bank.

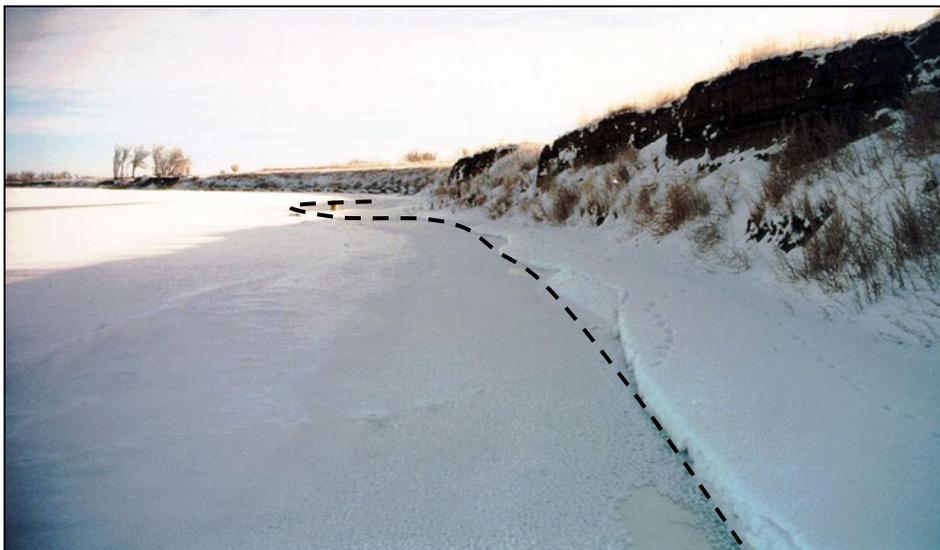
**Figure 88. Short groin with relocated shoreline crack.**

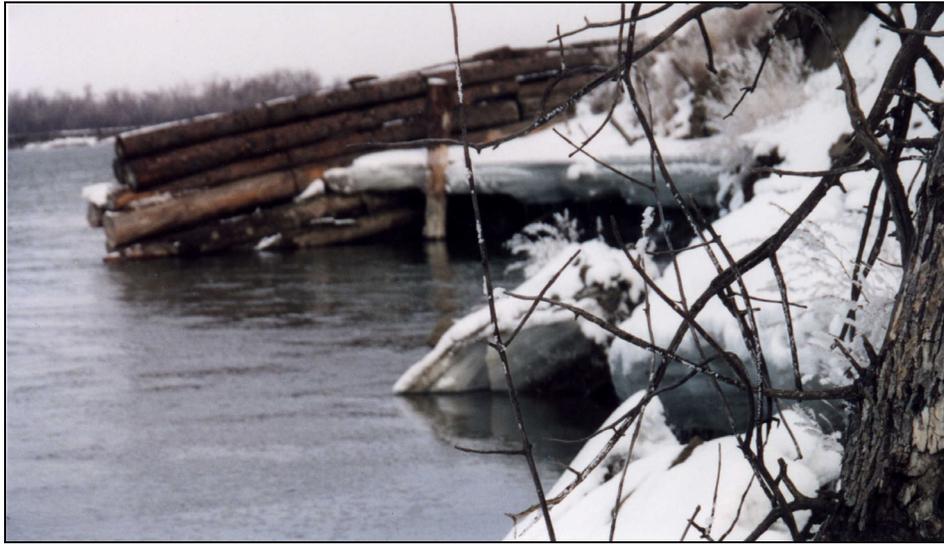
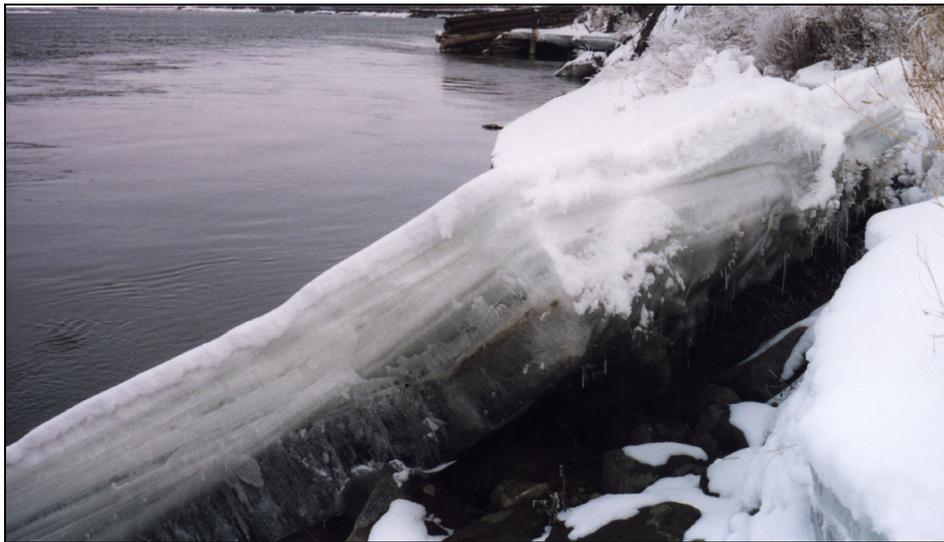
**Figure 89. Tall log groin.**

**a. Ice attached to groin.**

**b. Ice block sliding down the embankment.**

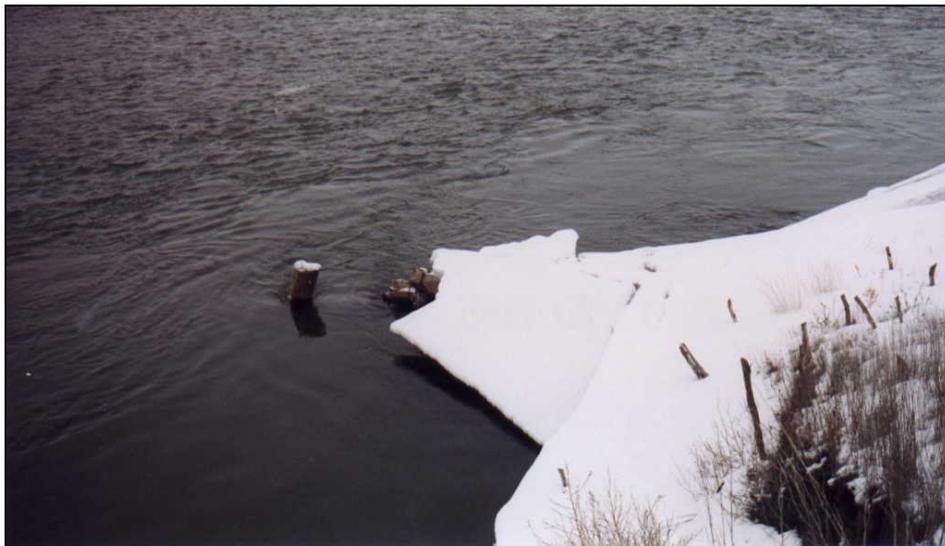
**Figure 90. Log cribs.**

The rock-filled log cribs, which are short, stout, and submerged well below the ice cover, appear to function effectively. Figure 90a shows the under-ice location of two cribs on 26 January 1999, with the relocated shoreline cracked designated. Figure 90b shows a crib shortly after the ice cover had broken up. The crib structures suffered no damage attributable to ice, and the structures did not unduly increase the local width of bankfast ice.

**b. After ice breakup in February.**

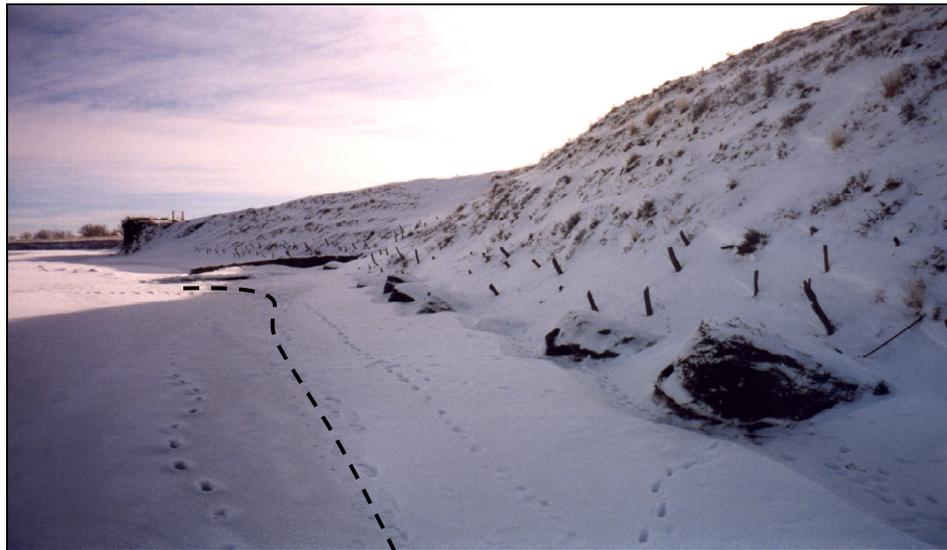
**Figure 91. Hay bale revetment frozen into the ice cover.**

The elevation of the ice cover on 26 January 1999 was such that the cover formed around and into the hay bales, which were wrapped in a geotextile fabric (Fig. 91). The ice cover did not seem to have directly damaged the bales. It froze well into the bales, enveloping them. They, in turn, seem to provide a reasonably secure anchoring for the bankfast ice; the bales themselves are anchored to the bank top by means of steel cables. The crack delineating the outer extent of the bankfast ice was located outside the bales. The dashed line in Figure 91 shows the location of the shoreline crack.

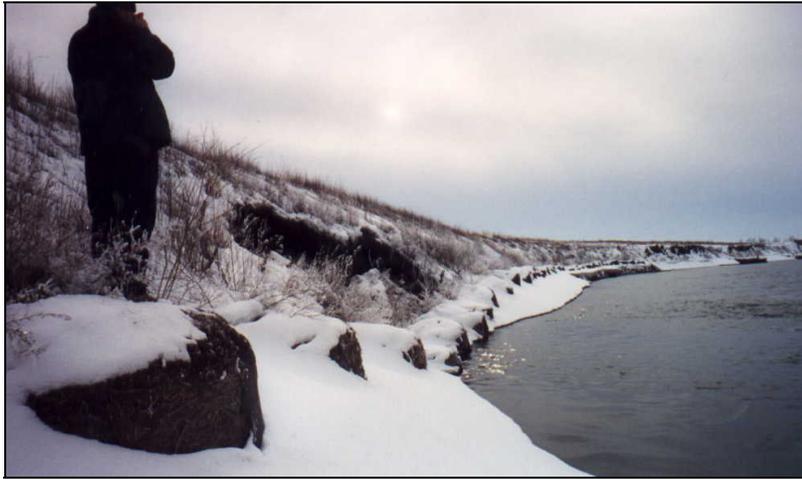
**Figure 92. Collapsed section of bank near the hay bale revetment following ice out in February.**

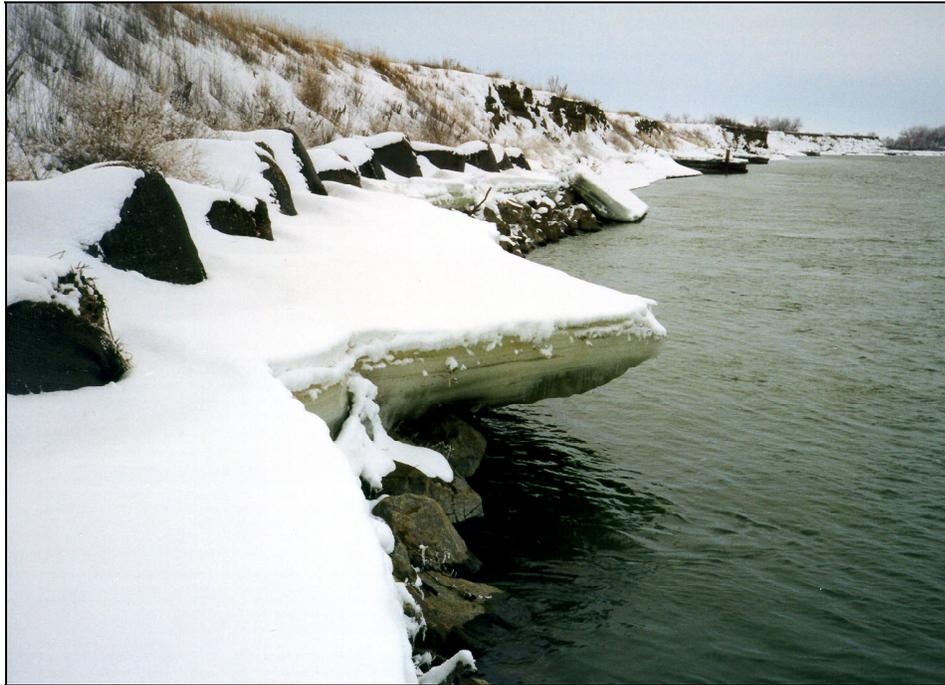
**Figure 94. Shorefast ice along riprap beaches.**

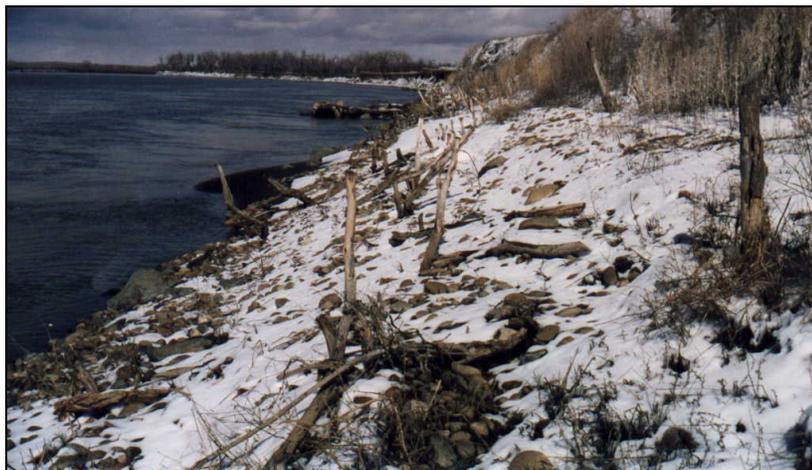
**Figure 95. Failed willow post.**

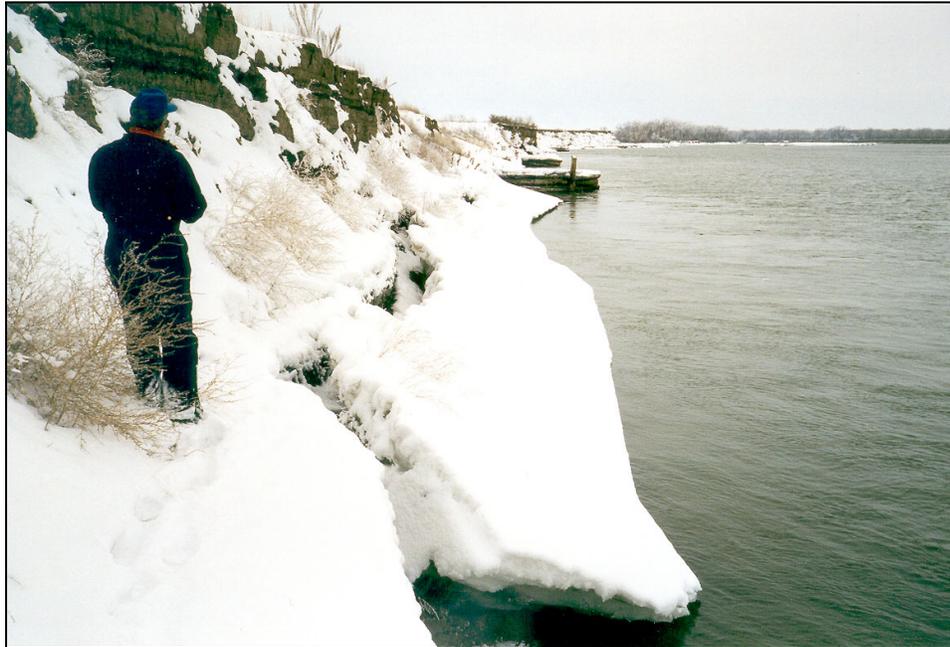
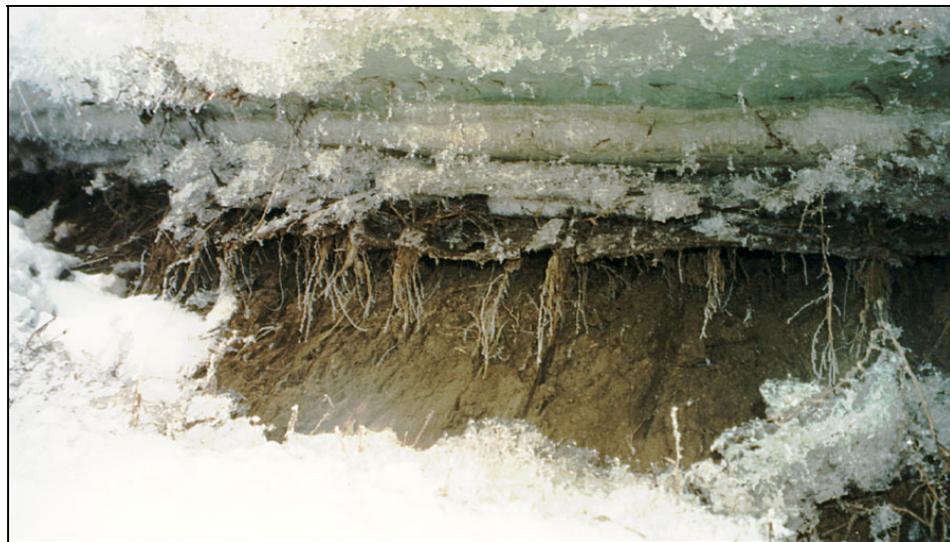
**Figure 96. Ice blocks sliding offshore.**

Observations at the Pipal site suggest that stabilization structures should not protrude into the river farther than the usual width of bankfast ice at the bank the structures are required to protect. Compared to open water conditions, shorter and closer-spaced structures are preferable for use in ice-covered flows. Structures longer than the normal bankfast ice width move the shoreline crack towards the channel, widening the bankfast ice and potentially loading banks excessively. Bankfast ice between and near the timber groins was significantly wider than elsewhere at the site. When the river was ice covered, the bankfast ice formed a floating membrane attached to the groins and the bank. When the ice cover broke up and the flow stage subsided, large slabs of bankfast ice collapsed, damaging the banks and vegetation along the banks (Fig. 96).

**a. Unsupported ice block.**

**b. Block pulling root structures of entrapped vegetation.**

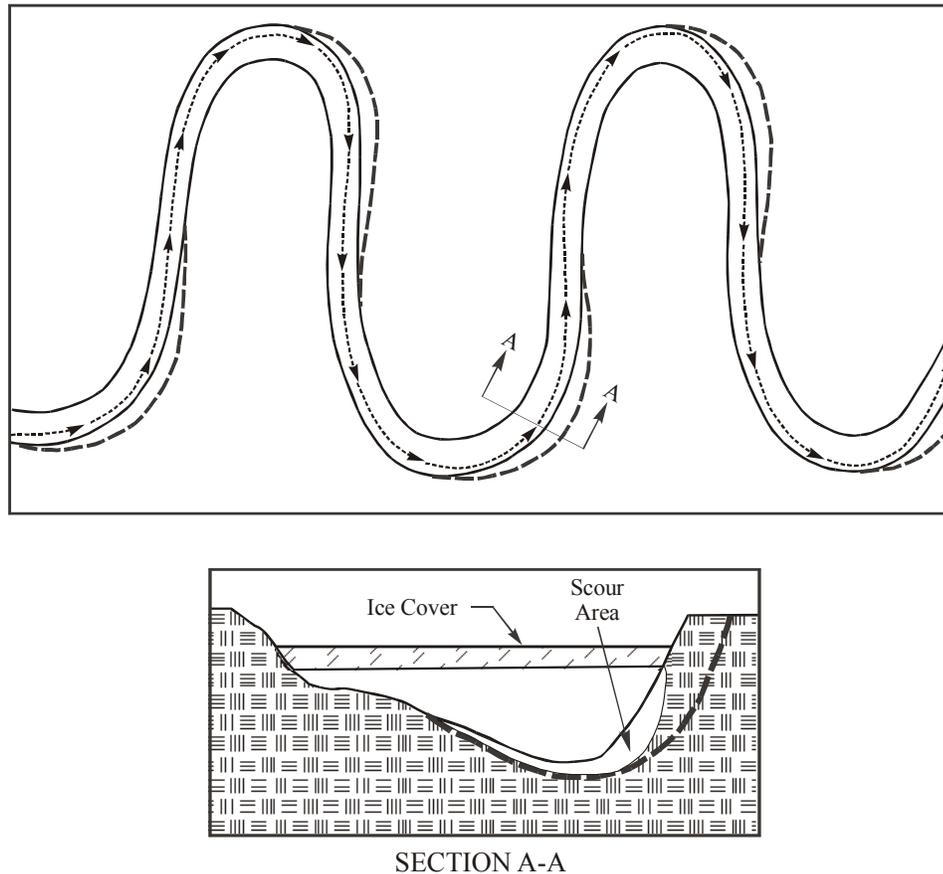
**Figure 97. Ice cover concentration of flow toward the outer bank of a bend, which accelerates bed scour along the bank toe, bank erosion, and downstream migration of the bend.**

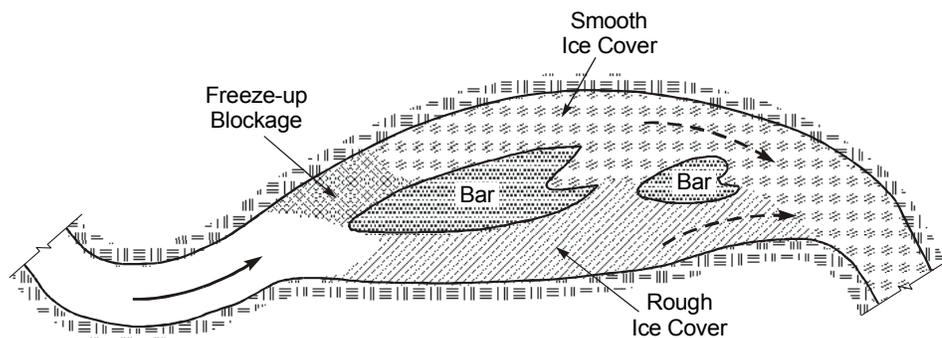
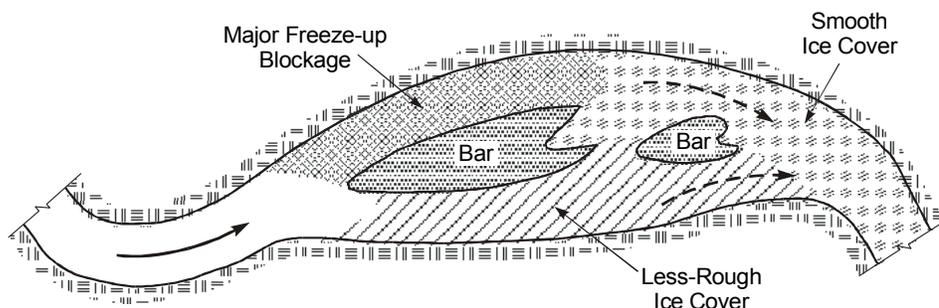
**a. A relatively short initial accumulation of drifting ice in the upper subchannel may divert ice into the lower subchannel, which then becomes extensively enveloped by a rough ice cover. Meanwhile, the upper subchannel freezes over with a smooth ice cover or may remain partially open. The greater flow resistance in the lower subchannel causes the flow to favor the upper subchannel, which then enlarges.**

**b. A relatively long initial accumulation of drifting ice in the upper subchannel may divert ice and flow into the lower subchannel, which then becomes extensively enveloped by a less-rough ice cover. The greater flow resistance in the upper subchannel causes the flow to favor the lower subchannel, which then enlarges.**

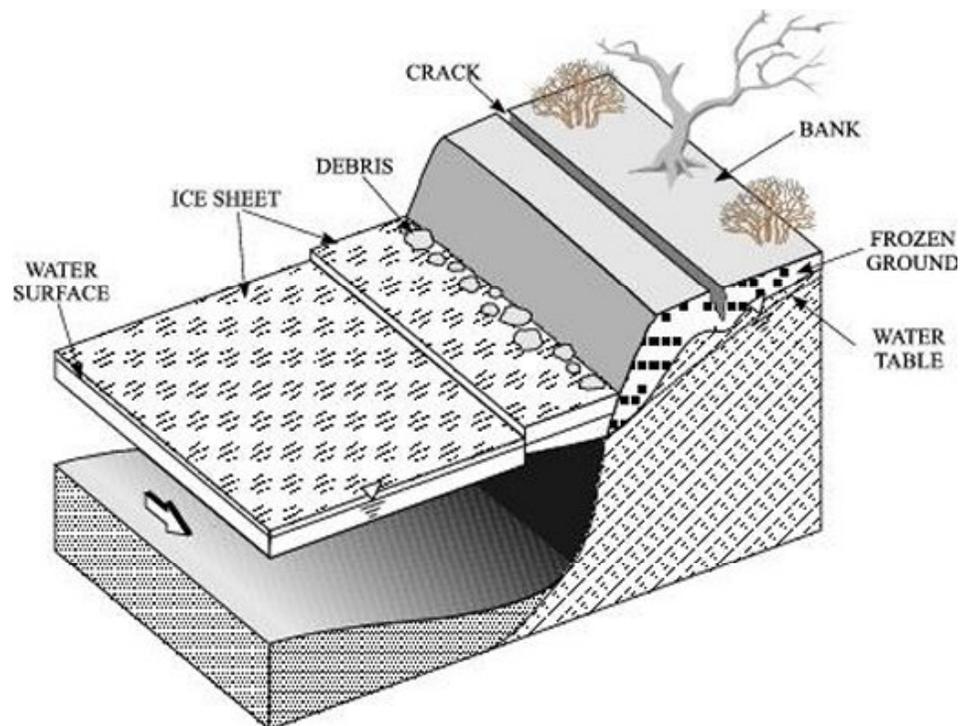
**Figure 99. Methods by which hydraulic influences (e.g., thalweg shift and bank toe erosion), together with geomechanical influences (e.g., freeze-thaw weakening, seepage pressures, and bankfast ice loading), may weaken and erode channel banks, resulting in continual channel destabilization.**
