Snow Guards for Metal Roofs

By Wayne Tobiasson, M.ASCE, James Buska, M.ASCE, and Alan Greatorex

This study was first published by the American Society of Civil Engineers for its 8th International Conference on Cold Regions Engineering in August 1996 and is reprinted by permission.

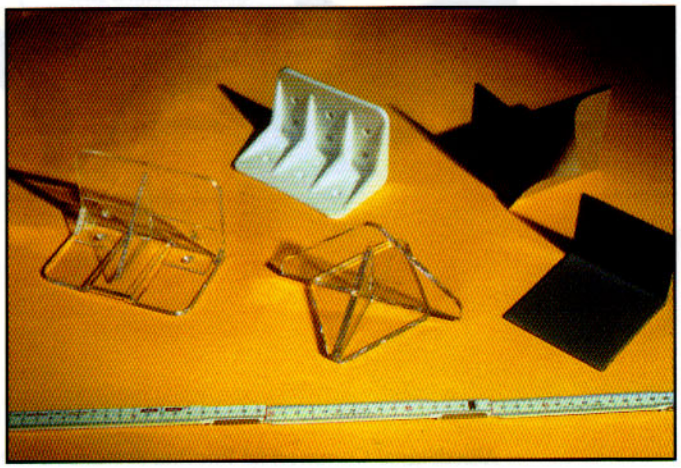
Several snow guards that are attached to metal roofing with adhesive are shown in Figure 1. Adhesives range from stiff epoxy and hard setting plastic to flexi-

Figure 1: *Examples of adhesively-attached snow guards.*

ble silicone and butyl-based peel-and-stick tapes. In the few cases where load tests have been conducted on coated metal surfaces, failure loads vary between 180 and 320 kg. (400 and 700 lb.) per unit.

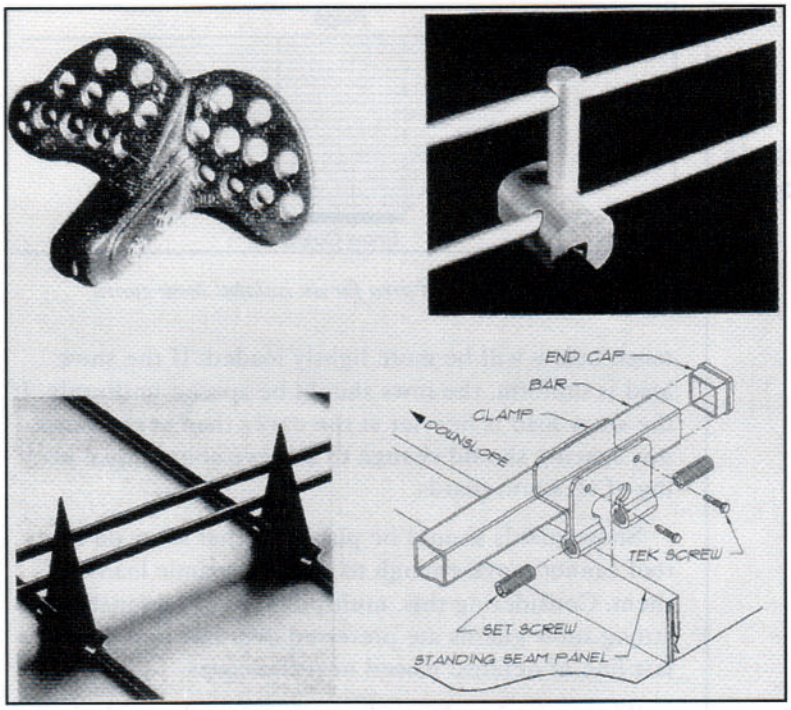
Figure 2: *Examples of mechanically-attached snow guards.*

Other snow guards are mechanically attached to metal roofs. Most mechanically-attached snow guards are secured with nonpenetrating fasteners at or near the top of the standing seam to place them above the base of the metal pan where rain and snow meltwater flow down the roof. Stainless steel set screws (sometimes used in conjunction with cams) are designed to grip the seam. They fit some seams better than others. Failure loads up to 1,800 kg. (4,000 lb.) are reported for some of these devices. As shown in Figure 2, some of the mechanically-attached snow guards are individual units, but many are in the form of continuous fences.

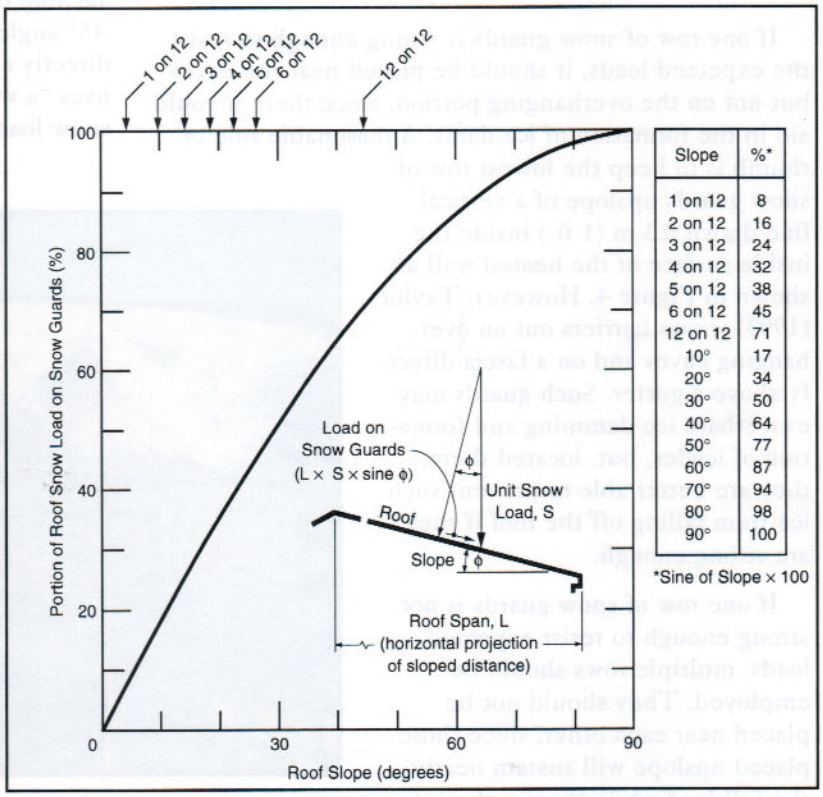
To determine the portion of the snow load that must be resisted by snow guards, the vertically-acting gravity load is resolved into two components, one parallel to and one perpendicular to the roof's surface. The component parallel to the roof is equal to the snow load times the sine of the roof slope angle. If friction along that slope is assumed to be zero, then the snow guards must resist the full component parallel to the roof. Figure 3 shows how this component varies with slope.

The assumption that friction is zero is appropriate since frictional resistance is near zero when the bottom of snow on a metal roof is at 0°C (32°F) and that snow contains some free water.

Figure 3: *Relationship between roof slope and the load on snow guards.*

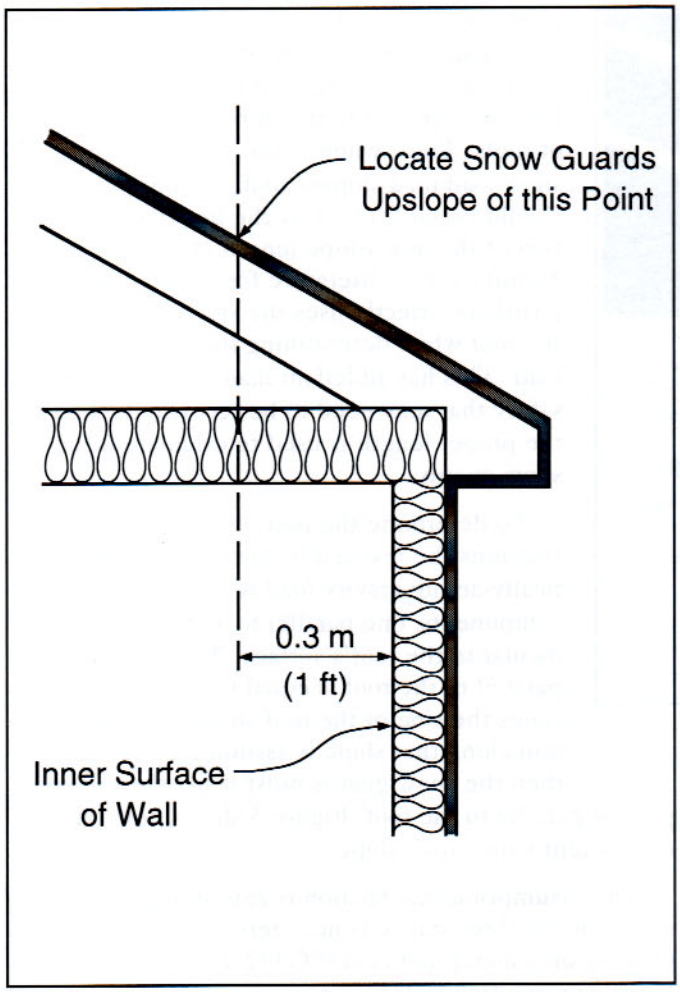
Figure 4: *Snow guards should be kept some distance above eaves to keep ice from accumulating on them.*

If one row of snow guards is strong enough to resist the expected loads, it should be placed near the eaves but not on the overhanging portion, since there it could aid in the formation of ice dams. A reasonable rule of thumb is to keep the lowest row of snow guards upslope of a vertical line drawn 0.3 m (1 ft.) inside the inside surface of the heated wall as shown in Figure 4. However, Taylor (1993) shows barriers out on overhanging eaves and on a fascia directly above a gutter. Such guards may exacerbate ice damming and formation of icicles, but, located there, they are better able to prevent such ice from falling off the roof if they are strong enough.

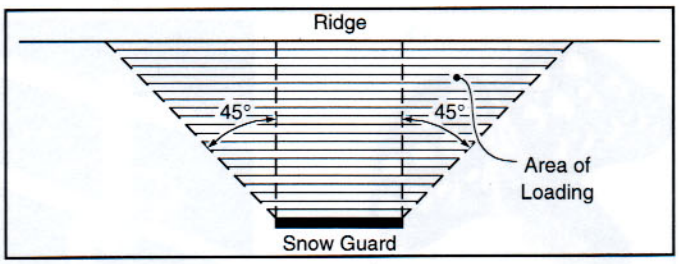
Figure 6: *Loaded area for an isolated snow guard.*

There are situations where snow guards are desired for only a portion of a metal roof. They might be installed just to prevent snow from falling at an entrance located below the eaves, to prevent snow from creeping down a valley, or to prevent snow from shearing off a plumbing vent that penetrates the roof. In these situations, snow alongside the guarded area is free to move, adding substantially to loads on the guards. Figure 5 illustrates this point. It shows a wedge of snow held in place by a single plumbing vent. To account for this effect, we assume that a series of snow guards must be able to sustain all the snow located within outward 45° angles upslope of their location plus all the snow directly above as shown in Figure 6. Paine (1989) also uses "a wedge about 45 degrees each side" to estimate snow loads on obstructions.

Studies of avalanche defense works (Katakawa et al., 1992) have shown that static loads at the ends of an object blocking the downslope movement of snow, which extends laterally some distance, can be almost twice the magnitude of the average load on the object. Thus the design load on any snow guard or snow guard fastener at the end of a row but not at the end of the roof (see Fig. 6) should be increased accordingly.

Single angles were installed near the eaves on three roofs. One is shown in Figure 8. Each one is heavily loaded as is described in Figure 6. All were installed with their upstanding leg upslope (i.e., as shown in Fig. 10a). One of these bars was riveted as described above with butyl-based tape placed between it and the metal roof. One of its upslope rivets subsequently loosened. We believe that the butyl-based tape and its effect on rivet mushrooming were the probable cause. The loose rivet was removed with a grinder and a larger rivet installed. This bar failed during the 1995-96 winter. All rivets were pulled up through the metal roofing. One of the other single bars was installed with self-drilling screws and the third was installed with self-tapping screws. We had no trouble installing the self-drilling screws and none have become loose. We have noticed some slight corrosion on these screws and the neoprene washer of one is cracked, but those defects have not yet created any real problems. We stripped the metal roof when installing two of the self-tapping screws. Our laboratory study indicated that this would be more likely with self-drilling then self-tapping screws, but on the job, just the opposite happened. We removed those screws, squirted silicone sealant into the holes and reinserted the screws more to waterproof the holes than to provide much strength. This bar failed during the winter of 1995-96. The self-tapping screws pulled out of the metal roofing.

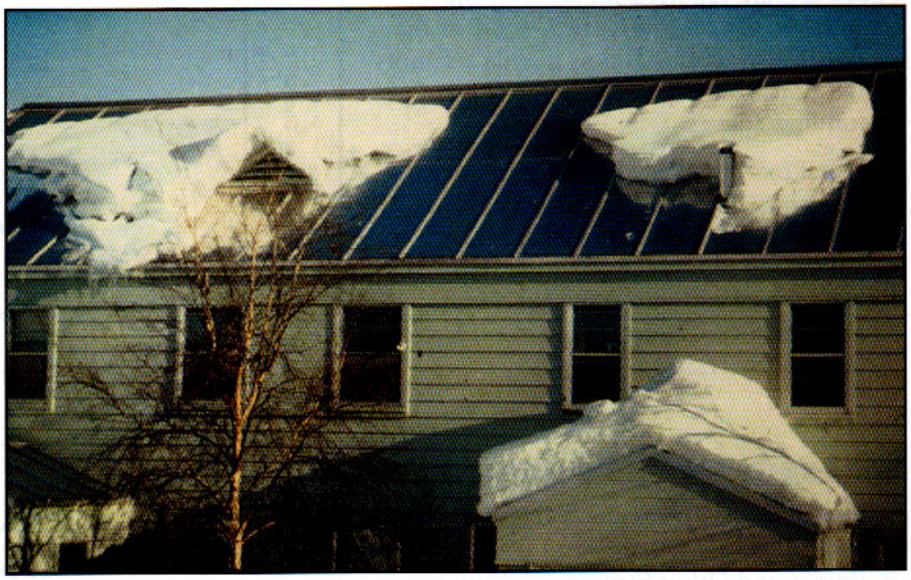
Figure 5: *A small object such as a plumbing vent can hold back a large wedge of snow.*

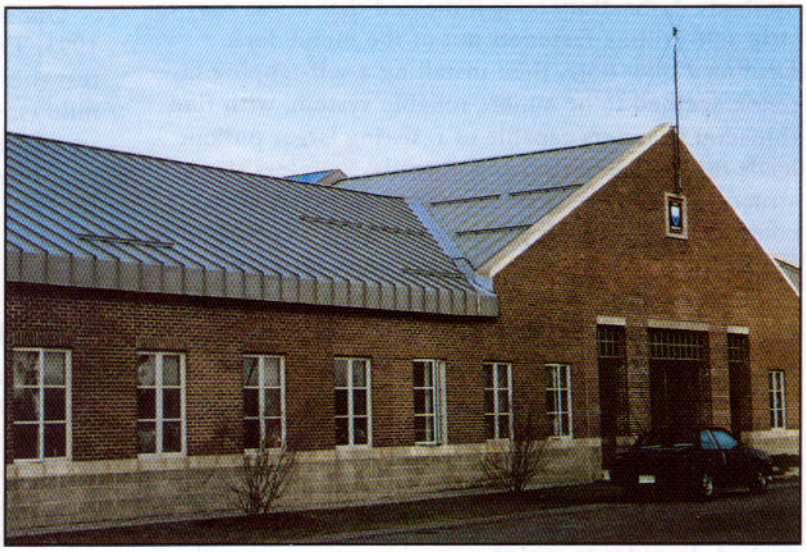
Figure 8: *Array of six aluminum angle snow guards used to protect a valley and, to the left, a single guard to study "worst case" loading.*

Figure 8 shows one valley protected by six such angle snow guards and a single angle guard along the eaves away from the valley.

The aluminum angle snow guards mechanically attached to the seams of metal roofs have performed reasonably well but some problems have occurred. One of the lower angles shown in the Figure 8 valley was ripped off during the first winter. Our examination of it caused us to conclude that the butyl-based tape placed between the metal seam and the base of the guard was thick enough to prevent complete mushrooming of some rivets. We also determined that the pullout load on the upslope rivet could be reduced by placing the upstanding leg of the angle on its downslope side instead of on its upslope side. Figure 10 illustrates this point.

The failed angle was replaced with a new angle. It was turned so its upstanding leg was on its downslope side (i.e., as in Fig. 10b), and no butyl-based tape was installed between it and the metal roof. That snow guard has suffered no problems since. The other five angles in that array have remained in place.

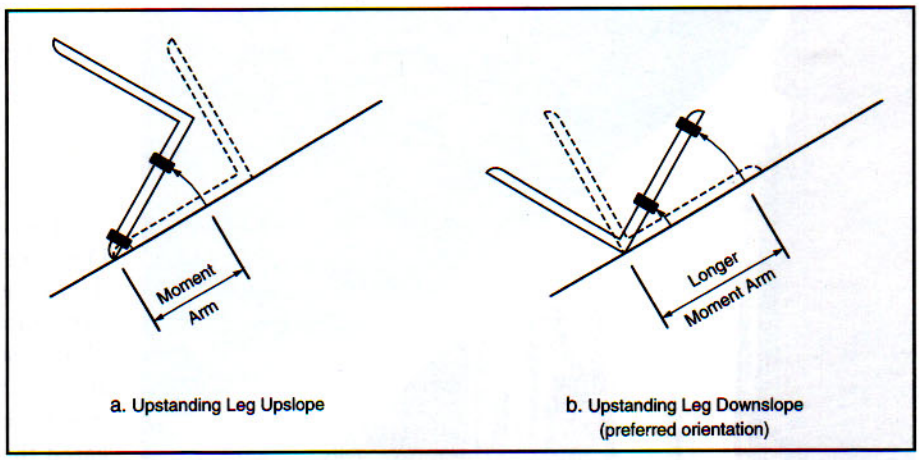
Figure 10: *Alternative orientations of the long aluminum angle snow guards. By placing the upstanding leg downslope, a stronger system was achieved.*

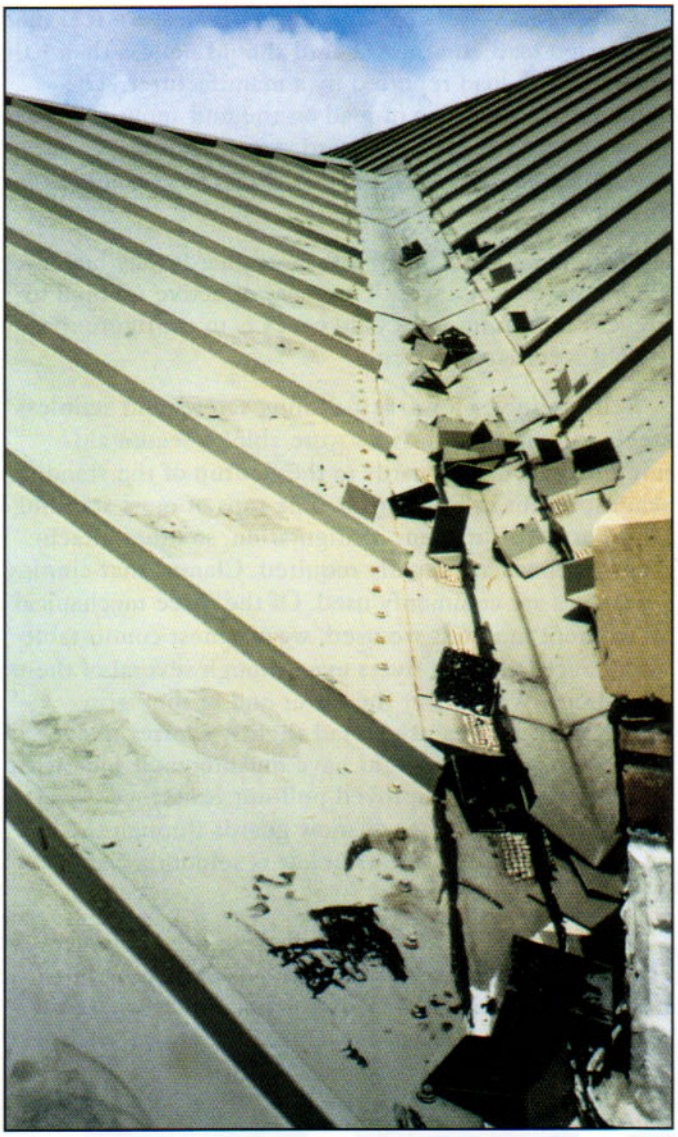
Figure 11: *All snow guards attached with butyl-based peal-and-stick adhesive failed the first year.*

All of the short aluminum angle and clear plastic snow guards attached with butyl-based peal-and-stick adhesive failed during the first winter. As is shown in Figure 11, most of the failures occurred between the adhesive and the coating on the metal roof, but some failures occurred cohesively in the butyl-based adhesive.

reliable than mechanical attachment. We had some success with neutral-curing, room temperature vulcanizing (RTV) silicone adhesives. Snow guards attached with conventional "hardware store" silicone adhesive were not able to take heavy loads, and that acetic-acid-liberating adhesive can cause rusting of the metal roof. We recommend against use of butyl-based peal-and-stick adhesives.
