An Evaluation of the Severity of the January 1998 Ice Storm in Northern New England

Report for FEMA Region 1

Kathleen F. Jones
Nathan D. Mulherin

April 1998

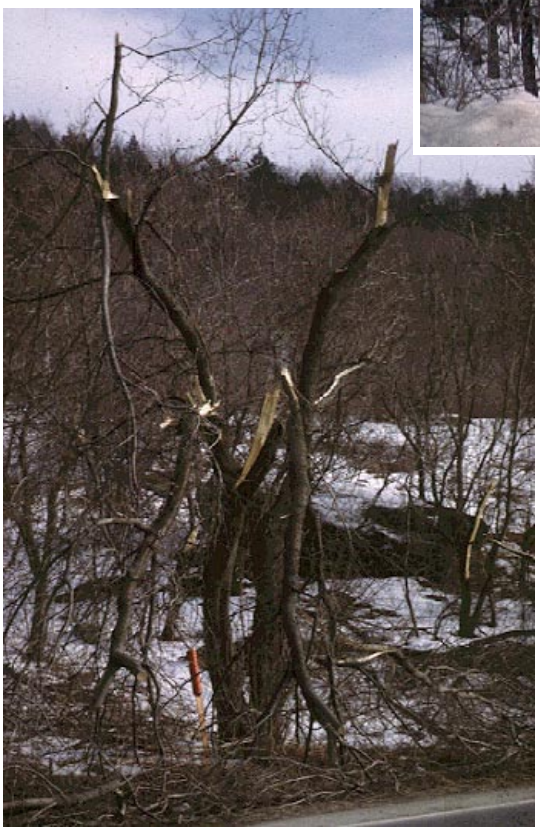
b. Near Starksboro (photo Jones).

Figure 12. Tree damage in and near Vermont.

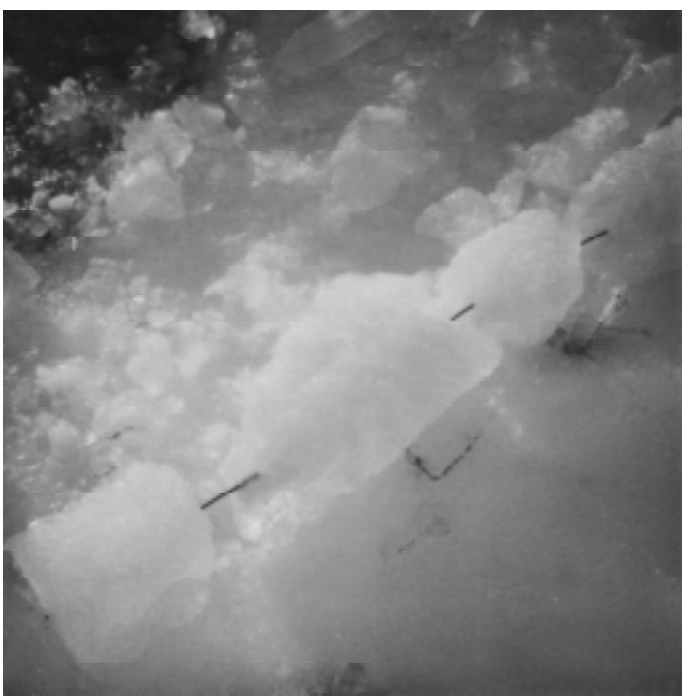
a. ~5 in. on a 0.25-in. guy on the summit of Cadillac Mountain (photo Robert Parker, U.S. Coast Guard).

Figure 22. Ice accretions with measured or estimated uniform ice thickness.
