Special Report 89-36

**US Army Corps
of Engineers**

Performance of wall coatings for concrete and masonry buildings in Alaska

Charles J. Korhonen and John J. Bayer, Jr.

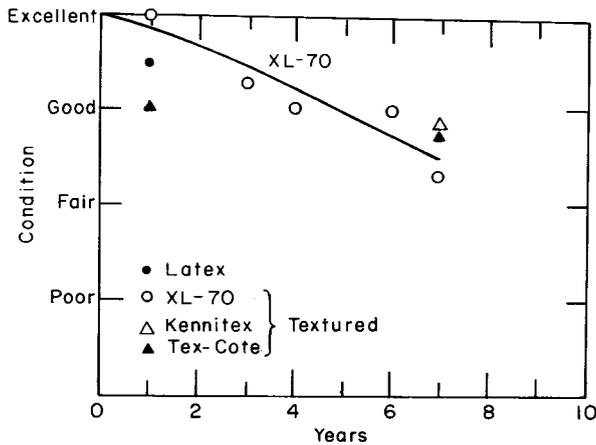
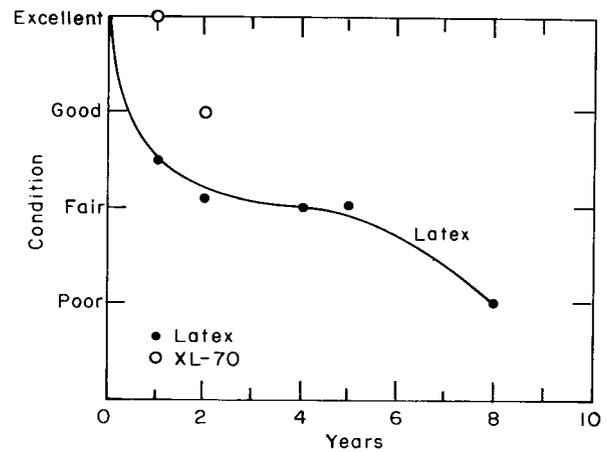
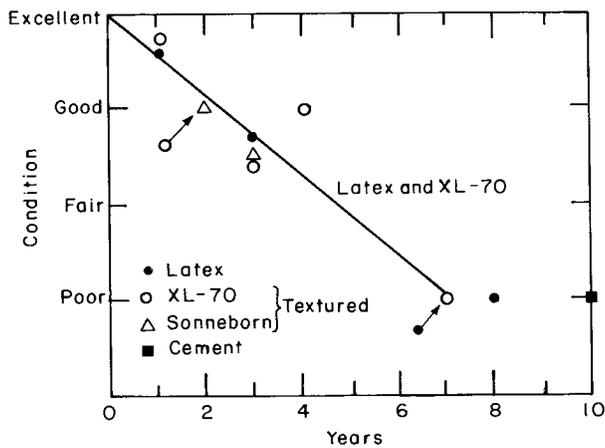
Figure 3. Averaged condition ratings. Arrows point to dual data point locations.

Figure 3 agrees quite well with these assessments. Since, in our rating system, "fair" represents the point at which work is first needed on a building, we selected it to represent our estimate of coating life. Thus, Figure 3 shows latex paint to last 4 to 5 years at Fort Greely and 4-1/2 years at Fort Wainwright; XL-70 should last 9 years at Fort Richardson (these data were extrapolated). Except for Fort Wainwright, these estimates agree with those of the maintenance personnel. The apparent discrepancy at Fort Wainwright can be explained in that it was our impression that buildings there were not repainted until they reached a rating of "poor." On Figure 3, this relates to a paint life of 7 years, which agrees with the 6- to 8-year cycle reported by the maintenance people.

This "validation" process not only provided a tie to real world experience, but gave us confidence to say something about the coatings not commented on by the maintenance people. For example, though Fort Richardson maintenance personnel expect XL-70 to last longer than latex, we don't expect it to be significantly better. We say this because Figure 3 suggests that XL-70 may be only slightly better than latex at Fort Greely and only equal to latex at Fort Wainwright. Therefore, unless the price difference between latex and XL-70 diminishes, it is not seen as an economical alternative to latex paint.

Kennitex, Tex-Cote and Sonneborn, the other textured paints, are represented by only a few data points on Figure 3 so conclusive evidence about their life expectancy is not available. However, it is worth pointing out that Sonneborn's performance fell below that of latex, Tex-Cote's was about equal to XL-70 and Kennitex's was slightly above that of XL-70. Thus, the oil-based textured coatings were

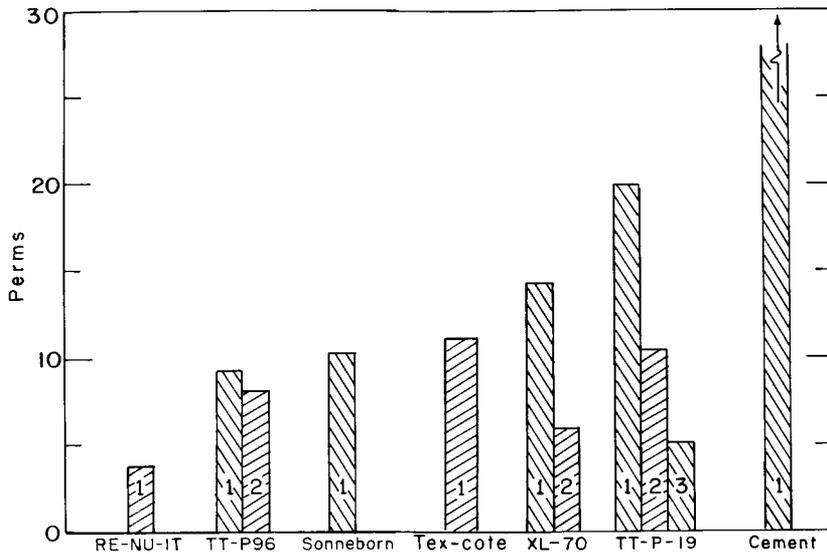
Figure 15. Permeance of coatings. The numbers relate to the layers of paint tested.

The WVT of the coatings was separated from that of the block* and was converted into permeance by dividing it by the vapor pressure imposed across the coating during the test. Permeance (gr/hr ft^2 [in. Hg]) is a common method of reporting material breathabilities in technical literature. The permeance of each coating is shown in Figure 15.

Cement paint was by far the most breathable paint tested. It did little to slow water vapor flow through the mortar block. In fact, depending on how the cement paint was formulated, it sometimes acted to increase vapor flow (denoted as no upper limit for cement paint in Fig. 15). We cannot explain why this happened, except to say that the cement paint may have roughened the block's surface, increasing evaporation.

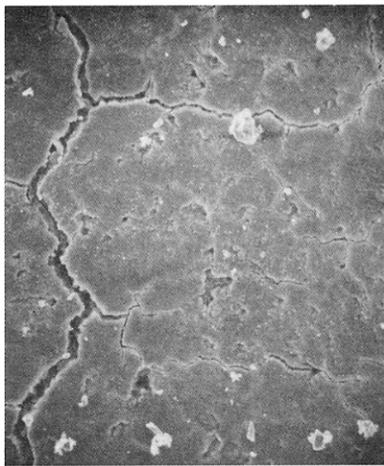
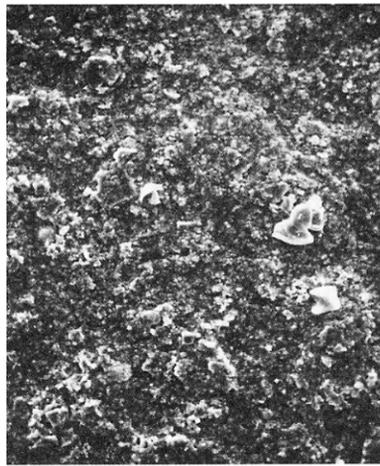
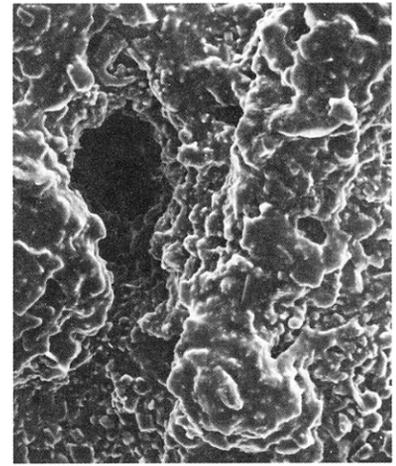
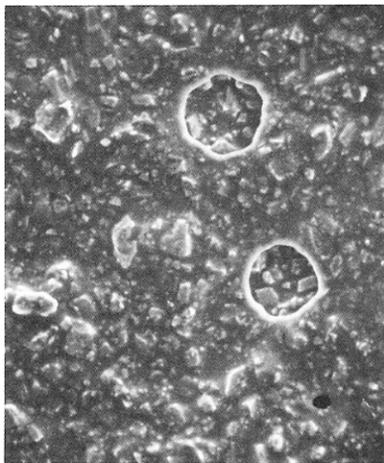
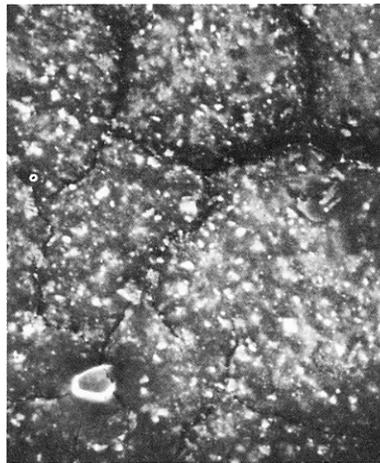
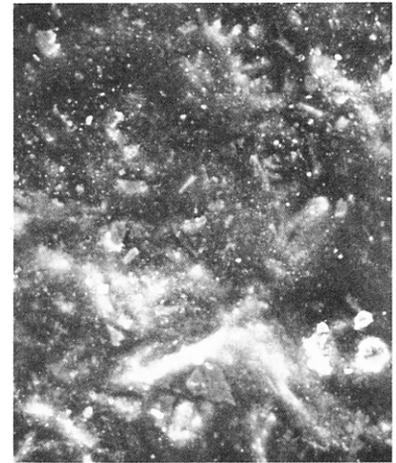
Figure 16. Scanning electron microscope images at $\times 350$ magnification.

Figure 16 shows a photomicrograph of each surface. The coatings with the densest looking surfaces are TT-P-96 and RE-NU-IT, which are relatively vapor tight according to the WVT tests. Cement paint is very cracked, and it had the highest permeance. TT-P-19, XL-70 and Sonneborn appear rough and porous. Their WVT results fall between

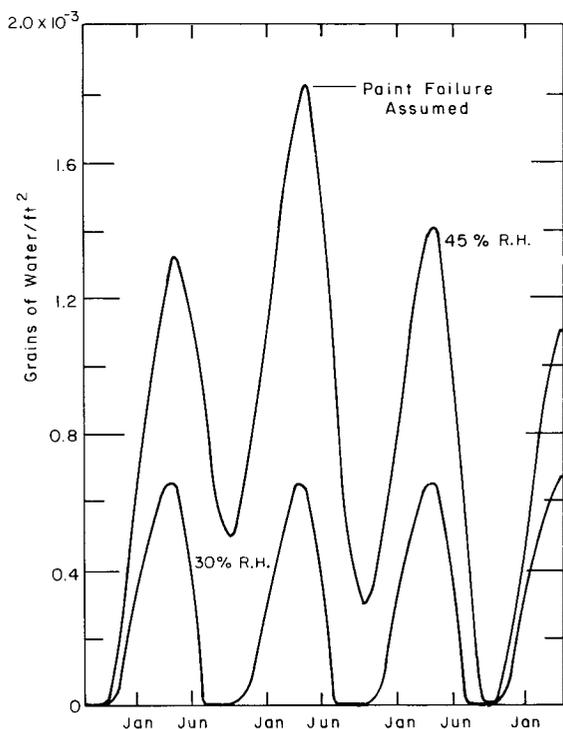
Figure 17 shows the theoretical amount of water, attributable to vapor diffusion, that may build up behind a painted surface. Building 610, Fort Greely, was chosen for this example because it provides dramatic evidence of paint failure based on two very different indoor humidities. Wall cross-section properties are given in Table 5 and indoor-outdoor conditions in Appendix B.

On the low humidity side of the building, where paint lasts 4 years, 657 grains/ft² of moisture build up each winter. This is significantly less than the buildup in the 45%-RH wall, but, obviously, it's still enough to cause premature failure.

Figure 17. Moisture wetting curves based on diffusion of water vapor for building 610, Fort Greely.
