96-12

# **PCC Airfield Pavement Response During Thaw-Weakening Periods**

## **A Field Study**

Vincent C. Janoo and Richard L. Berg

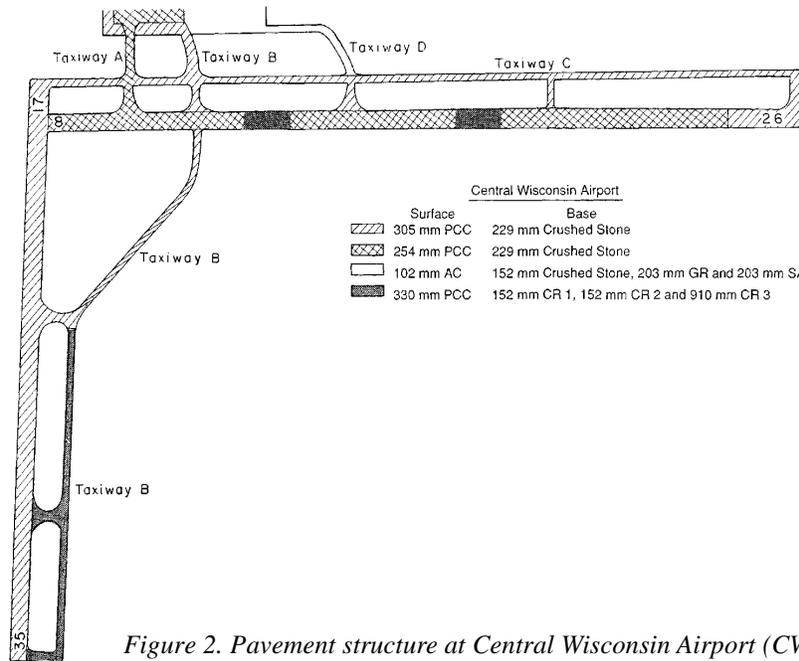
Figure 2. Pavement structure at Central Wisconsin Airport (CWA).

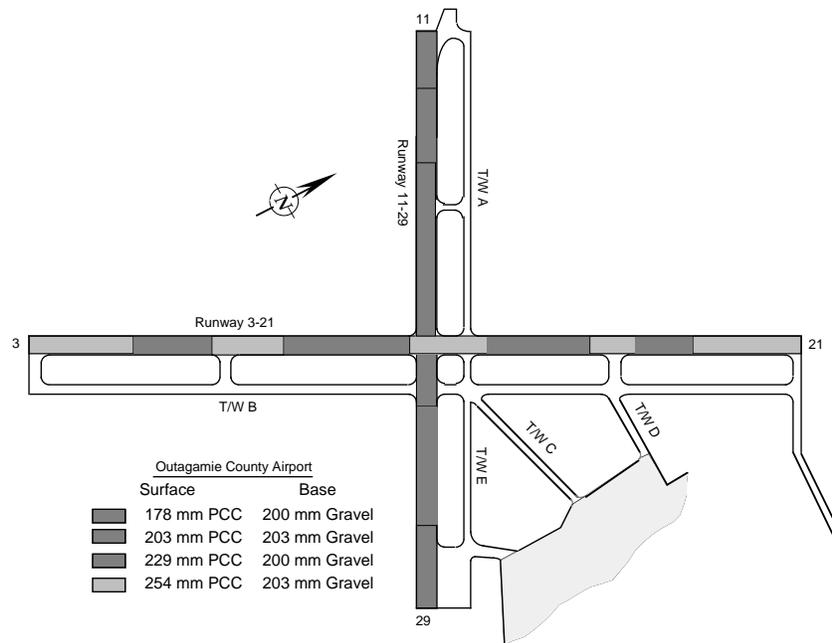
Figure 3. Pavement structure at Outagamie County Airport (OCA).

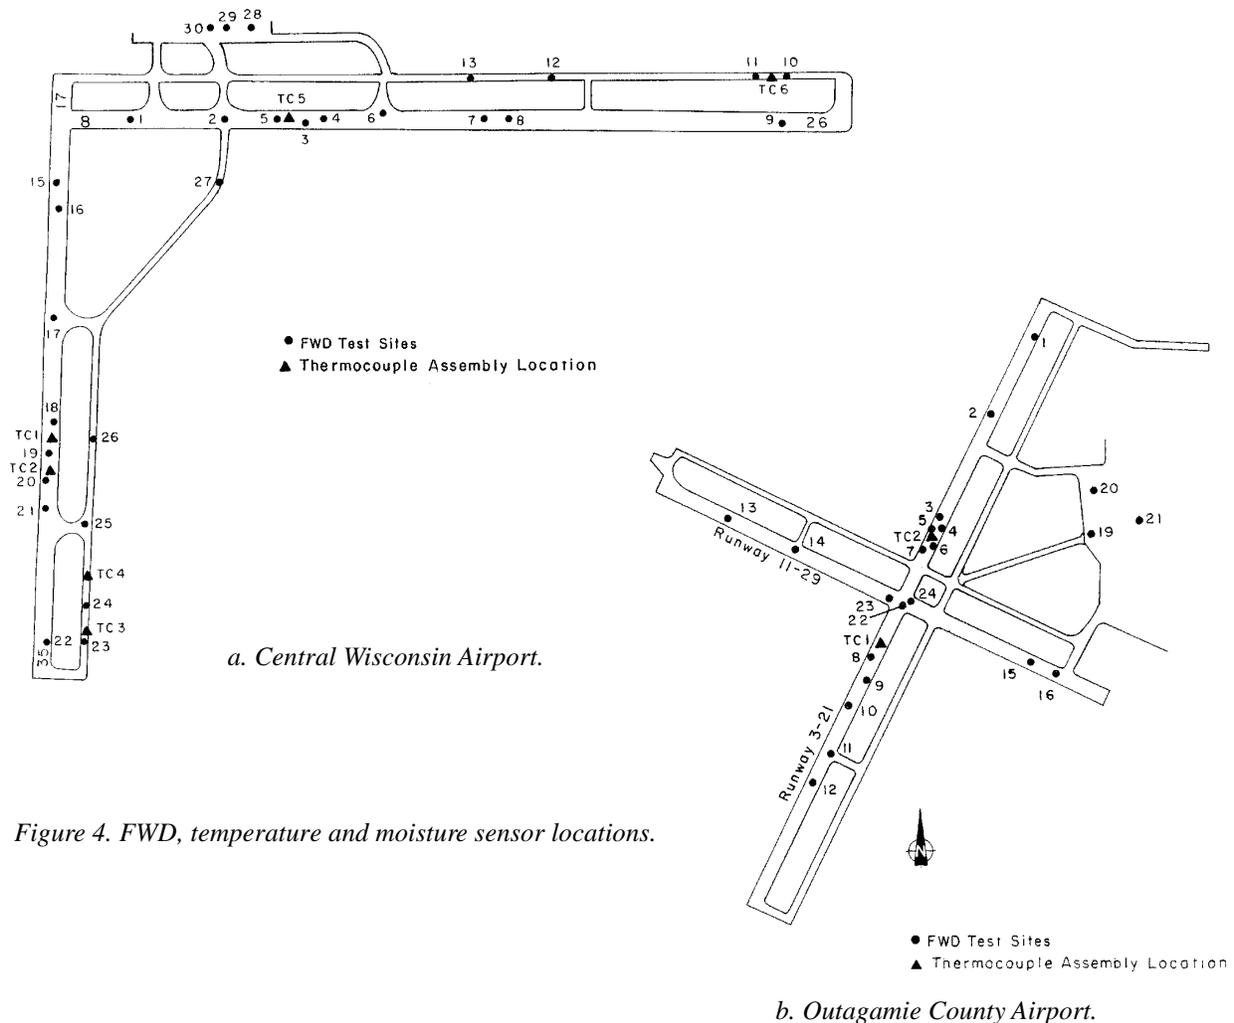
Figure 4. FWD, temperature and moisture sensor locations.

at the center of the slab, at transverse joints, longitudinal joints and at a corner. The FWD test program consisted of one drop at each of four height levels producing loads of 600, 900, 1100 and 1600 kN, respectively, on the pavement surface. The deflection sensors were located at 0, 300, 600, 900, 1200, 1500 and 1800 mm from the center of the loading plate. The FWD loading plate used was 300 mm in diameter. The location of the FWD tests at the two airports are shown in Figure 4.

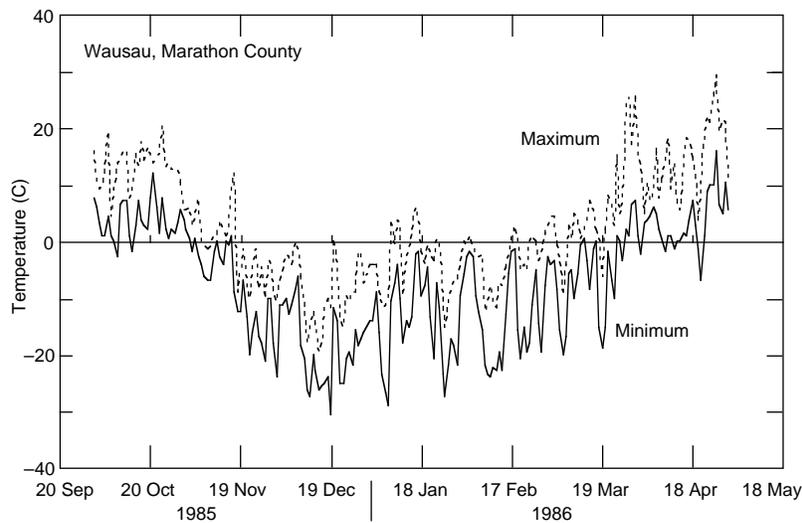
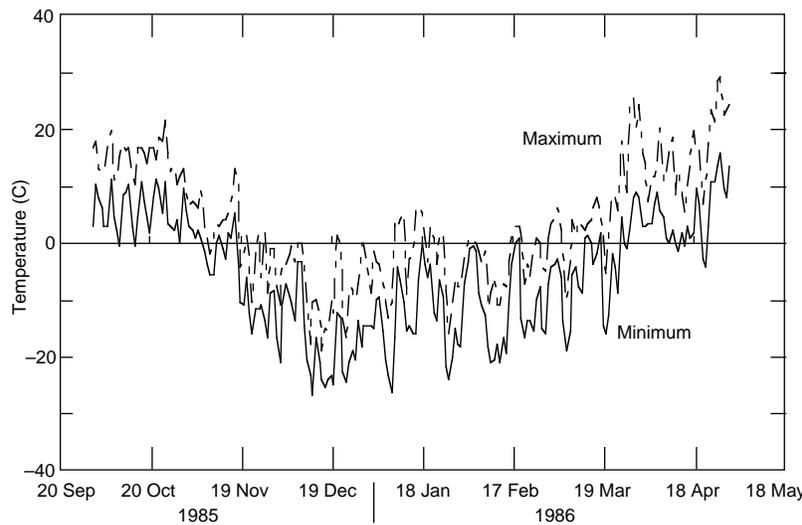
Figure 5. Daily maximum and minimum temperatures.

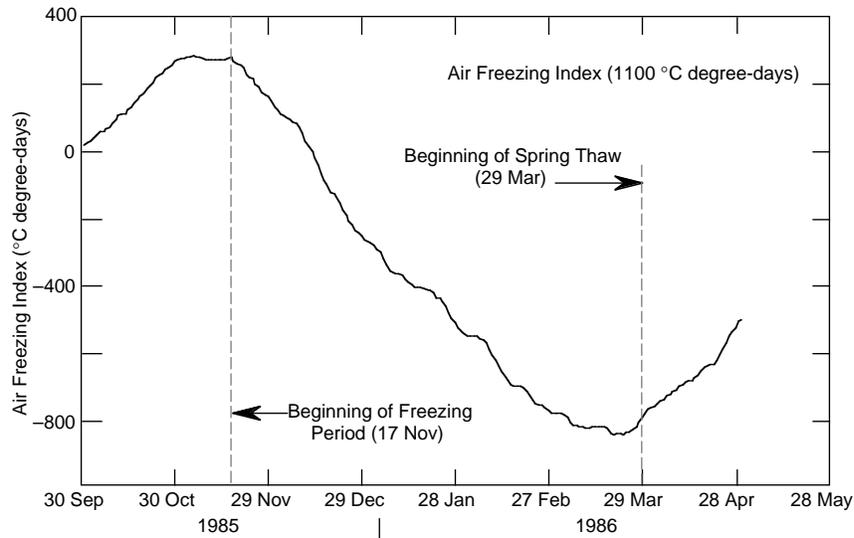
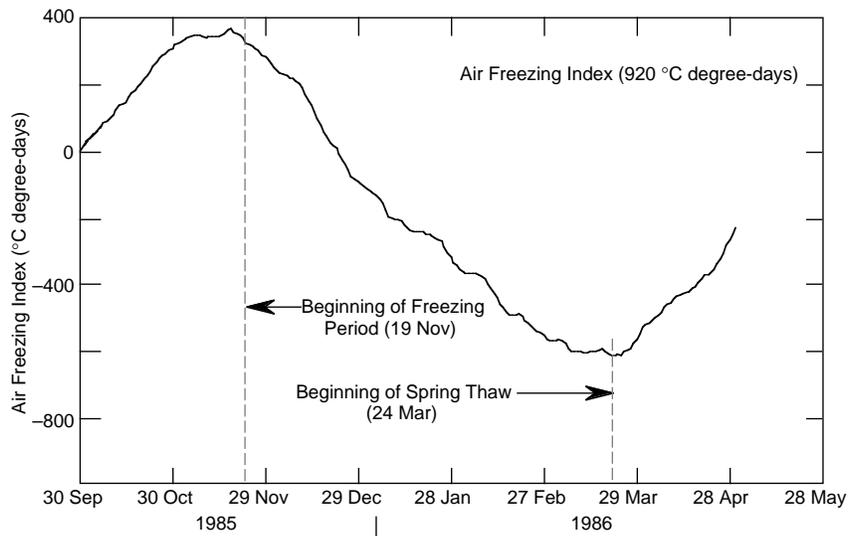
Figure 6. Air-freezing indices.

The air-freezing index range was 1100 and 920°C days at CWA and OCA respectively. The design freez-

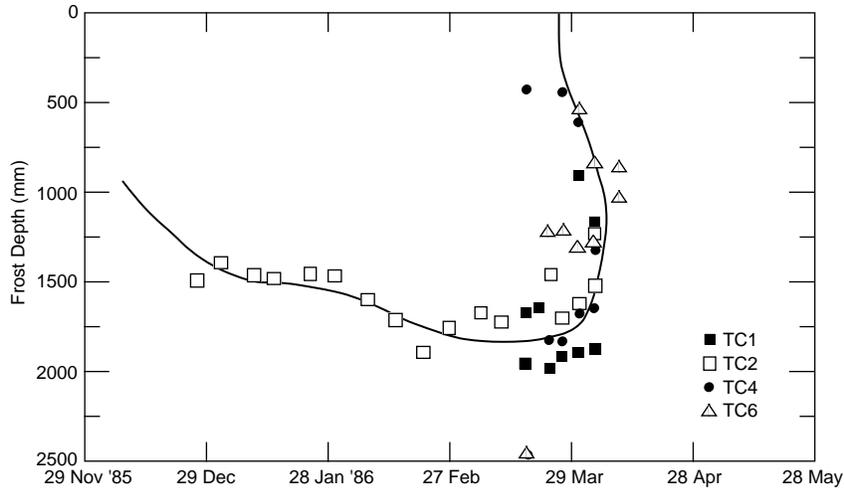
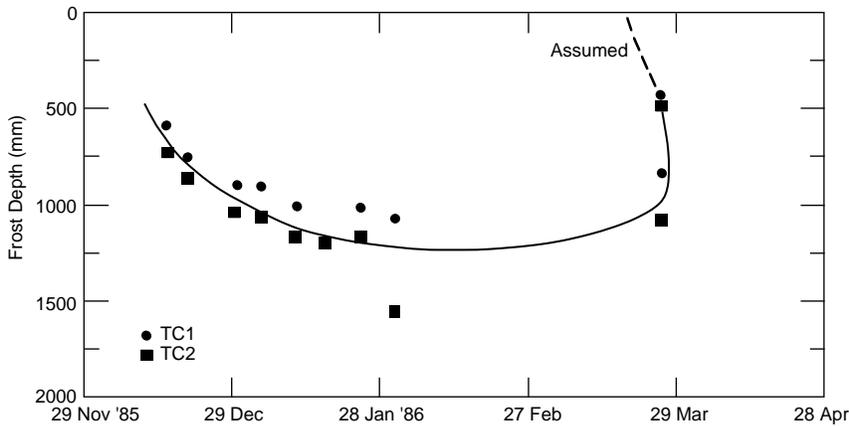
Figure 7. Frost and thaw depths calculated from subsurface temperature measurements.

Using the temperature measurements gathered from the various thermocouple locations, we determined frost and thaw depth, which we assumed to be where the temperature was 0°C. Frost depths at the beginning of the winter were calculated for some of the locations and are also presented in Janoo and Berg (1966). A summary of the frost and thaw penetration depths at CWA and OCA is presented in Figure 7. The maximum measured frost penetration at CWA ranged

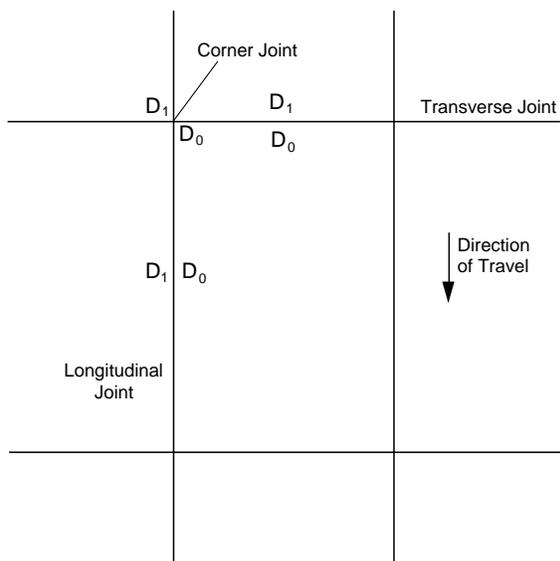
Figure 8. Location of FWD sensors across joints and corner of a PCC slab.

corner of the slab. The placement of the sensors across the joints and corner is illustrated in Figure 8. The FWD measurements were alternated between the two airports. At CWA, FWD deflection measurements began on 18 March and continued to 24 April 1986 (Table 3a). At OCA, FWD testing started on 15 March and continued to 26 April 1986 (Table 3b). The FWD deflection measurements taken at both airports are presented in Janoo and Berg (1966).

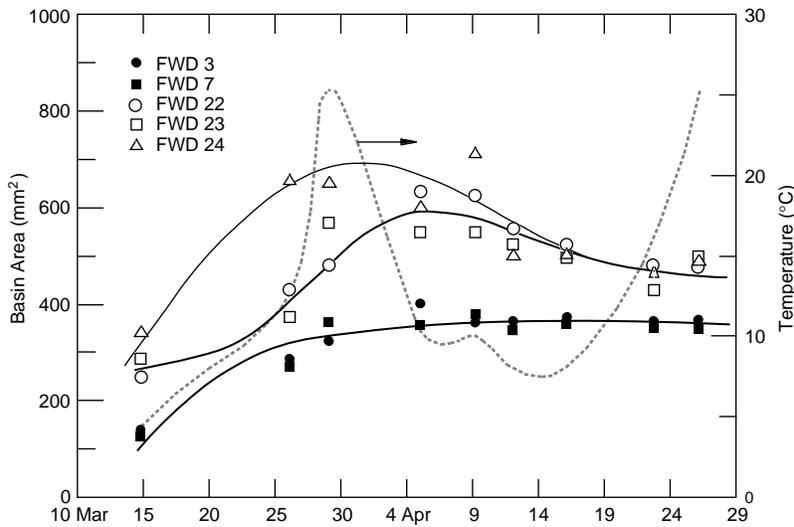
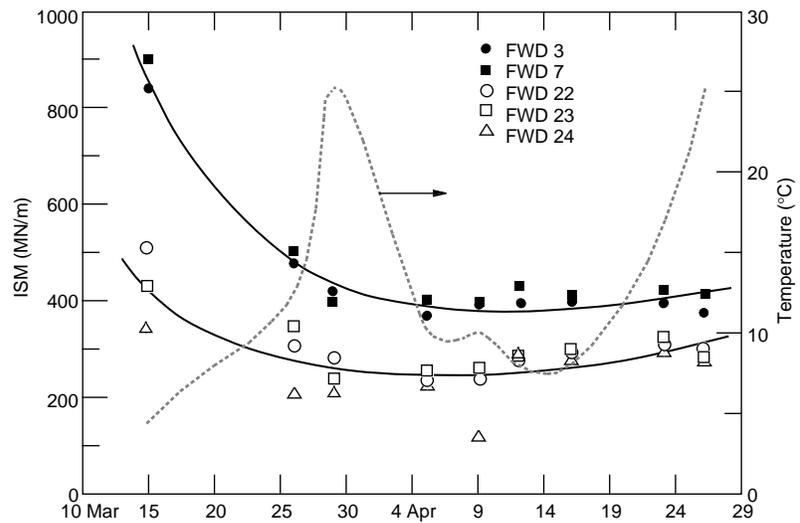
Figure 9. Changes in basin area and impulse stiffness modulus during spring thaw at Outagamie County Airport.

Typical changes in ISM values and basin areas at the centers of selected slabs are presented in Figures 9–11. The measured surface temperatures at the FWD sites are also plotted in these figures.

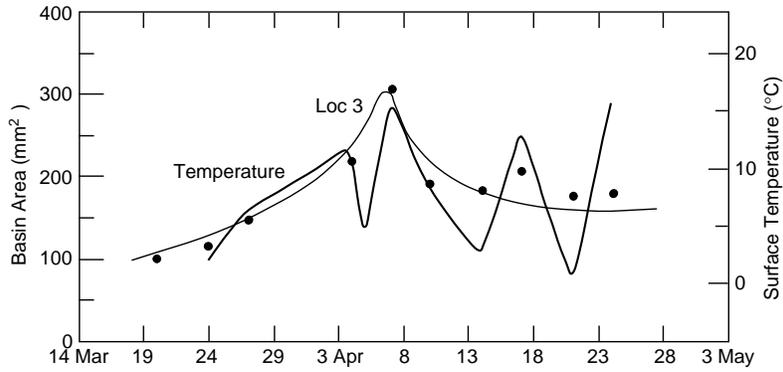
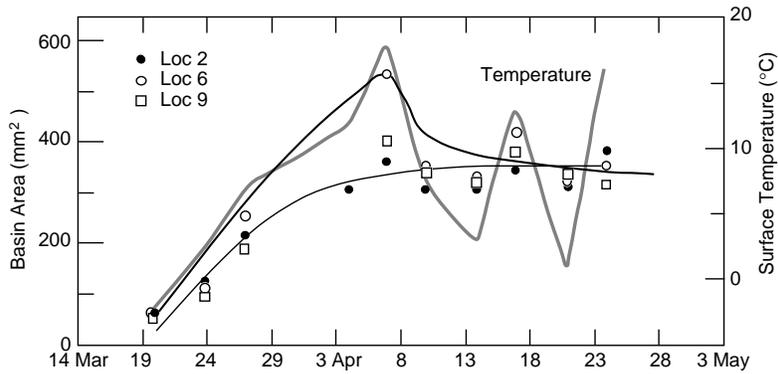
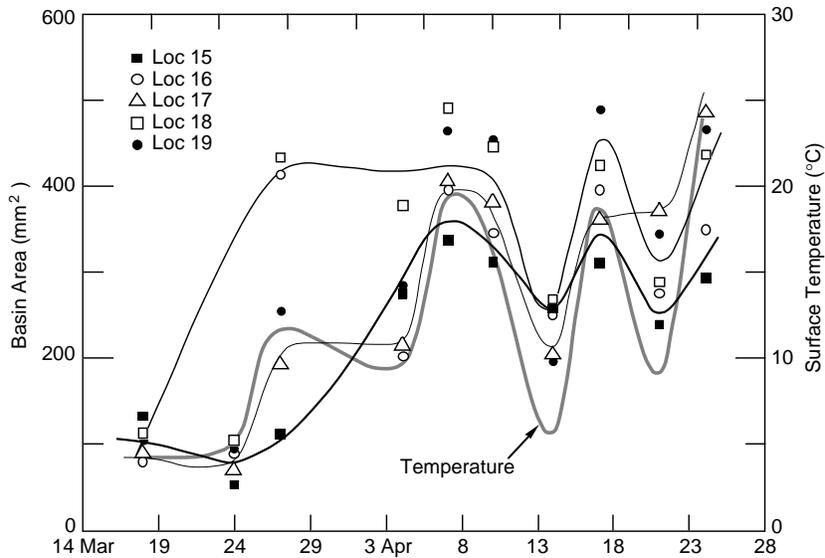
Figure 10. Changes in basin area during spring thaw at Central Wisconsin Airport.

gressed were also made at CWA (Fig. 10a,b). At some locations, we observed that the basin areas are a function of the pavement surface temperature during the recovery period (Fig. 10c). As the temperature changed, so did the basin area.

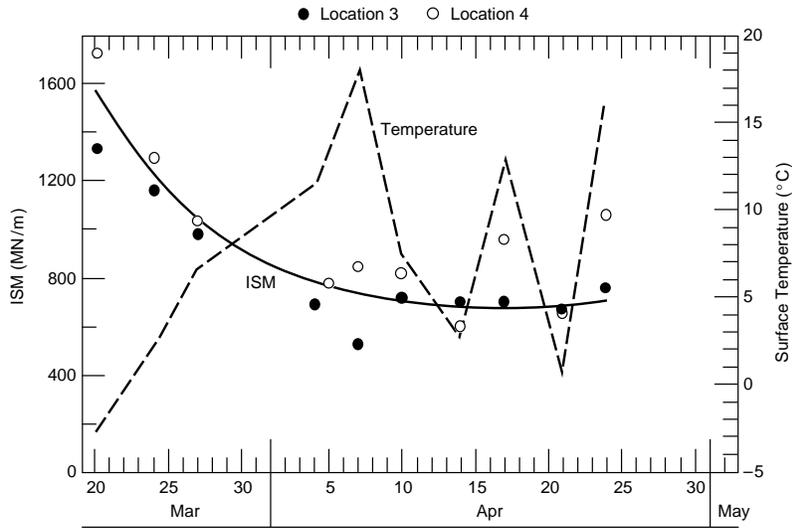
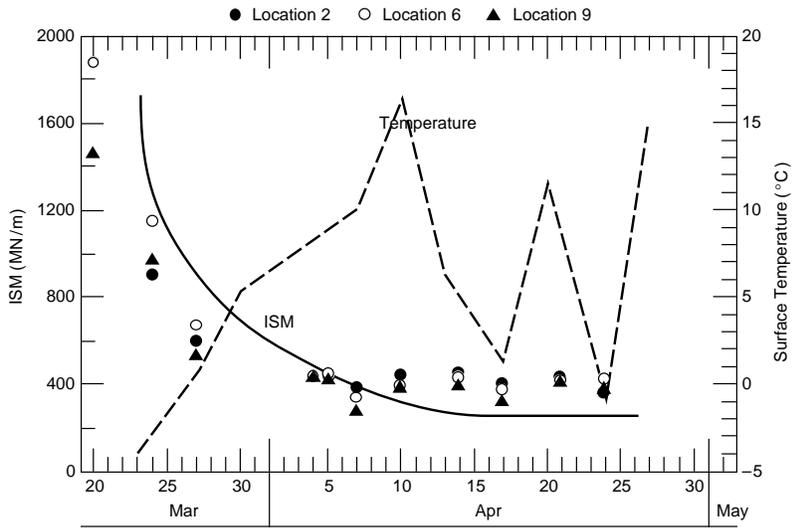
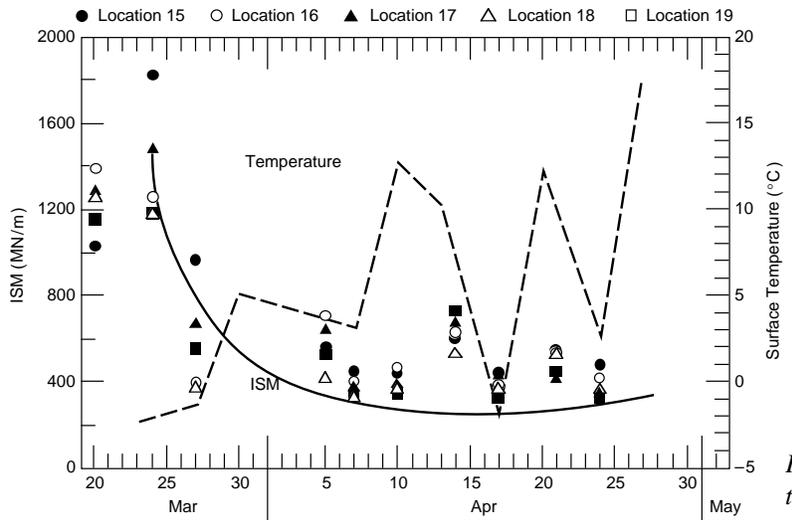
Figure 11. Changes in ISM during spring thaw at Central Wisconsin Airport.

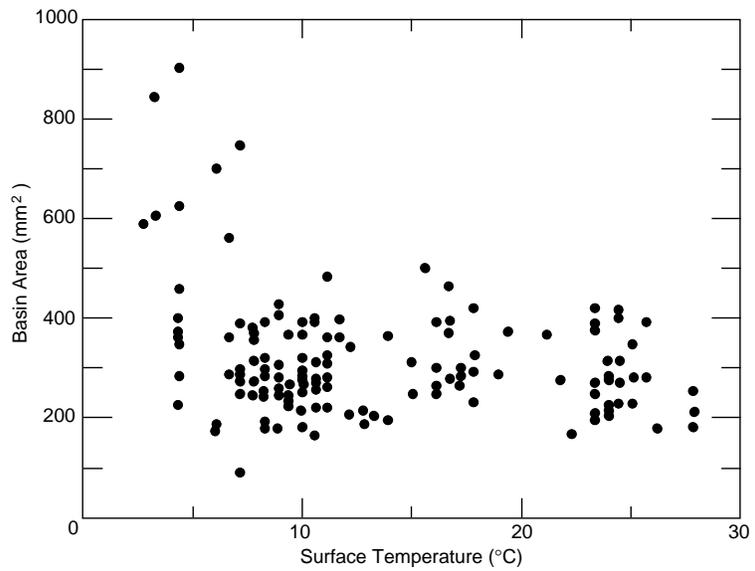
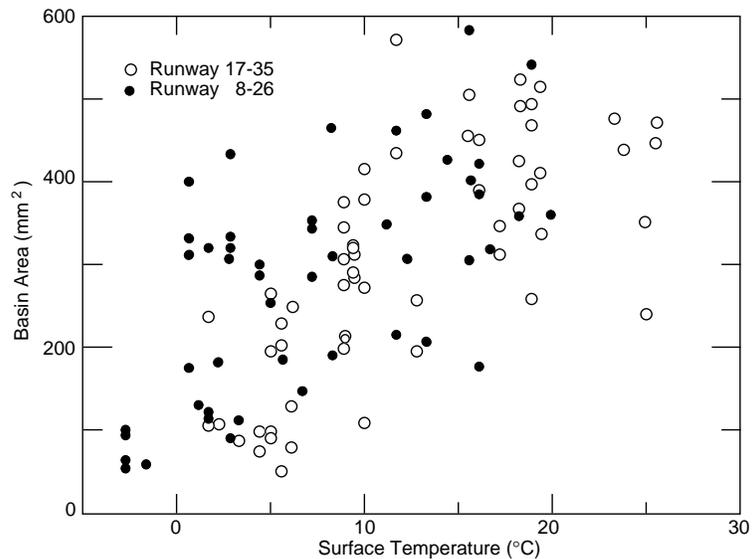
Figure 12. Relationship between surface temperature and basin area.

A study was made to see if there was any relationship between surface temperature and ISM or basin area. Figures 12a and 13a show that there is no relationship between either basin area or ISM with surface temperature at OCA. The data around 5°C indicate some form of relationship. However, we felt that the decrease in basin area or increase in ISM was probably attributable to the presence of frozen subsurface layers.

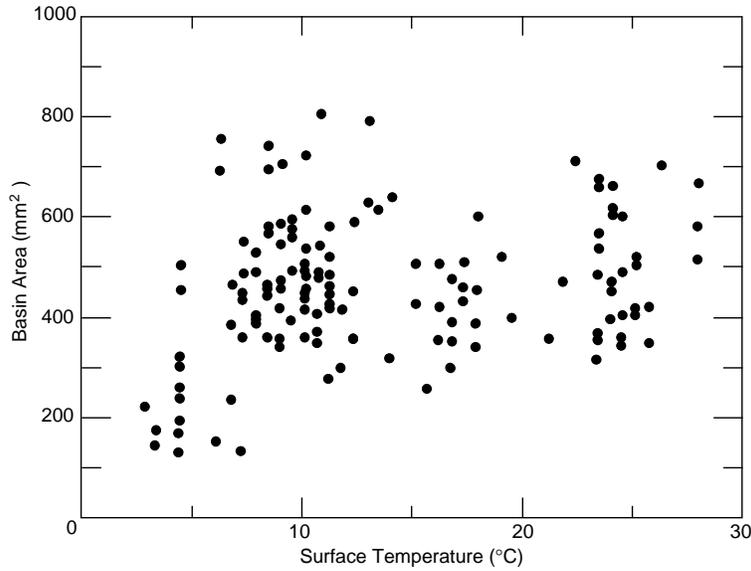
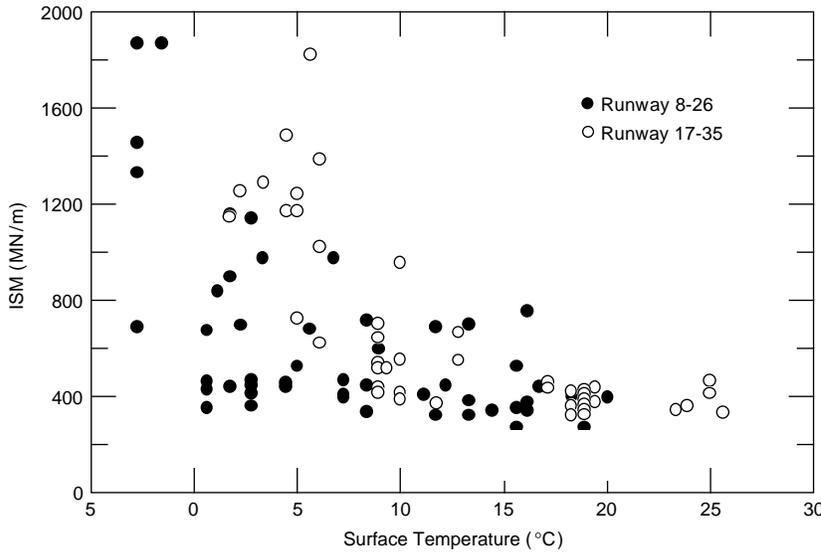
Figure 13. Relationship between surface temperature and ISM.

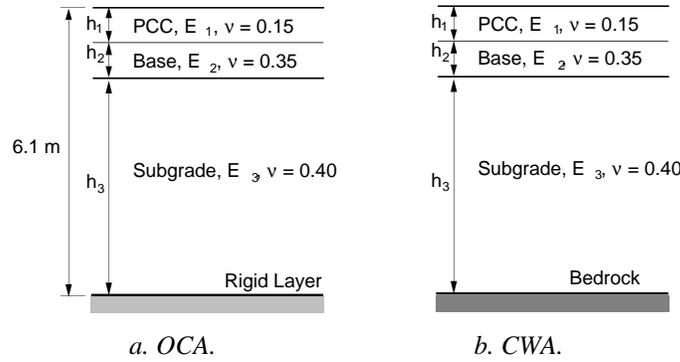
Figure 14. Idealized pavement structures.

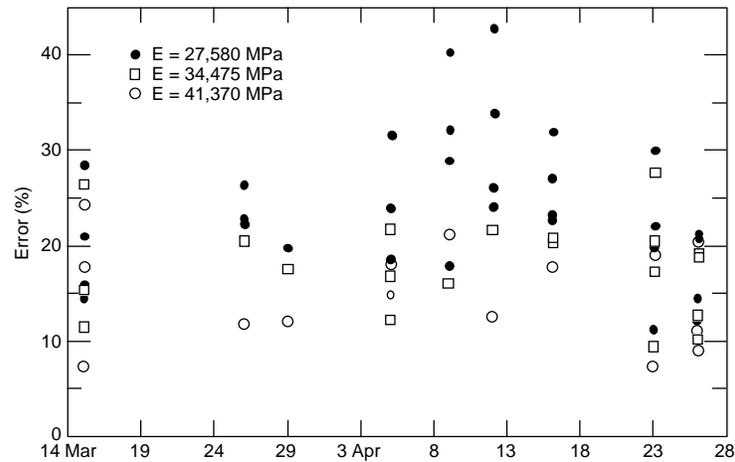
Figure 15. Effect of PCC Modulus on WESDEF absolute error (OCA).

1. Increasing the PCC stiffness from 27,580 to 41,370 MPa reduced the errors to more reasonable (AA < 20%) differences between the measured and

calculated the deflections (Fig. 15). The Absolute Arithmetic (AA) error is the absolute sum of the errors between measured and calculated deflections for the seven sensors.

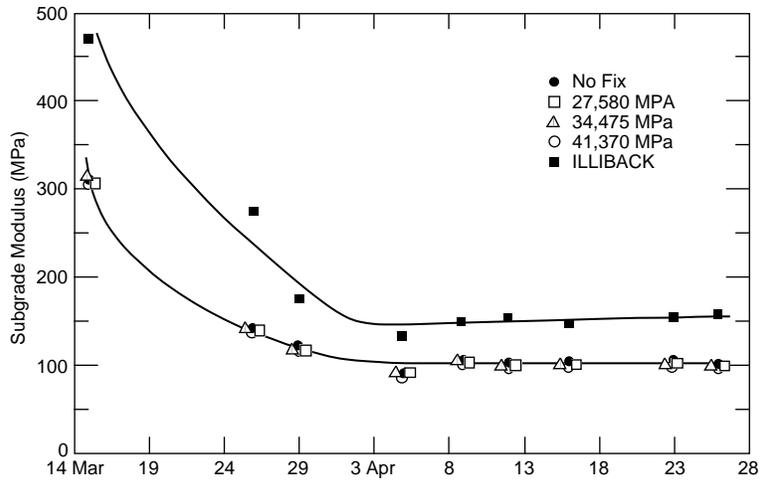
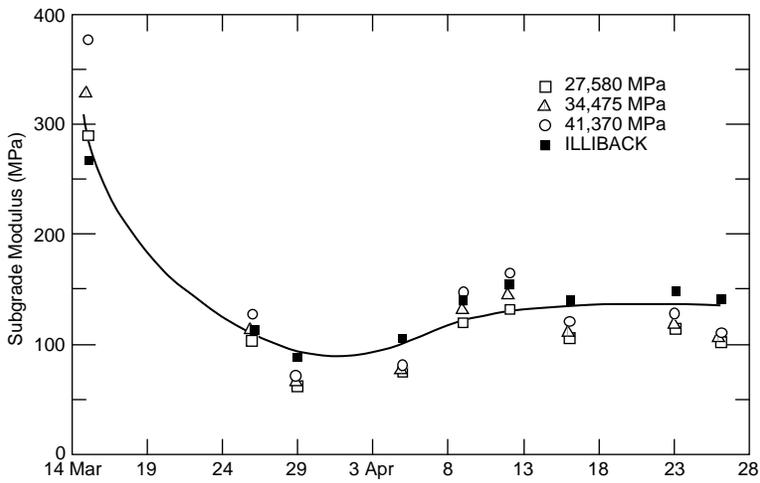
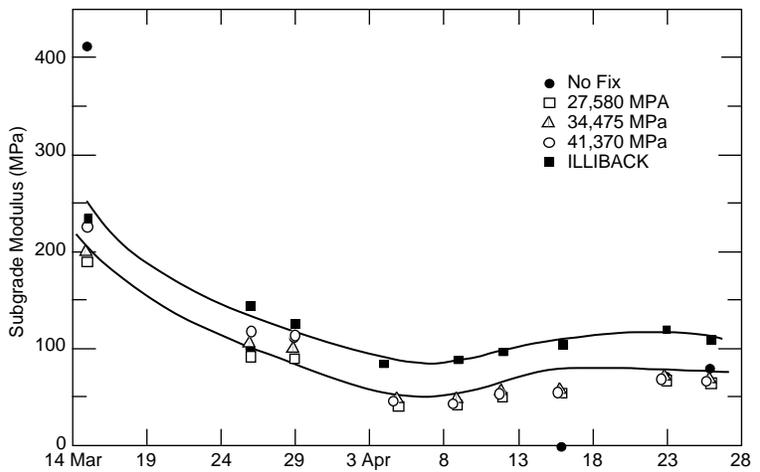
Figure 16. Effect of PCC modulus on change in subgrade modulus from WESDEF during spring thaw at Outagamie County Airport. Comparison of subgrade modulus from ILLIBACK and WESDEF.

2. Changing the PCC modulus within the range did not significantly affect the subgrade modulus (Fig. 16). We also found that the subgrade modulus obtained from the first attempt, i.e., when the modulus of the PCC layer was not established at some particular value, was very similar to that obtained when it was. This infers that, as far as the subgrade modulus is concerned, large differences between the measured and calculated deflections can be tolerated for PCC pavement.

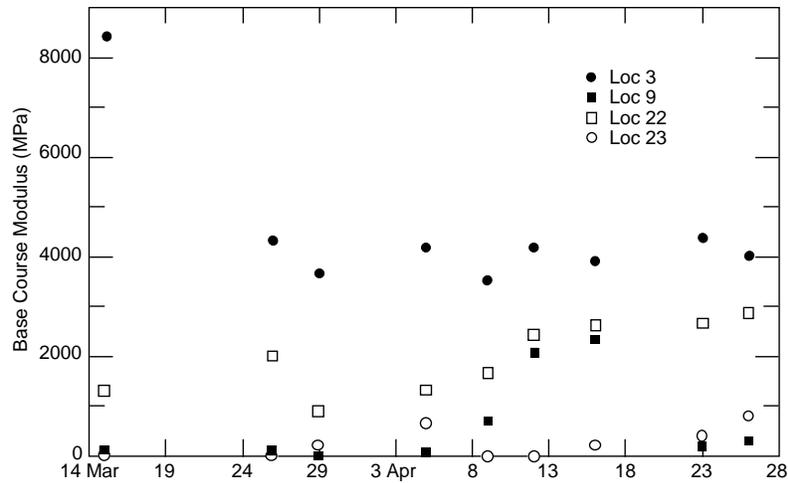
Figure 17. Backcalculated base course modulus using WESDEF (OCA).

also attempted to backcalculate the base course modulus under FWD location 3. Location 3 was different from the other sites because the base course layer was founded directly on top of the bedrock. The structure at FWD location 3 was 330 mm of PCC over 1220 mm of base over bedrock. We were unable to get reasonable agreement between the calculated and mea-

sured deflections. The AA error was in the vicinity of 450%.

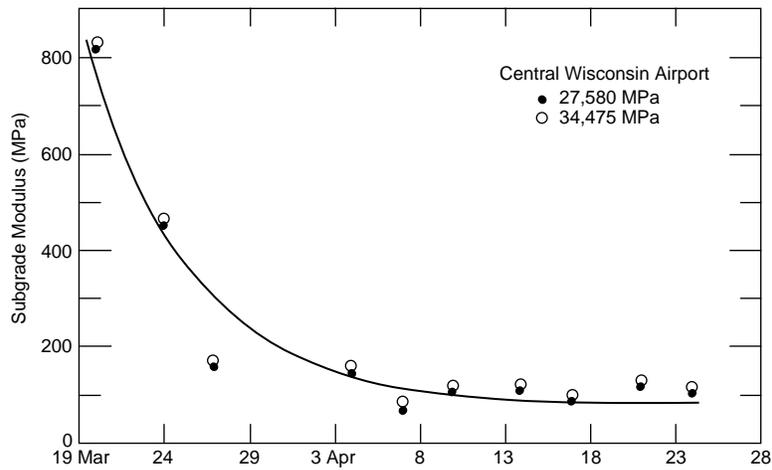
Figure 18. Change in subgrade modulus during spring thaw (FWD location 9, CWA).

found at OCA, changing the PCC modulus did not significantly affect the backcalculated subgrade modulus (Fig. 18 for location 9). However, as was also found at OCA, changing the PCC modulus had a significant effect on the base course modulus (Fig. 19). Trends in the data indicate that the base was in a weakened state from the end of March through about mid-April. The values reported here for the base course modulus are still considered too large. By combining the change in the PCC modulus with changing the different layer thicknesses, singularly or simultaneously, we found that, in some cases, we were able to reduce the base course modulus to more reasonable values. However, we felt that changing the layer thicknesses was introducing another unknown variable into the analysis. Therefore, although the base course moduli are high, we have opted to present the results obtained for the reported thicknesses. It is very clear that a small coring program should be conducted with FWD testing to verify thicknesses. Irwin et al. (1989) reported that a 6-mm change in layer thickness has a large impact on the backcalculated layer modulus. Also note that, although changing the PCC modulus affected the base course modulus, the change produced very small changes in the absolute error (Table 7).

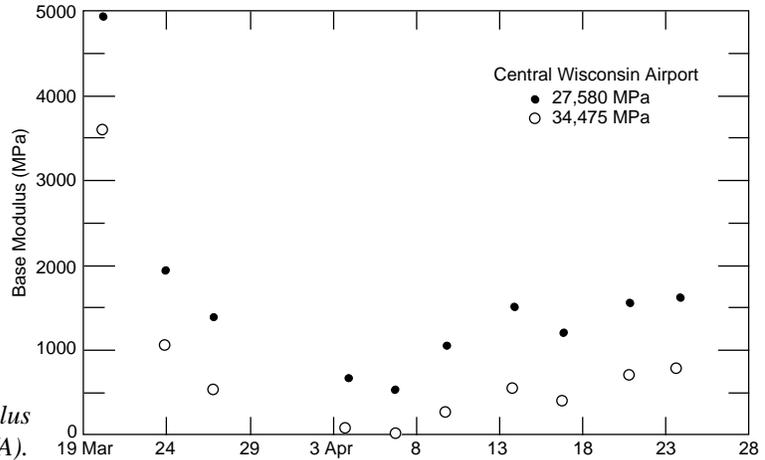
Figure 19. Change in base course modulus during spring thaw (FWD location 9, CWA).

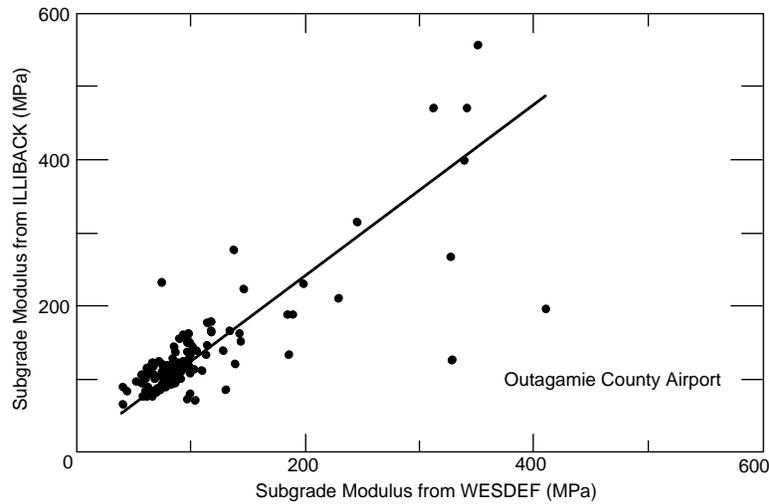
Figure 20. Relationship between subgrade moduli backcalculated by WESDEF and ILLIBACK.

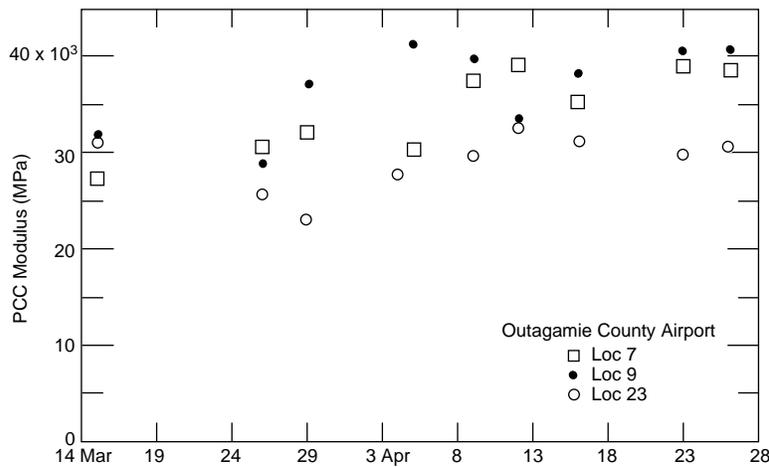
Figure 21. Typical backcalculated PCC modulus from ILLIBACK (OCA).

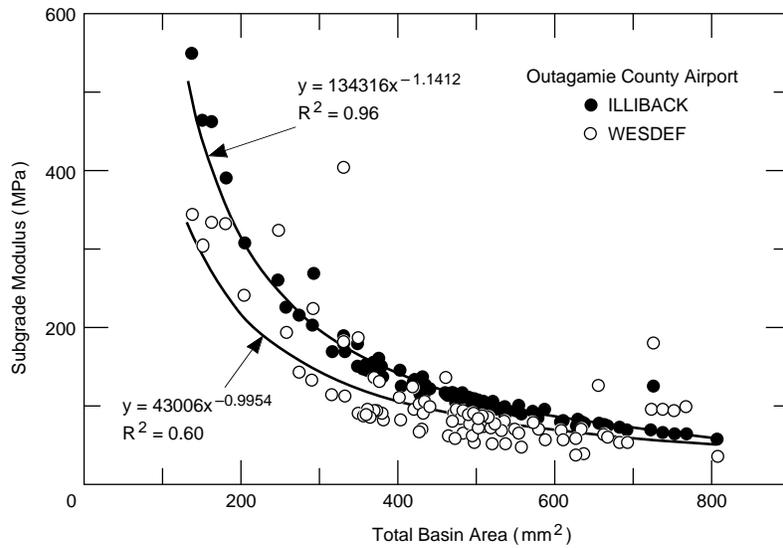
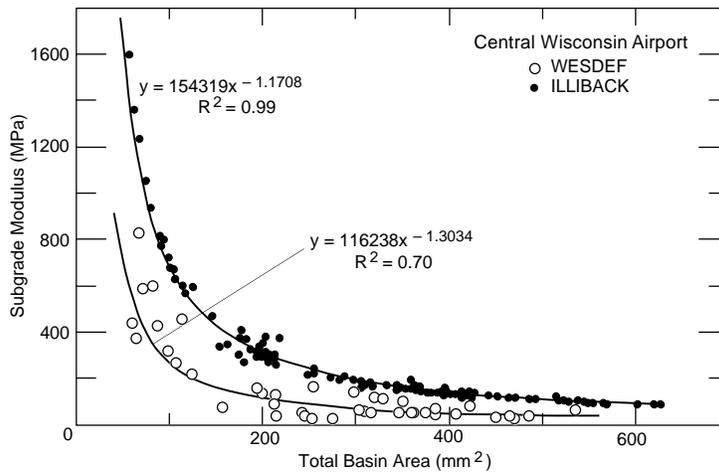
Figure 22. Relationship between measured total basin area and calculated subgrade modulus.

oped. Basin area results from ILLIBACK and WESDEF are shown for both OCA and CWA in Figures 22 and 23. In Figure 22, the total basin area was calculated using all seven deflections. In Figure 23, the basin area was calculated using the third to seventh deflections.

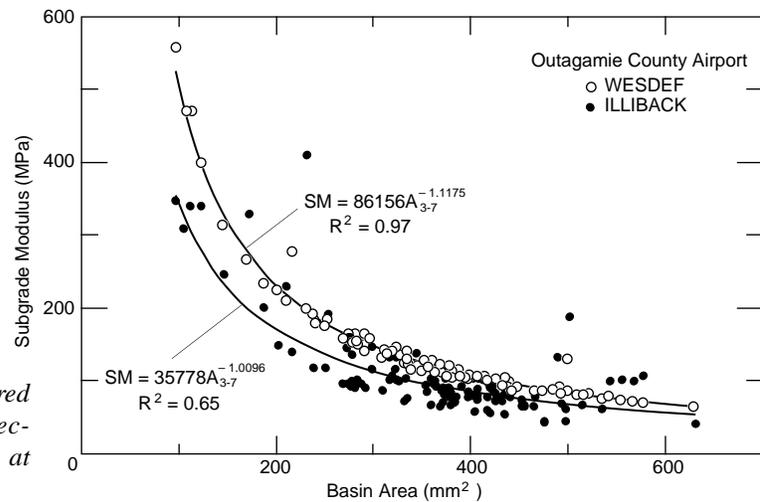
Figure 23. Relationship between measured partial basin area (third–seventh deflections) and calculated subgrade modulus at Outagamie County Airport.

Previously, we had determined that the thaw depth under AC pavements could be related to the partial basin area calculated using the third to seventh deflections (Janoo and Berg 1990). The current data indicate that this partial basin area ( $A_{3-7}$ ) may be related to the subgrade modulus. The figures show that as the total basin area or partial basin area increased, the subgrade modulus decreased. A power relationship was found to best fit the total basin area or partial basin area and the subgrade modulus. We also found that a better correlation existed with the subgrade modulus obtained from ILLIBACK. The use of the partial basin area ( $A_{3-7}$ ) (Fig. 23) did not significantly increase the correlation at OCA. We used other combinations of deflections to

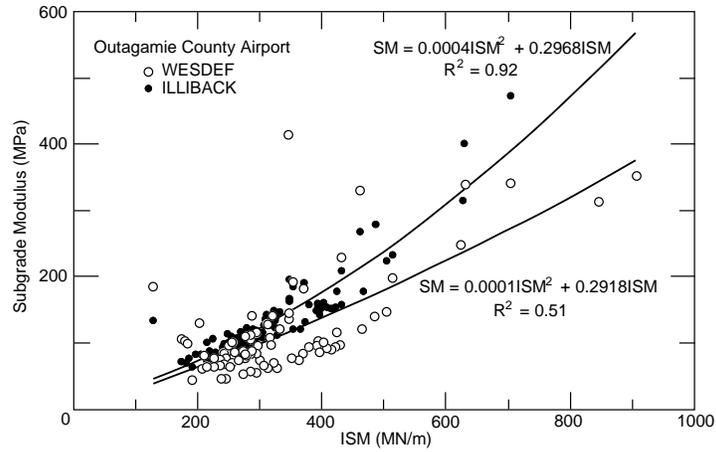
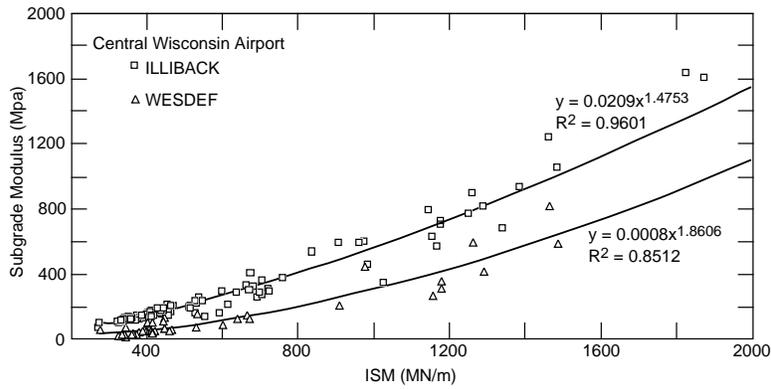
Figure 24. Relationship between measured ISM and calculated subgrade modulus at Outagamie County Airport and Central Wisconsin Airport.

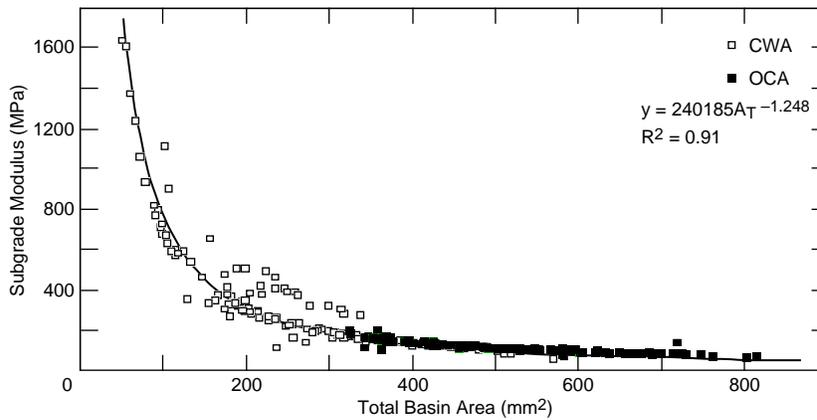
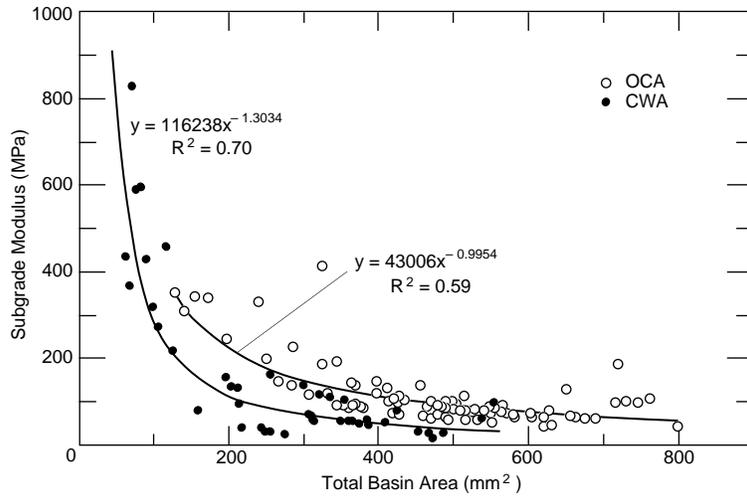
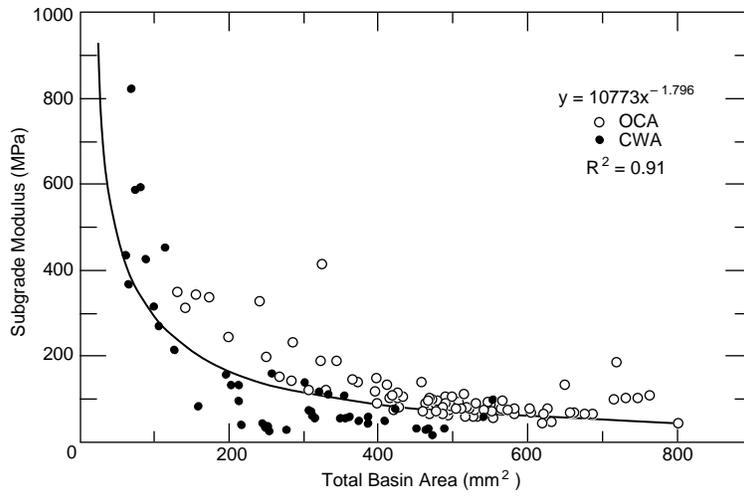
a. Calculated using ILLIBACK.

Figure 25. Relationship between total basin area and subgrade modulus at Outagamie County Airport and Central Wisconsin Airport.

b. Calculated using WESDEF.

c. Calculated using WESDEF with a single power trend.

The results from OCA and CWA are combined in Figures 25 and 26. In Figure 25a presents a relationship developed between the measured total basin area and subgrade modulus calculated from ILLIBACK for both sites. An excellent correlation between total basin area and subgrade modulus is found. In Figure 25b, the relationship developed between the total basin area and subgrade modulus calculated from WESDEF for both sites is presented. There are two distinct trends. This is probably attributable to the separation of the base and subgrade in WESDEF. Again, a power curve seems to

best fit the data, so for estimation, a single power trend was applied to the data as shown in Figure 25c. Figure 26 shows the relationship between the measured total basin area and the coefficient of subgrade reaction ( $k$ ) computed from ILLIBACK for both sites. The following equations have been developed from the ILLIBACK results and can be used to estimate the subgrade modulus and the coefficient of subgrade reaction ( $k$ )

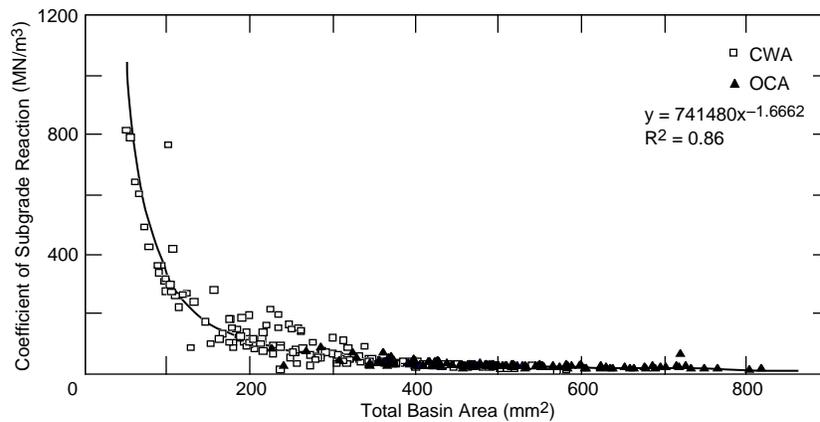
Figure 26. Relationship between total basin area and coefficient of subgrade reaction calculated using ILLIBACK at Outagamie County Airport and Central Wisconsin Airport.

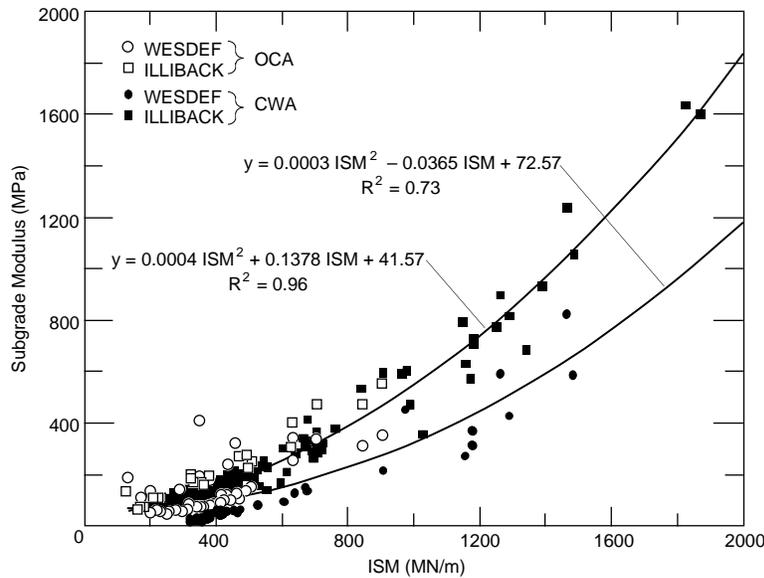
Figure 27. Relationship between ISM and subgrade modulus at OCA and CWA.

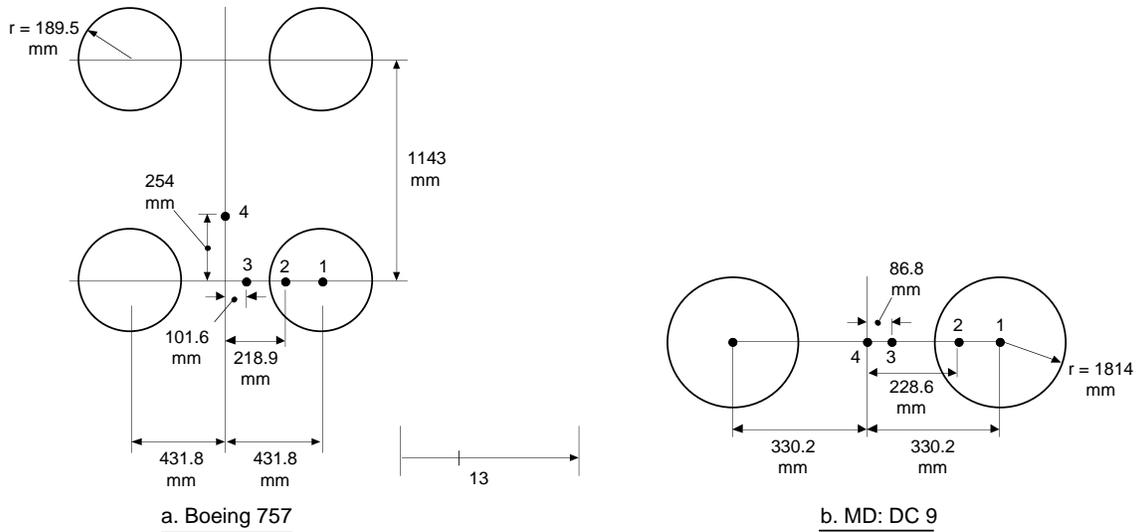
Figure 28. Configuration and location of stress calculations for Boeing 757 and MD-DC9.

Layer moduli from ILLIBACK were used to represent the pavement structures. The computer program BISAR was used to calculate the stresses at locations shown in Figure 28. The stress calculation points are the same as those used in FAALEA. The results are tabulated in Table 10 and damage is shown for CWA in Figure 29. As thaw progresses, the amount of damage increases until thawing is complete; then it levels off with time. The results also indicate that the damage is a function of pavement thickness, a linear relationship being found in the 24 April data from CWA (Fig. 30).

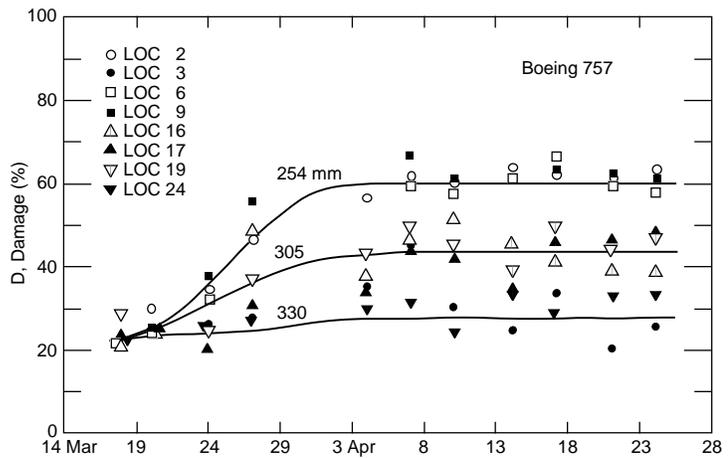
Figure 29. Amount of damage during spring thaw at Central Wisconsin Airport.

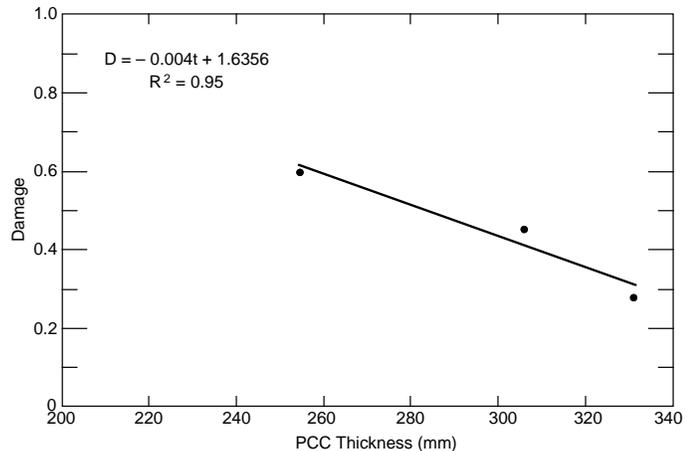
Figure 30. Effect of pavement thickness on damage at Central Wisconsin Airport.

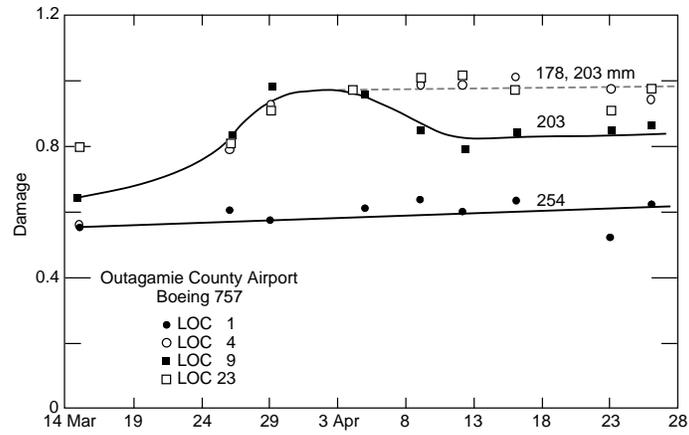
Figure 31. Amount of damage during spring thaw at Outagamie County Airport.

The thinner pavements (178 to 203 mm) at OCA showed potential near-failure conditions during the spring thaw (Fig. 31). Some pavements recovered somewhat, as typified by location 9 (Fig. 31). The thicker section (location 23, 254 mm) had a similar amount of damage as those sections of similar thickness at CWA; however, the OCA sections did not exhibit the loss during the thawing period observed at CWA.

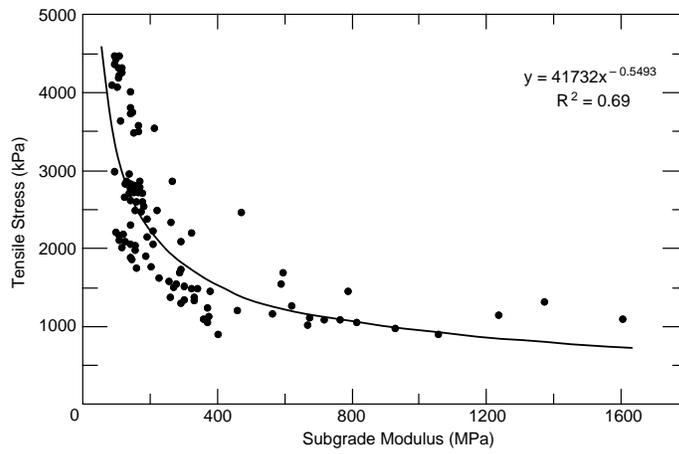
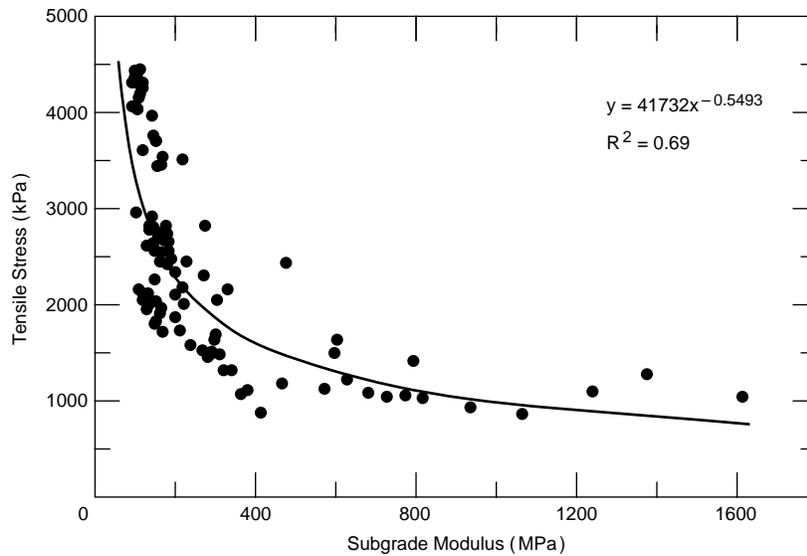
Figure 32. Effect of subgrade modulus on the horizontal tensile stress at the bottom of the PCC layer (OCA and CWA).

The horizontal stresses are plotted as functions of the subgrade modulus, coefficient of subgrade reaction and the PCC modulus in Figures 32–34. With respect to the PCC modulus, no trends were seen (Fig. 34), and nonlinear trends were observed for all of
