96-12

# **PCC Airfield Pavement Response During Thaw-Weakening Periods**

## **A Field Study**

Vincent C. Janoo and Richard L. Berg

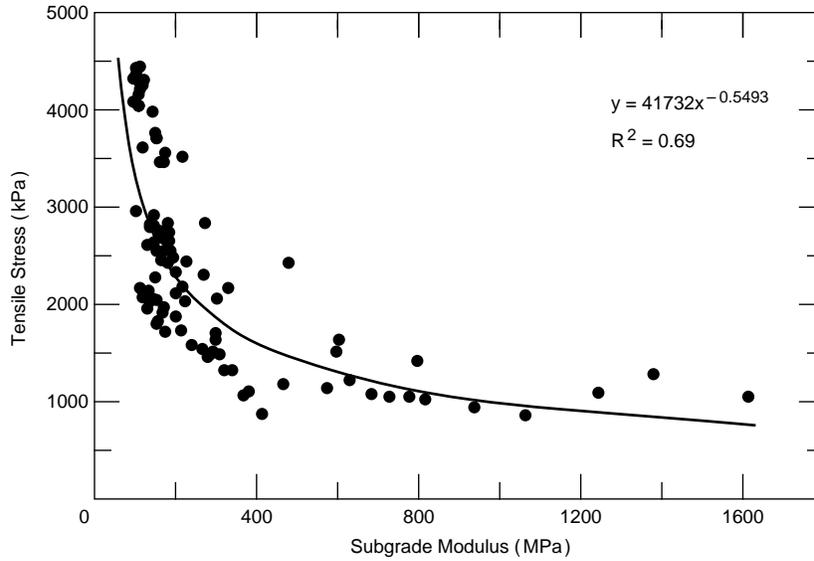
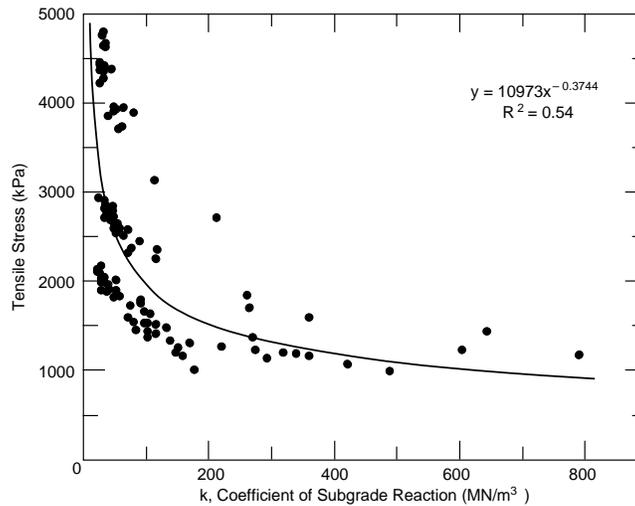
Figure 33. Effect of the coefficient of subgrade reaction,  $k$ , on the horizontal tensile stress at the bottom of the PCC layer.

The horizontal stresses are plotted as functions of the subgrade modulus, coefficient of subgrade reaction and the PCC modulus in Figures 32–34. With respect to the PCC modulus, no trends were seen (Fig. 34), and nonlinear trends were observed for all of

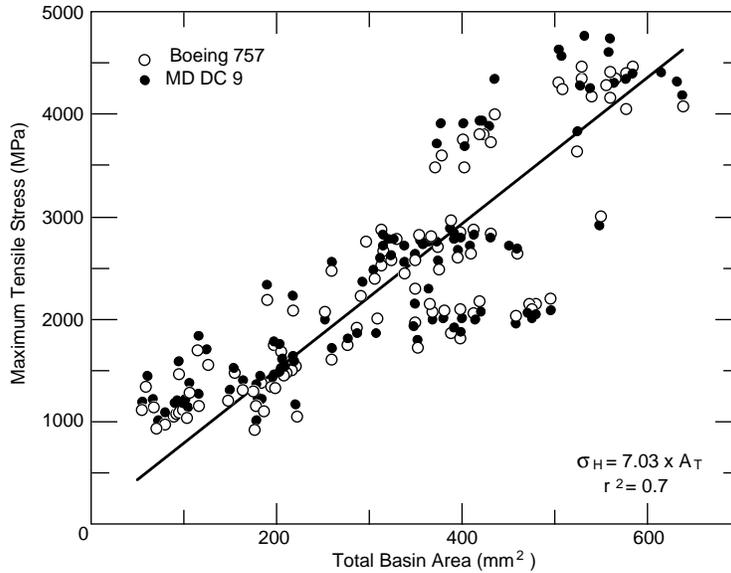
Figure 35. Linear relationship between total basin area and maximum horizontal tensile stress at bottom of PCC Layer.

The relationship between the total basin area and the horizontal stresses ( $\sigma_h$ ) at the bottom of the PCC layer is shown in Figure 35. A linear trend was applied to the

results. We used partial basin areas, but found no better correlation. The following equation can be used to determine  $\sigma_h$  from the total basin area

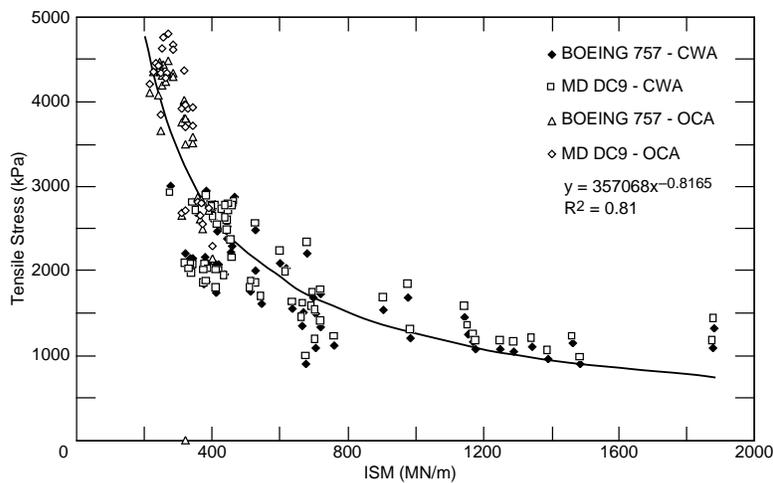
Figure 36. Relationship between ISM and horizontal tensile stress at bottom of PCC Layer.

The ISM can also be used to estimate  $\sigma_h$ , as shown in Figure 36. A power relationship was found to best describe the relationship between ISM and ( $\sigma_h$ )

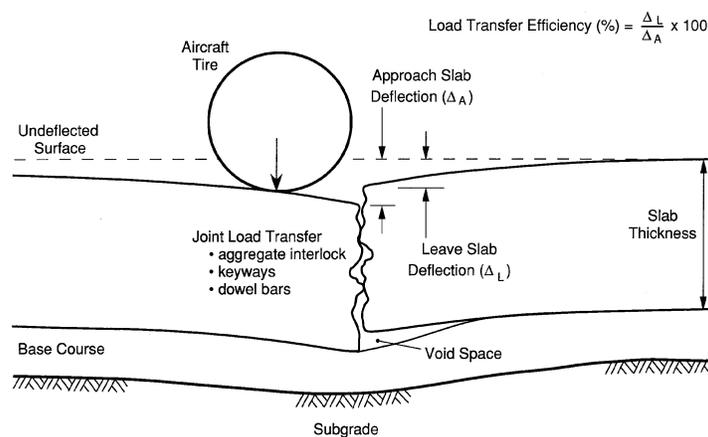
Figure 37. Load transfer efficiency across a joint.

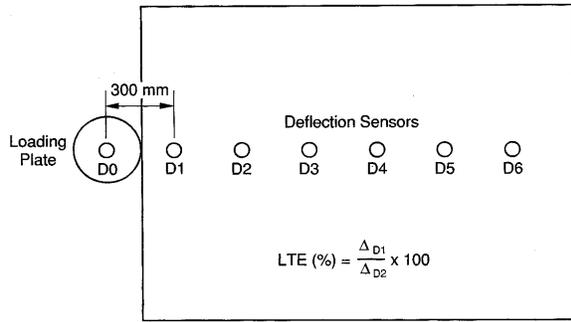
Figure 38. Placement of FWD sensors for load transfer efficiency test.

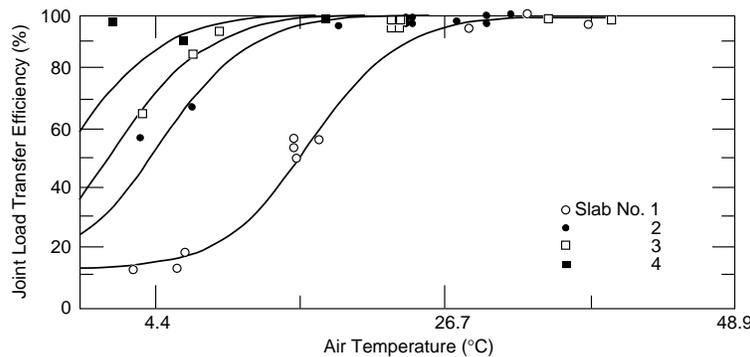
Figure 39. Relationship between air temperature and transverse joint load transfer efficiency (after Foxworthy 1985).

Foxworthy (1985) developed relationships for predicting the LTE. He found that, in general, an S type curve could be used to fit his results concerning load transfer efficiency and temperature (Fig. 39). The JTE-temperature relationships obtained by Foxworthy were from tests conducted at different times of the day where the only changes that were occurring were in the PCC layer. Since the base and subgrade strengths were changing very little with time, these results may not be applicable to pavements during thaw-weakening periods. So, we used the limited data collected at OCA and CWA to study the effects of changing subbase-subgrade stiffness during spring thaw on JTE.

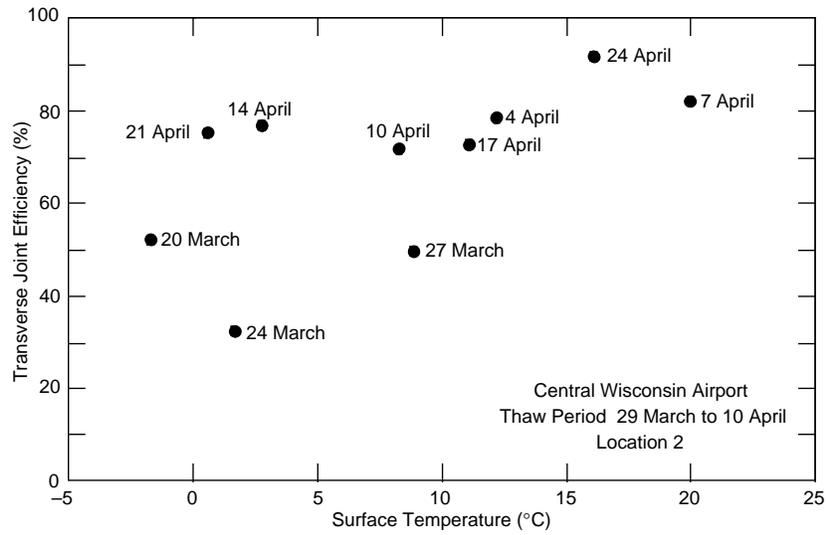
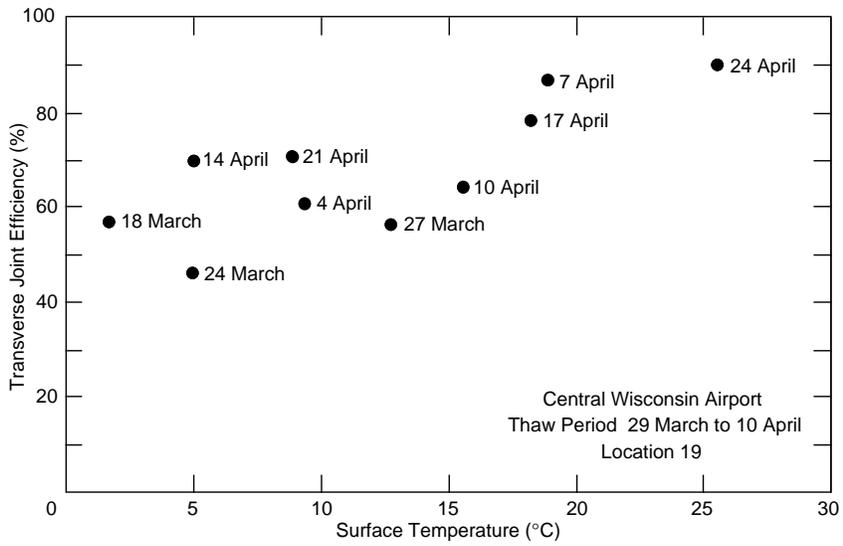
Figure 40. Change of transverse joint efficiency with surface temperature.

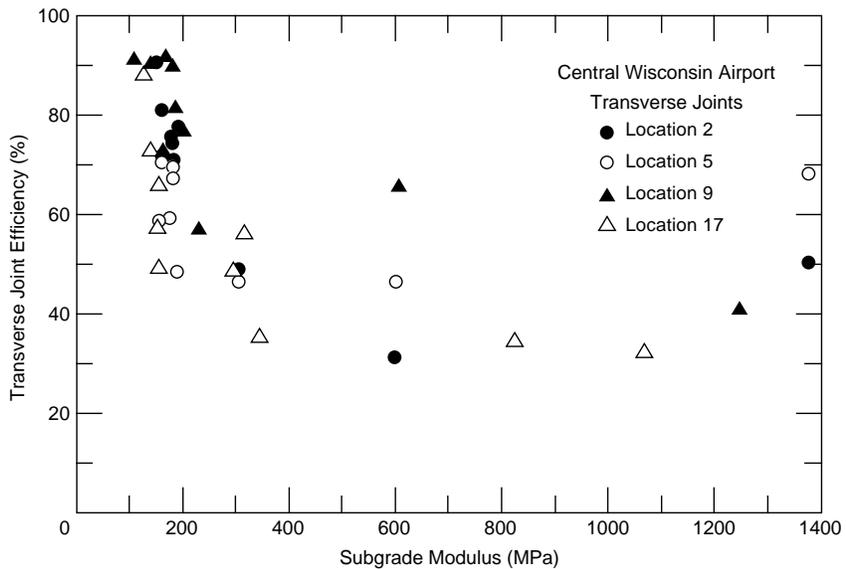
Figure 41. Effect of subgrade modulus calculated with ILLIBACK on transverse joint efficiency.

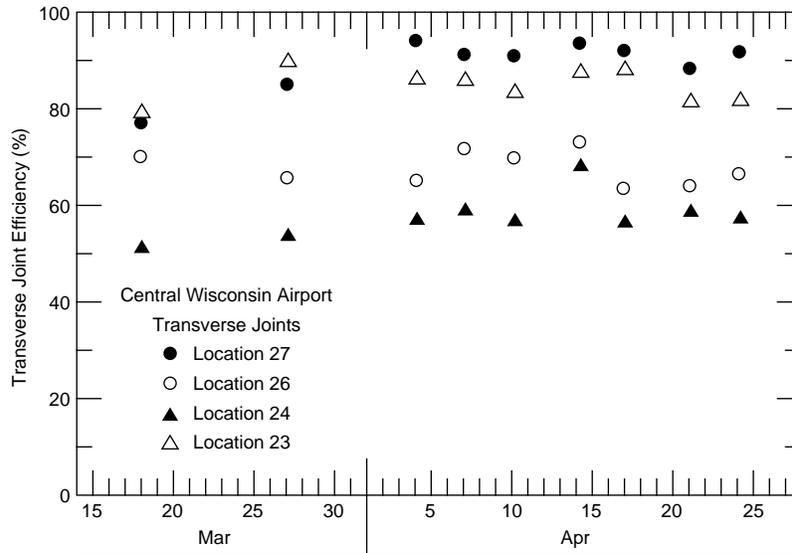
Figure 42. Change in transverse joint transfer with time on taxiway B.

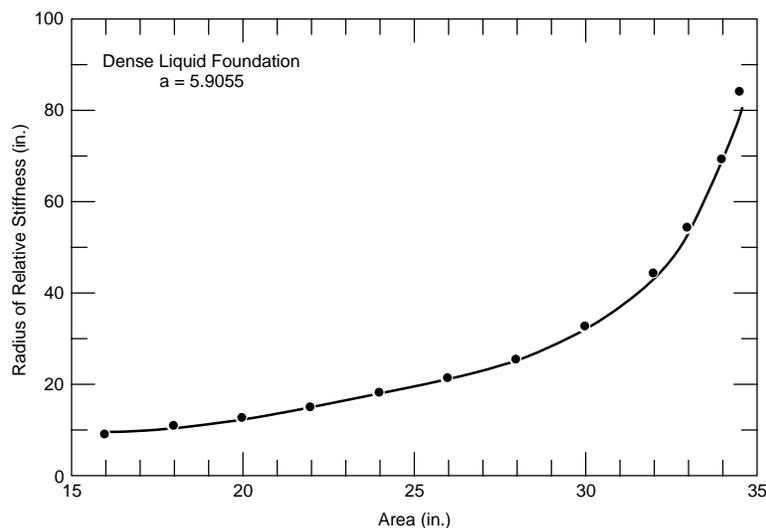
Figure 43. Relationship between AREA and  $l$  for a dense liquid foundation,  $a = 5.90655$  in. (after Hammon and Pittman 1993).

The LTE was determined for the transverse joints both at CWA and OCA using the procedure outlined in Hammons and Pittman (1993). The LTE across a joint is estimated as a function of the radius of relative stiffness ( $l$ ) and the JTE. The JTE is determined from FWD deflection data as discussed above. The radius of relative stiffness ( $l$ ) is determined from the normalized basin area ( $AREA$ ) from a unique relationship developed by Ioannides (1989). This relationship for a dense liquid foundation is reproduced in Figure 43. A sixth-order polynomial equation was developed for

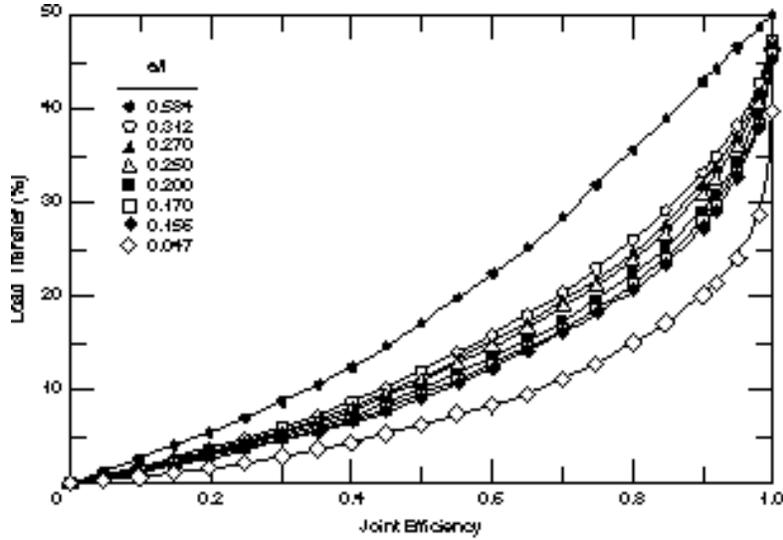
Figure 44. Interpolated relationships between joint efficiency and load transfer as a function of  $a/l$  (after Hammon and Pittman 1993).

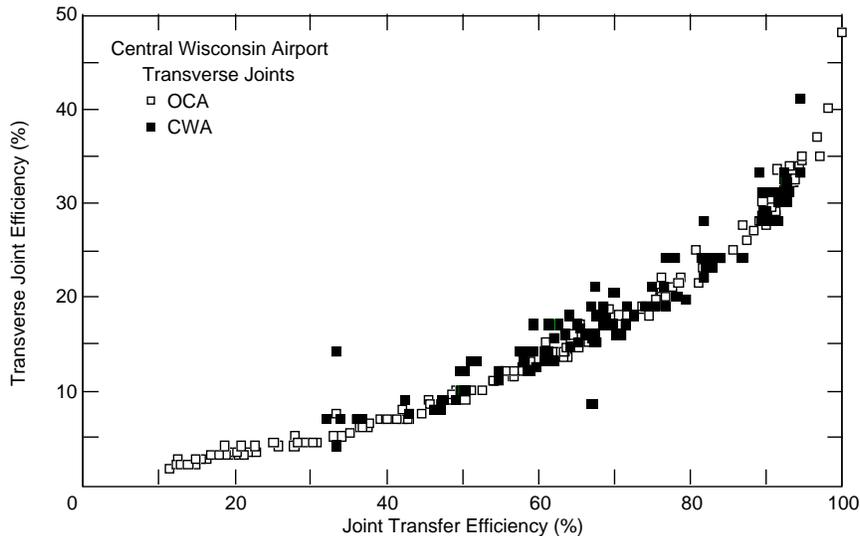
Figure 45. Relationship between JTE and LTE for transverse joints.

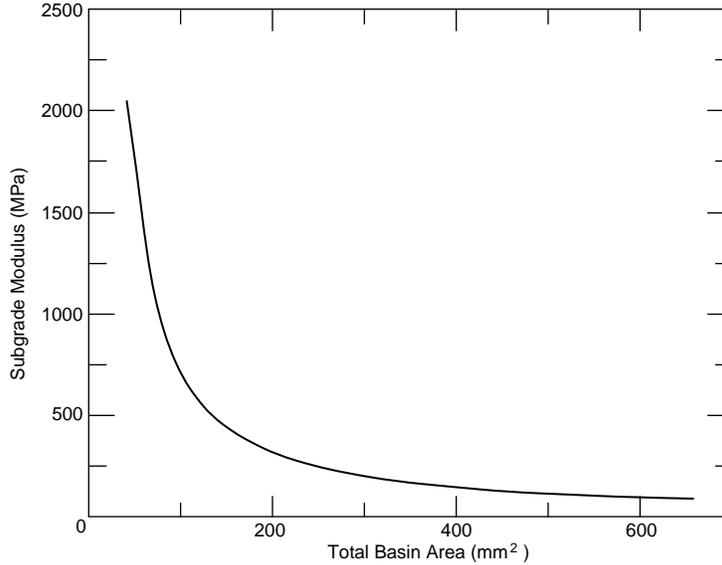
Figure 46. Relationship between total basin area and subgrade modulus.

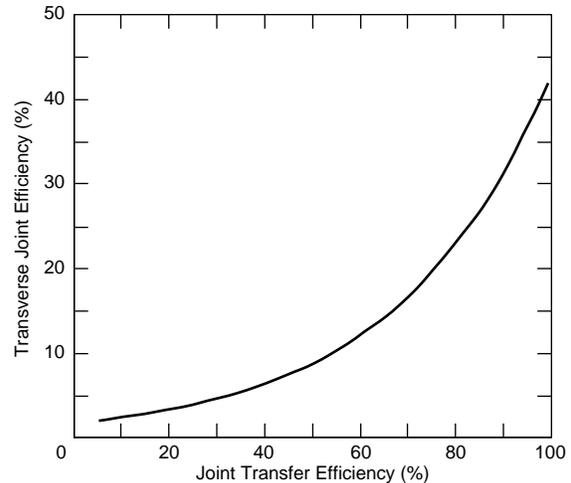
Figure 47. Relationship between JTE and LTE.
