ERDC/CRREL TN-05-6

**Cold Regions Data Acquisition and Analysis
for Section 227 *National Shoreline Erosion
Control Development and Demonstration
Program* Miami Park South, Allegan County,
Michigan**

September 2005

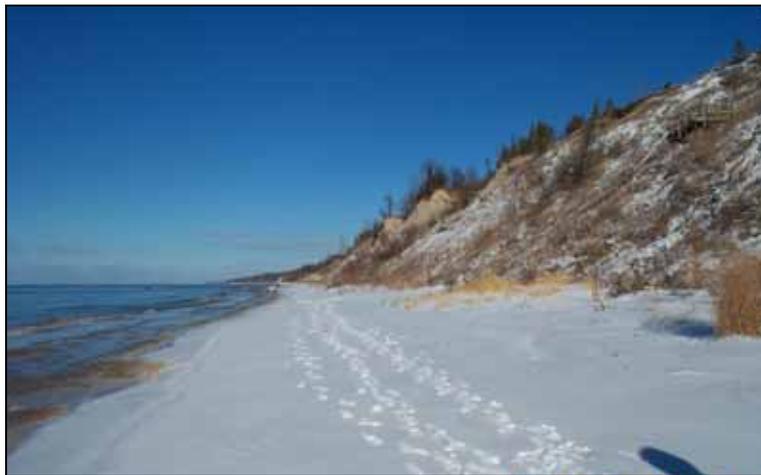
Figure 1. Bluff at Allegan, Michigan looking north. The remediated portion of the bluff is in the right foreground adjacent to the wooden stairway. Lake Michigan is on the left.

The bluff being monitored for this study of soil FT effects on bluff erosion and stability is situated along the southeastern shore of Lake Michigan near the southwestern boundary of the town of Miami Park, Allegan County, Michigan (Fig. 1). The approximate coordinates of the site are UTM 16 561343E 4701534N. The soil is classified as a Capac loam (fine-loamy, mixed, active, mesic Aquic Glossudalfs) (Knapp 1987), and the vegetation is grass and brush. This study site is 500 ft (152 m) long, and the bluff there is 80 ft (24 m) high with an average slope of 28°. Chase et al. (2001) provide a more complete description of the soil and bluff at this site.

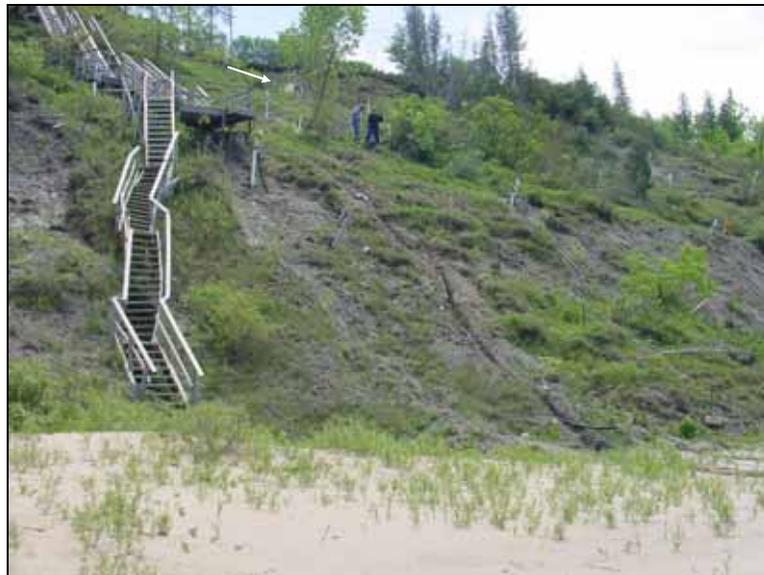
Figure 2. View from below of the remediated section of bluff containing pumping wells, piezometers, and our temperature, soil moisture and resistivity instrumentation. The arrow points to our data logger and web camera.

Western Michigan University (WMU) has monitored the bluff at Miami Park South (MPS), in association with the U.S. Army Engineer District, Detroit, as part of a long-term study of bank failure processes. Their automated instruments currently in operation at MPS to monitor the quantity of water removed, groundwater elevations and temperatures, weather, and slope response include flow meters, nested piezometers (pressure transducers), thermistors, a meteorological station, and slope inclinometers, respectively. Active (electric pumps) and passive (open holes) drains for dewatering have been installed in the sand layers along the remediated section of the bluff (Fig. 2) at depths from 10 to 35 ft (3 to 11 m). These drains connect through a series of pipes instrumented with flow meters, and discharge into sumps on the beach. The overall layout of this instrumentation is mapped in Figure 3.

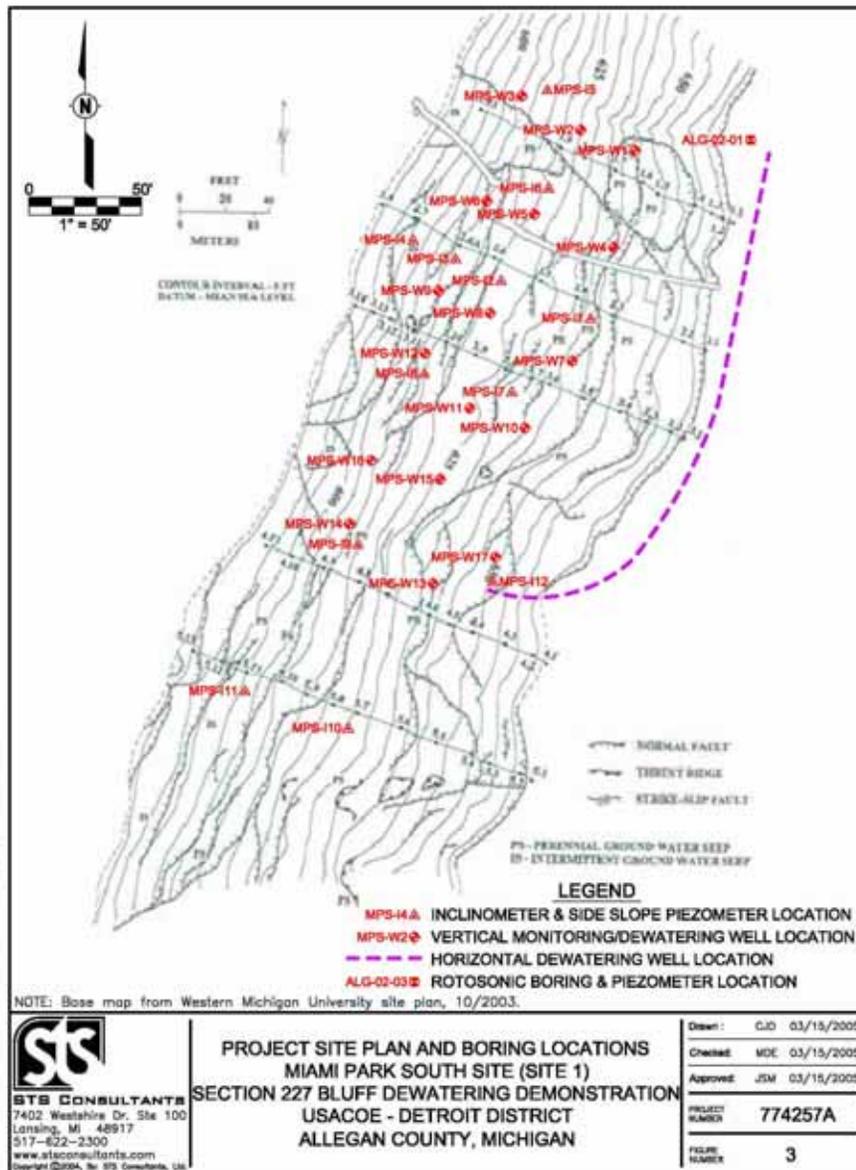
Figure 3. Site plan of Miami Park South bluff stabilization demonstration project. Remediated site instrumentation is just upslope of MPS-I7, and control site instruments are just upslope of MPS-I10.

Our supplemental data acquisition equipment, focused on freeze-thaw processes, was installed in May 2004 at a pair of nearby bluff locations at MPS. Our sites were located just upslope of MPS-I7 in the part of the bluff remediated

against slope failure by dewatering, and just upslope of MPS-I10 in a nearby control area of the bluff (Fig. 3). The instrumentation installed at the remediated and control sites was identical, and is depicted in Figures 4 and 5, respectively. Boreholes drilled at each site the previous fall allowed us to place the instruments at significant depths in the bluff. The instrumentation installed in these boreholes monitor profiles of soil moisture, temperature, and resistivity, indicating the frozen or thawed state of the bluff. Each instrument or string of instruments was hard-wired to a data logger located nearby. Web cameras at each site, mounted above the loggers, photograph ground conditions at the instrument locations three times a day to monitor snow and vegetation cover, ice formation on the slope or lake, and slumping of the slope. The data and photographs are sent from the loggers via RF radio links to the instrumentation building at the top of the bluff, and then transmitted via modem through phone lines to CRREL for web posting and archiving at <https://webcam.crrel.usace.army.mil/allegan/>. The loggers, powered by 12-V batteries that are recharged by 50-W solar panels, contain external backup data storage units that can be manually downloaded to preserve the data record at times when data transmission is not functioning.

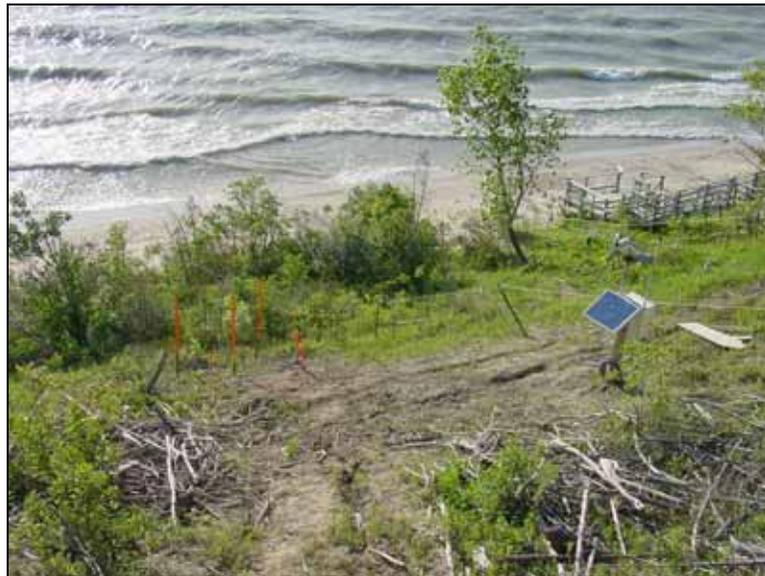
Figure 4. View from above of our site in the remediated part of the bluff. Soil temperature, moisture, and resistivity instrument profiles in the bluff are marked by orange stakes, with solar panel, data logger, and web camera visible in a cluster on the right.

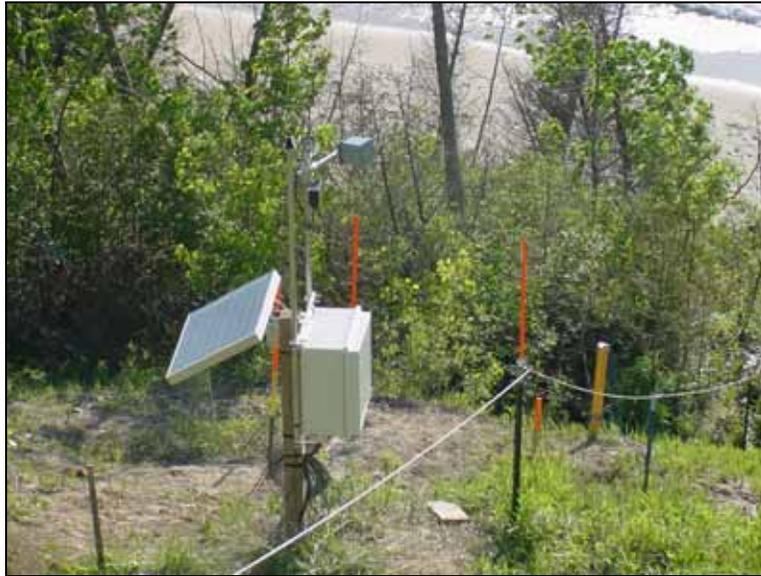
Figure 5. View from above of our site in a nearby control section of the bluff. Soil temperature, moisture, and resistivity instrument profiles in the bluff are marked by orange stakes, with solar panel, data logger, and web camera visible as a cluster in the foreground.

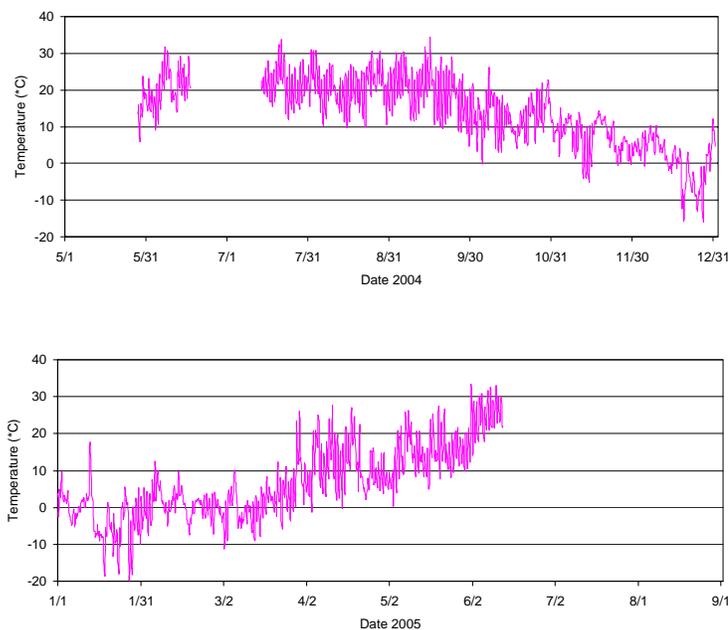
Figure 6. Logger/air temperature data from the remediated site, May 2004 into June 2005.

Air temperatures for the complete period of record at the remediated site are given in Figure 6. The data gap from 17 June to 13 July 2004 in this and subsequent figures was caused by a combination of data transmission malfunction and an error in the setup of the local backup data storage system. After this gap, the

data storage backup was restored and worked properly for the rest of the period. Large diurnal air temperature changes are common through much of the year, but are not in evidence from mid-November through January. Short-term temperature changes during a brief period in January exceeded 30°C , and changes nearly as large can also be noted at several other times during the year. Several brief periods with air temperatures below -10°C occurred in mid- to late December, and again in mid- to late January. Air temperatures remained above -20°C during all of these events. Temperatures exceeding 10°C occurred three times in December and twice in January. Air temperatures in November through mid-December, and again in February, were generally above freezing. Even without a snow cover, these relatively mild winter temperature conditions are not usually sufficient to develop frozen ground at depth. Soil resistivity at both the control and remediated sites did not deviate significantly from $0\ \text{V}$ at any depth during the winter, indicating that soil freezing was limited to the upper 5 cm at the measurement locations.

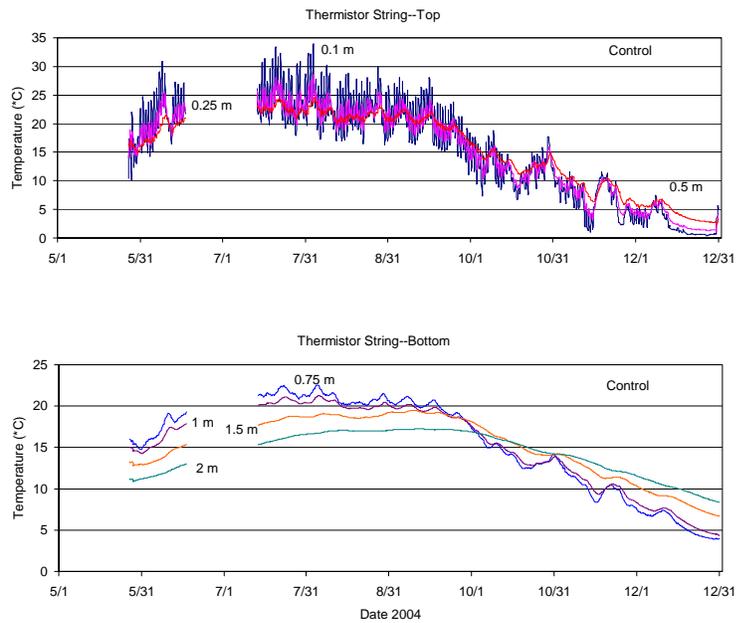
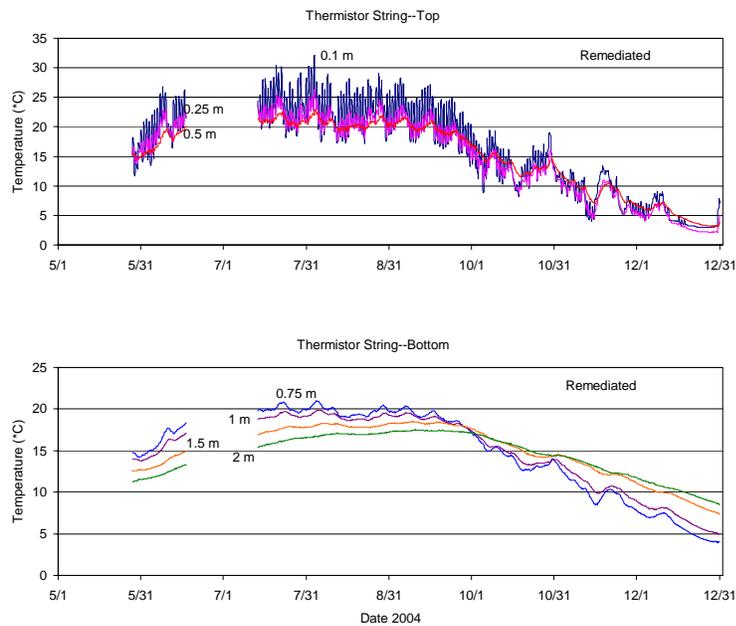
a. Control site.

b. Remediated site.

Figure 7. Soil temperature data for the upper 2 m obtained by the thermistor string in 2004.

Soil temperature data for 2004 obtained from the thermistor strings are given in Figure 7a for the control site and in Figure 7b for the remediated site.

Diurnal temperature changes are clearly visible in the 0.1- and 0.25-m records at both sites, with the shallower depth producing the larger fluctuations. The temperature records at 0.5 m are smoothed, and clearly show short-term temperature trends. These short-term trends remain visible down to 1.5 m, while 2 m temperature records indicate nearly identical seasonal trends at the two sites. The 2-m temperatures were very stable through 2004, with a complete range of only 8.9°C. The temperatures at 0.1, 0.25, and 0.5 m exceeded 30, 25, and 22°C, respectively, at both sites during August, and are generally higher than the deeper temperatures during the summer. Soil temperatures at 0.75 and 1 m peaked near 20°C in August at both sites, while those at 1.5 and 2 m peaked at 19 and 17°C, respectively, in September. Shallow soil temperatures were lower during the fall than those at greater depth, with a transition that occurs in late September to early October. Minimum temperatures at the end of the year, 0.5 and 2.1°C, were located near the top surface of each profile, while 2-m temperatures remained at 8.4°C. These positive temperatures concur with the lack of soil freezing indicated by the resistivity and air temperature data. Several discrete warming and cooling events show that soil temperature change is initiated at the surface and propagates downward through the profile with time, lagging and diminishing in amplitude. For example, a fall temperature trough of 1.0°C at 0.1 m on 14 November causes subsequent troughs of 6.7°C at 0.5 m on 16 November, 9.4°C at 1 m on 17 November, and 11.3°C at 1.5 m on 19 November. The shallow-depth diurnal soil temperature fluctuations at both sites diminished through the fall of 2004, and disappeared in mid-December. The decrease in soil temperature fluctuations follows from diminished air temperature fluctuations.

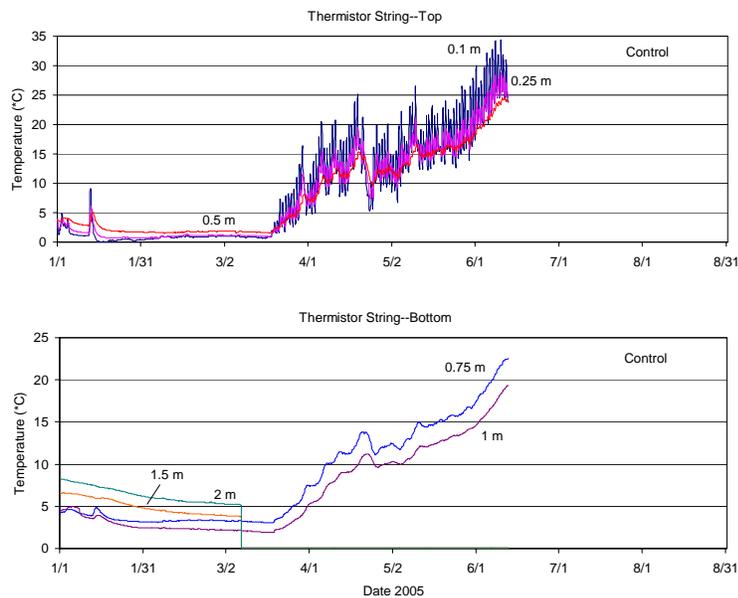
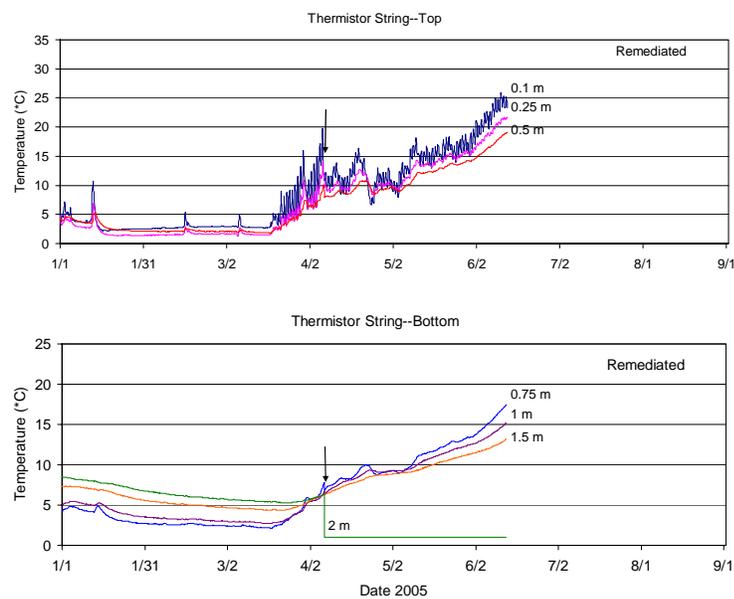
a. Control site.

b. Remediated site, with arrow indicating event of 7 April.

Figure 8. Soil temperature data for the upper 2 m obtained by the thermistor string in 2005.

Figures 8a and 8b extend the thermistor string soil temperature records into 2005 for the control site, and the remediated site, respectively. Starting on 31 December, the shallow ground temperatures at both sites increase and remain elevated during the first several days of January. This increase is in response to an air temperature increase immediately prior that was followed by a sustained warming. A spike in air temperature on 12 January above 17°C is reflected in the ground temperature response at both sites down to 1 m over the next several days. Winter soil temperatures were generally stable at both sites following this event, with the exception of small increases in the upper 0.25 m at the remediated site on 15 February and 8 March. Both of these events were related to elevated air temperatures immediately before. According to the met station records for the top of the bluff, there was steady, light precipitation on 13–15 February, but no significant precipitation was recorded on or before 8 March. Also on 8 March the lower two sensors of the thermistor string at the control site were lost, probably in response to a local slope failure between 1 and 1.5 m. Progressively increasing air temperatures through the middle of March were eventually reflected in shal-

low soil temperature increases from winter levels, beginning on 20 March at both sites, and diurnal temperature fluctuations at 0.1 m resumed shortly thereafter.

On 6 April the air temperature peaked at about 25°C, and on 7 April at about midday the 2-m sensor at the remediated site was lost and all other thermistor string soil temperatures there decreased abruptly (upper part of Table 2). Temperatures at 1 and 1.5 m decreased to the pre-event temperature at 2 m (6.3°C), while temperatures at 0.25, 0.5, and 0.75 m decreased by 1.9, 2.2, and 1.0°C, respectively. A soil temperature decrease at this time of year indicates deeper groundwater moving into shallower depths. Following this brief excursion of a few hours, these temperatures recovered to their previous trends. There was no corresponding event at the control site, and no precipitation was recorded at the met station during this period. A probable interpretation of this event is a failure of the remediated slope between 1.5 and 2 m that caused or was associated with a short duration vertical groundwater head gradient and flow toward the soil surface at the location of the thermistor string.

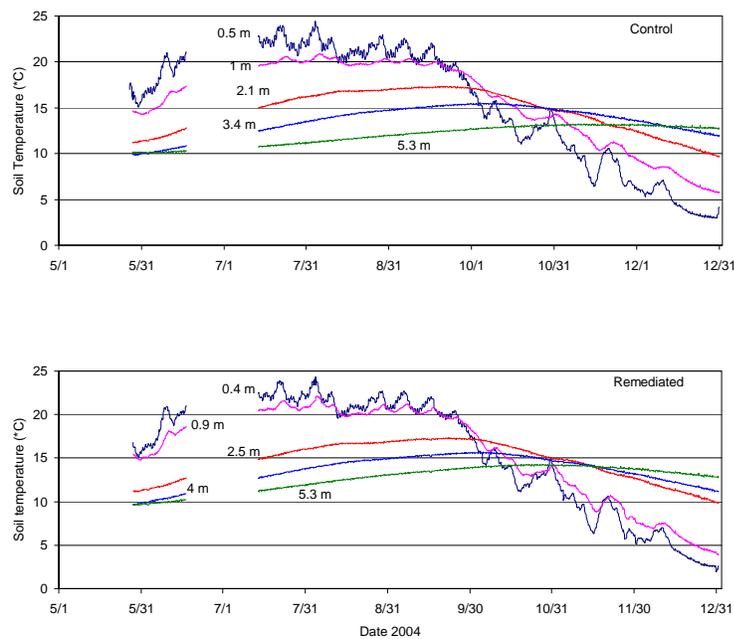
Figure 9. Shallow and deep soil temperature data obtained with the Vitel probes in 2004: control site (top), remediated site (bottom).

Figures 9 and 10 provide additional soil temperature data obtained with the Vitel probes at both sites in 2004 and 2005, respectively. Here, the depth range, 0.4 to 5.3 m, is much greater than that of the thermistor strings. The data from 2004 (Fig. 9) show higher soil temperatures at shallower depths during the warm months, a temperature inversion in the fall, and increasing temperatures with depth in the winter. Diurnal temperature fluctuations are evident at 0.5 m during the warm months, and short-term thermal events initiated at the surface can be

seen at 1 m, lagged in time from shallower depths. At depths exceeding 2 m, only seasonal temperature trends are evident. Figure 10 depicts the same winter thermal events and timing of spring temperature increase at shallow depths that were seen in the thermistor string data. Abrupt soil temperature changes occurring at the remediated site during midday on 7 April are given in the lower part of Table 2. Again, there was no corresponding event at the control site. Unlike the decreasing thermistor string temperatures, the Vitel soil temperatures all increased sharply for a few hours before returning to their original trends. These temperature increases were comparable at all depths, though somewhat larger at shallow depths. Opposite temperature trends between the thermistor string and Vitel profiles, separated horizontally by only a few meters, indicate complex, three-dimensional local flow conditions in response to the disturbance.

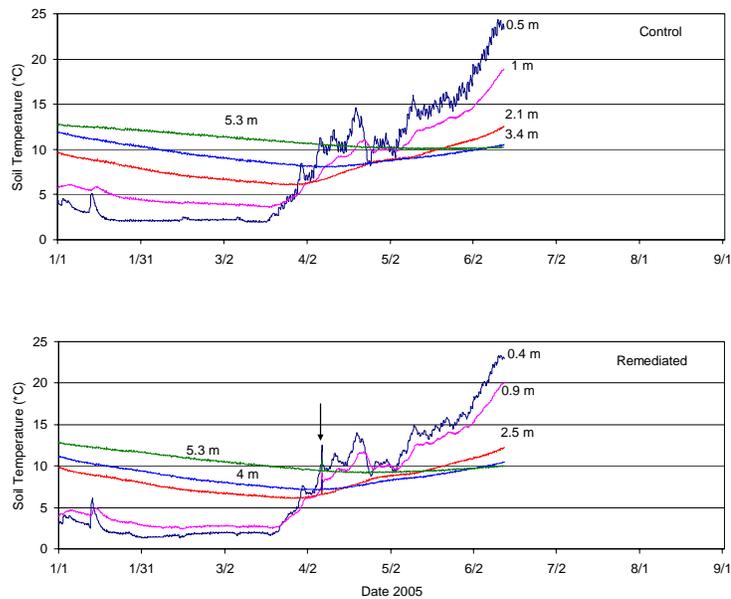
Figure 10. Shallow and deep soil temperature data obtained with the Vitel probes in 2005: control site (top), remediated site (bottom) with arrow indicating event of 7 April.

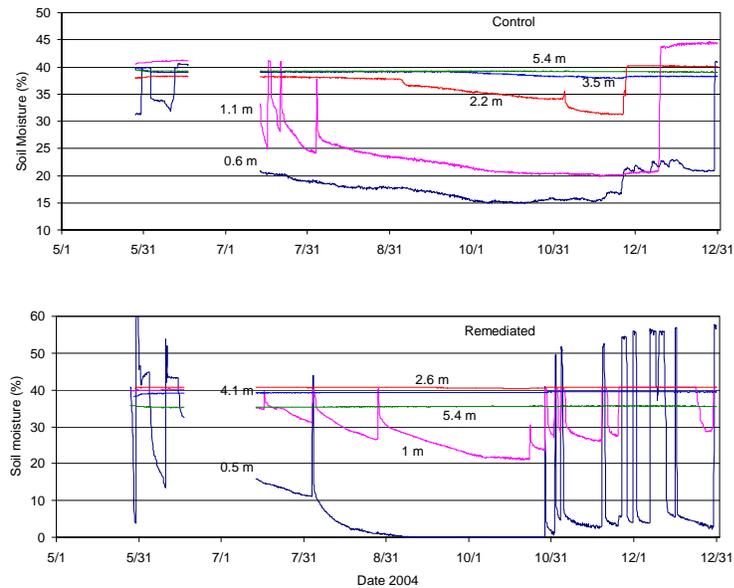
Figure 11. Shallow and deep soil moisture data obtained with the Vitel probes in 2004: control site (top), remediated site (bottom).

Soil moisture profiles at both sites are given in Figures 11 and 12 for 2004 and 2005, respectively. Soil moisture at 0.5 m is dynamic at both sites, especially the remediated site. Increases in soil moisture in the upper 2.2 m of the profile at both sites are frequently correlated with rainfall events recorded at the met station on the top of the bluff. Several soil moisture increases at the remediated site occur together in both the 0.5- and 1-m data. These shallow soil moisture sensors also document drying events affecting the upper portion of the soil column. In 2005 (Fig. 12), the remediated site soil moisture at 0.5 m remains dynamic, while its counterpart at the control site is much less so. On 7 April, the control soil moisture profile is undisturbed, while all remediated site sensors respond at mid-day (arrow in Fig. 12, bottom of Table 2). At 0.5 m the soil moisture increased significantly, while the deeper sensors at the site generally indicated diminished soil moisture, especially at 5.4 m. This deep measurement decreased by 7.5%, and then unlike any other sensor, began to fluctuate. The daily variations were initially more than 3%, but gradually diminished to less than 1% by late May. This soil moisture sensor response is consistent with dewatering of the bluff by nearby pumps. The responses of all instruments listed in Table 2 were coincident with the loss of the 2-m thermistor, linking the arrival of the piezometric surface depression at 5.4-m depth to the shallow slope failure.

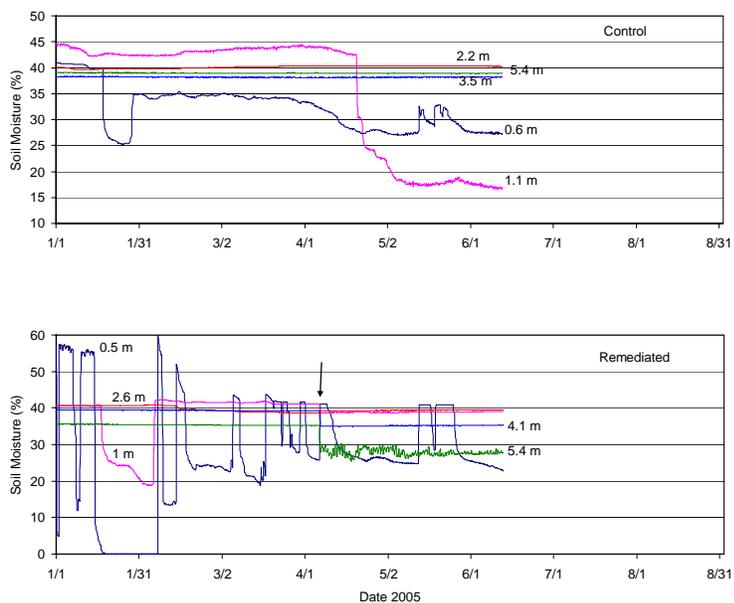
Figure 12. Shallow and deep soil moisture data obtained with the Vitel probes in 2005: control site (top), remediated site (bottom) with arrow indicating event of 7 April.
